**RE: Site Inspection, need for repairs, Georgetown Mine, Permit No. GR020RE**

**MINING INSPECTION REPORT**

**Annual Inspection  
9/30/2009  
Georgetown Mine**

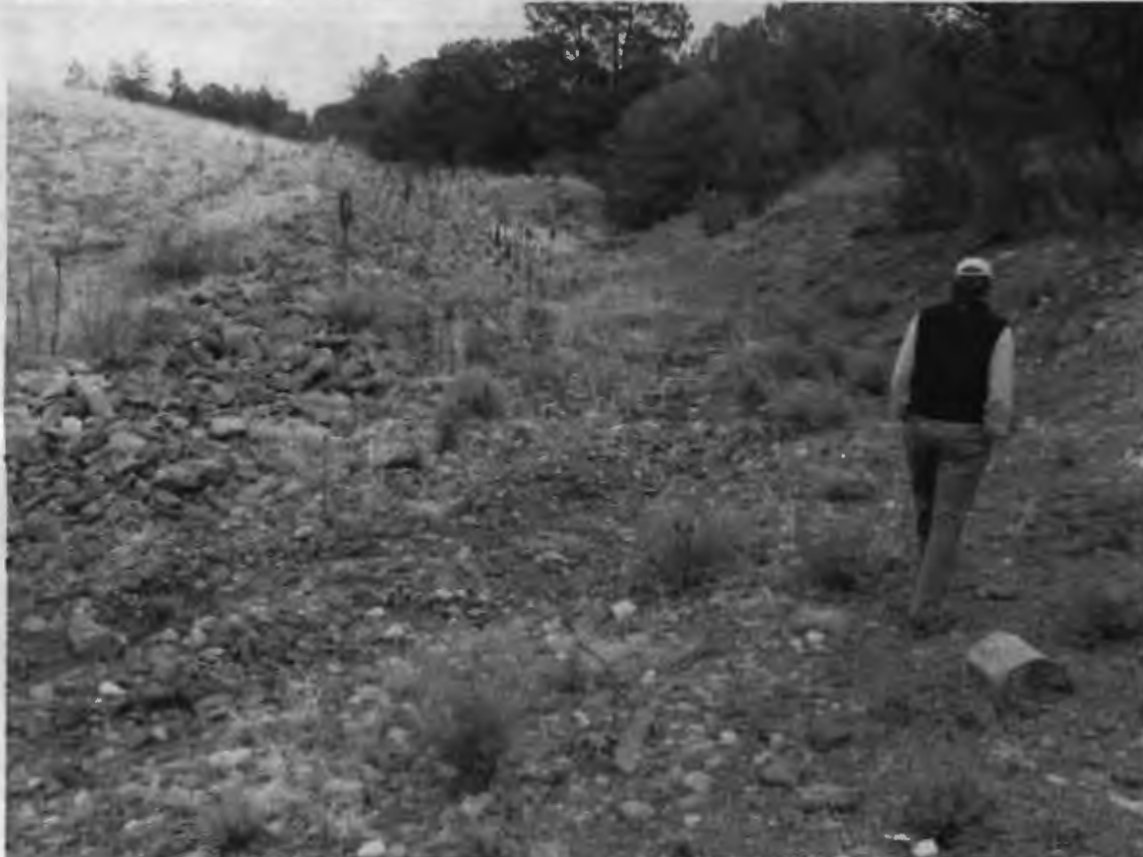
The reclaimed leach pad and the armored ditches around the south perimeter of the waste pile were inspected. The covered waste rock pile is stable and demonstrates a robust vegetation cover, though in winter dormancy. However, some of the riprap armoring in the bottom of the south side diversion channel has been displaced due to a storm event (when?) that caused excessive run-on, from the hillside to the south, with enough energy to move the undersized rip rap. This erosional feature can easily be repaired and would eliminate any risk to the integrity of the cover leach pad. Perhaps some run-on prevention would aid in stabilizing this channel.

**Photo of south side diversion.**

The operator needs to be made aware of the need for maintenance. The meandering nature of the diversion channel ought to be preserved as an energy dissipater.

Stabilize the diversion channel.

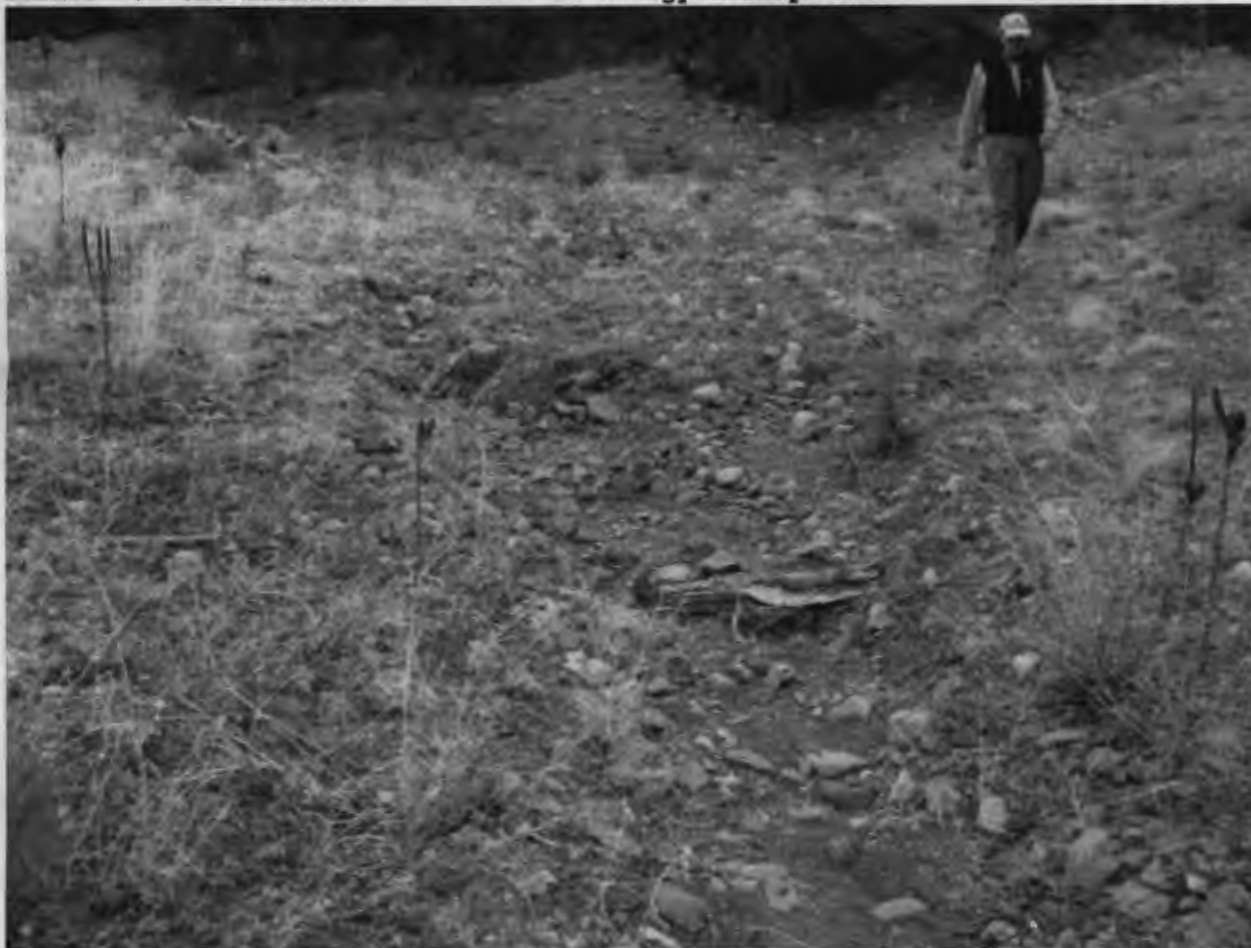
Additional photo of south side diversion. Note meanders, if supported and/or reinforced the meanders could aid in energy dissipation.
