**DEMING MILL AND TAILINGS
REISSUED PERMIT NO. LU009RE**

Updated: RECLAMATION AND UTILIZATION PLAN

**DEMING MILL & MILL TAILINGS
DEMING, NEW MEXICO**

**Updated: Reclamation for Tailings
Identified by Test Pitting**

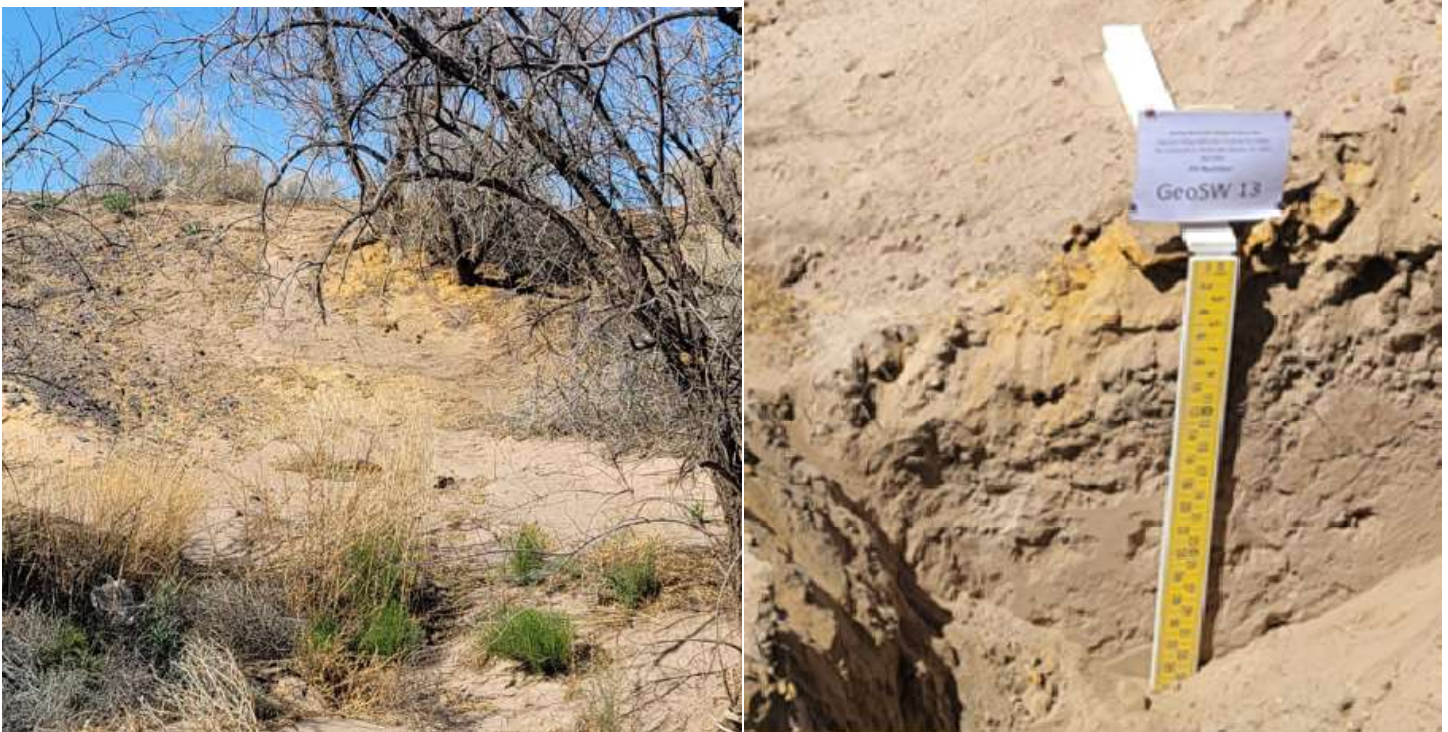
Figure 4. Tailings on Mimbres Riverbank at A – A' Longitudinal Section

“Limited testing in this area immediately adjacent to the river channel revealed only one site where the tailings are present. Here 15 inches of weakly cemented interbedded fine grained sand tailings mixed with medium to coarse alluvial sand was encountered at the surface, in the bank but not in the river channel. There is little evidence to indicate that the tailings are being transported downstream in the river channel but rather are related to slope wash. It is estimated that only 1,837 square feet of this material is present here.” See Figure 3.

1. Trees will be removed from areas underlain by mill tailings.
2. A track backhoe with an extended arm and 1 yard bucket will be used to peel back the surface where tailings are present in six-inch layers until undisturbed, natural sediments, without tailings are encountered. Tailings to be excavated are estimated to be less than 600 cu yds.

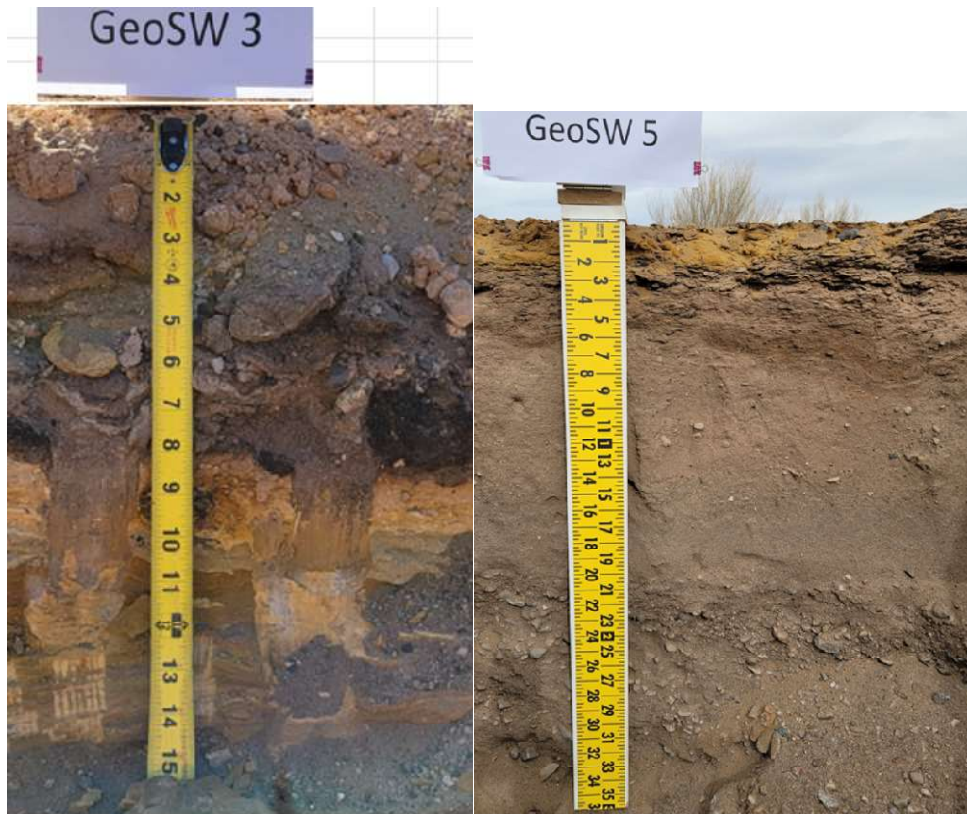
Figure 8. Tailings in Middle Flat Area at B – B' Longitudinal Section

Only three pits in this area intersected tailings. The most notable occurrence was in pit GEOSW3 where very well cemented tailings prevented excavation beyond 19 inches. The tailings consisted of 10 inches of well cemented sandstone comprised of tailings overlain by 5 inches of Interbedded loosely cemented light gray and black medium grained sand with root fragments. Further study revealed that the cementing agent here is gypsum. In an adjacent pit, GEOSW5, the tailings covered soil containing root material. Leaching from the tailings above was sufficient to produce 4 inches of soil with a pH of 3.78. This area is estimated to contain 1.51 acres of tailings.

1. Much of the area outlined for Middle Flat is underlain by mill tailings. They will not be moved or disturbed.
2. Tailings from the Mimbres River and Thickener Tank South areas will be hauled to the Middle Flat area, dumped, leveled, and contoured prior to adding cover material. The actual volume of the tailing material coming from other areas is not known.

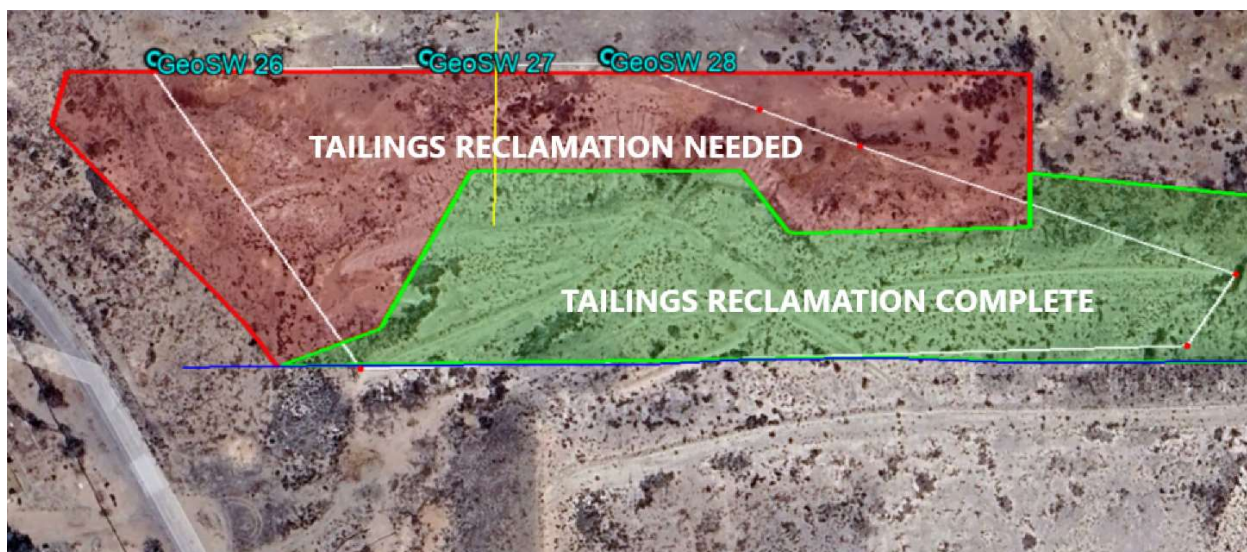
Figure 12. Cypress North Slope Reclamation Map

Detailed mapping completed during the current Alternatives Analysis has resulted in a more accurate understanding of the geographic distribution and nature of the mill tailings in this area. Much of the reclamation of the Cypress North Slope area included in Permit No LU009RE was completed by past operators and is still viable, covered with material from the borrow pit. Therefore, no additional efforts will be needed in this area. See Figure 12. Tailings Reclamation Complete

The area to the north (3.13 acres) with exposed mill tailings is still in need of reclamation. The reclamation of this area was also completed by previous operators, but subsequent erosion has exposed the underlying tailings and washed them down slope. The tailings at the toe of the original pile are several feet thick and do not lend themselves to relocation. Figure 12. Tailings Reclamation Needed.

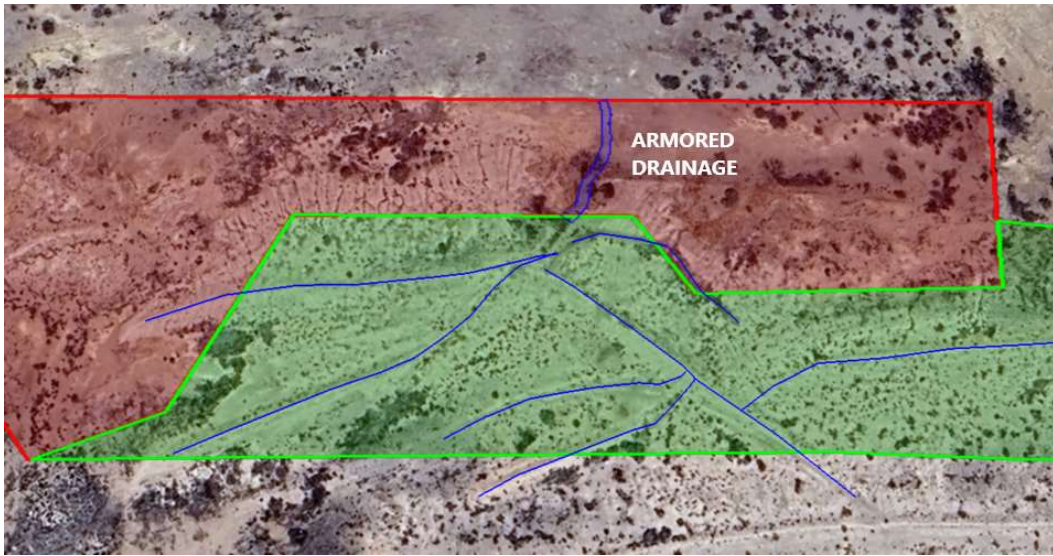
Figure 16. Existing water collection & Proposed Armored Drainage in the Cypress North Slope Area

6. Finished slopes at the edges of the cover material will be (flatter than) less than 3 to 1 horizontal to vertical ratio.
4. Where tailings reclamation was completed by Cypress a network of cross-slope ditches and berms captures water in the up-slope areas and routes the flow across areas of the current reclamation effort. Most of these ditches show no erosion due to very low flow gradient. However, one area shown in Figure 15, by double blue lines, has been identified as an area of

steeper flow gradient where erosion has occurred. The collection drainage in this area will be armored to prevent future erosion of cover materials and tailings.

5. Armor material will be cobbles measuring 6 to 7 inches in diameter and will be obtained from a gravel company in the Deming area. Approximately 25 cubic yards of armor material will be needed and is estimated to cost \$1,000.00.
6. Areas disturbed or covered with pit material during this reclamation effort will be revegetated according to requirements cited in Section 9.F Reissued Permit No LU009RE – Permit Revision 14-1.

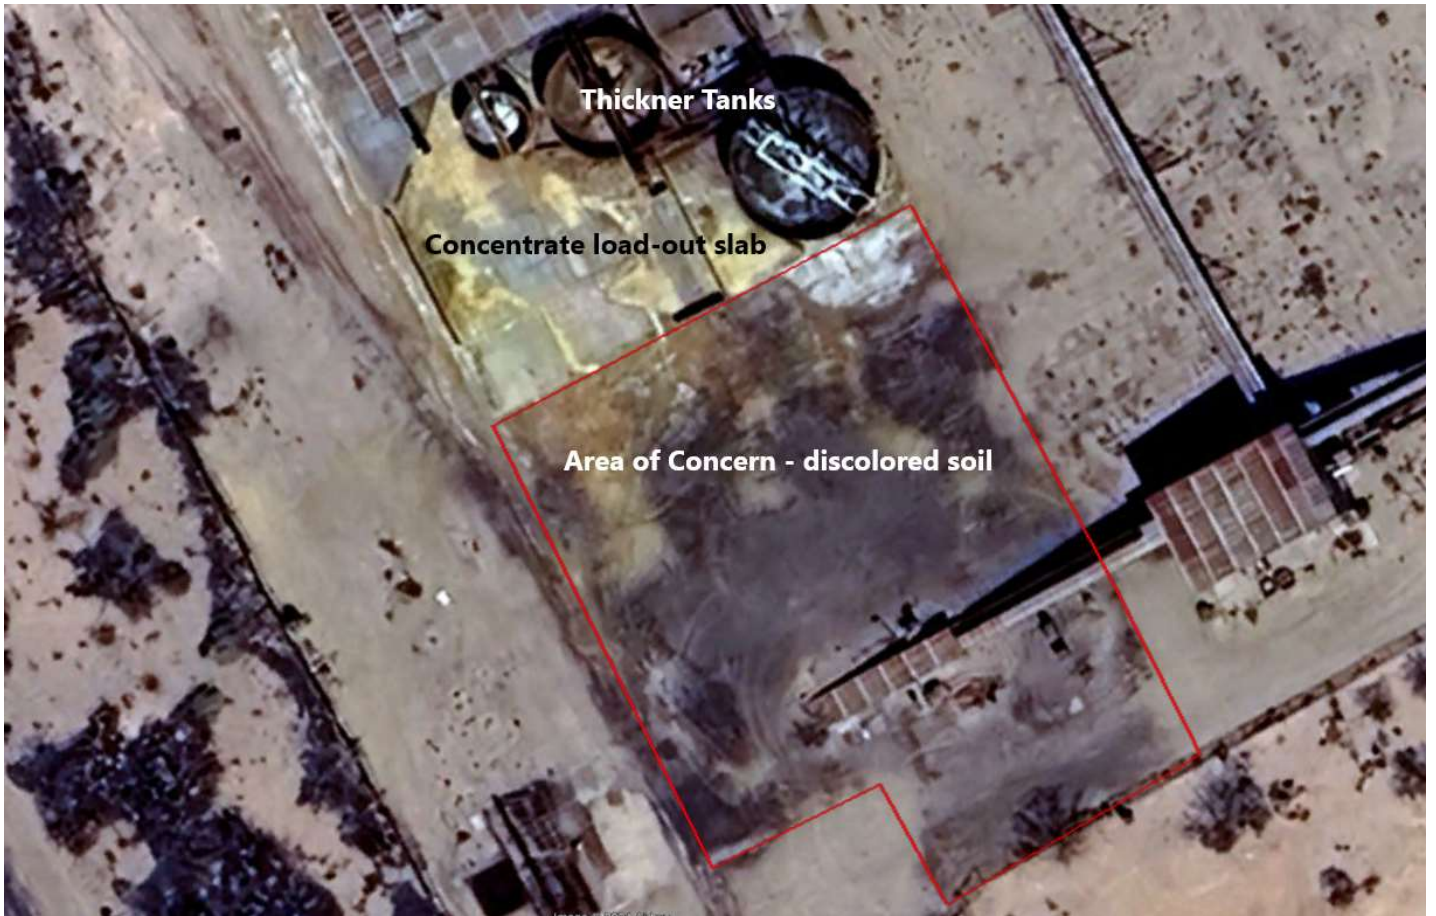
Revision 14-1 Permit No. LU009RE Geo Southwest Deming Mill & Tailings, Luna County, NM, Updated Closeout Plan and Permit Re-issuance effective December 11, 2023, identifies an area of concern south of the thickener tanks at the mill (See Section 9.I.d and Section 9.I.e), hereafter referred to as the Thickener Tanks South Area. Several years ago, reclamation of this area was completed by ENVIRON. Subsequent rainwater leaching of the zinc/copper concentrates located in the large thickener tank followed by, leakage and drainage to the south contaminated and discolored the soil. The concentrate is still present in the thickener tank. The following steps will be taken to complete the reclamation of this area.

1. Areas of contamination will be visually identified within the 0.56-acre area of concern.
2. Contaminated soil will be removed using a track back-hoe with an extended arm by scraping a few inches at a time, removing only the contaminated material.
3. The contaminated soil will be hauled by dump truck to the Mid Flat area and spread out in a thin layer where existing mill tailing will be in the process of reclamation.
4. The relocated contaminated soil will be covered with 3 feet of cover material from the borrow pit in due process as the mid flat area reclamation is completed.

5. Cover material from the borrow pit will be used to bring the soil surface in the thickener tanks south area back to its original level and grade for stormwater control using dump trucks and a road grader.
6. This is an active work area for the mill. Therefore, no attempt will be made to revegetate the area which will be finished as a graveled yard.
7. Estimated Cost: \$5,000
