MINING INSPECTION REPORT

Name of Operator: B.O.W. Corporation
Name of Mine: B.O.W. Mine
Address:
Permit Number: OT001MN
Commodity: Garnet <u>X</u> SURFACE <u> </u> UNDERGROUND
Date of Inspection: October 8, 2008
Time of On-Site Inspection: 3:00 PM – 5:30 PM
Weather Conditions: Warm (75F), clear, very little wind
Purpose of Inspection: annual
Lead Inspector: Chris Eustice
Present During Inspection: MMD: Chris Eustice
ENFORCEMENT ACTION TAKEN: None NOTICE OF VIOLATION: # <u> </u> YES: <u> </u> NO: <u> X</u> CESSATION ORDER: C07-12-1 YES: <u> </u> NO: <u> X</u>
Time: On-Site: <u> 2.5 </u> Permit Review: <u> 1 </u> Travel: <u> 4 </u> Report Writing: <u> 1 </u>
TOTAL INSPECTION TIME: <u> 8.5 </u> HOURS
NOTE:

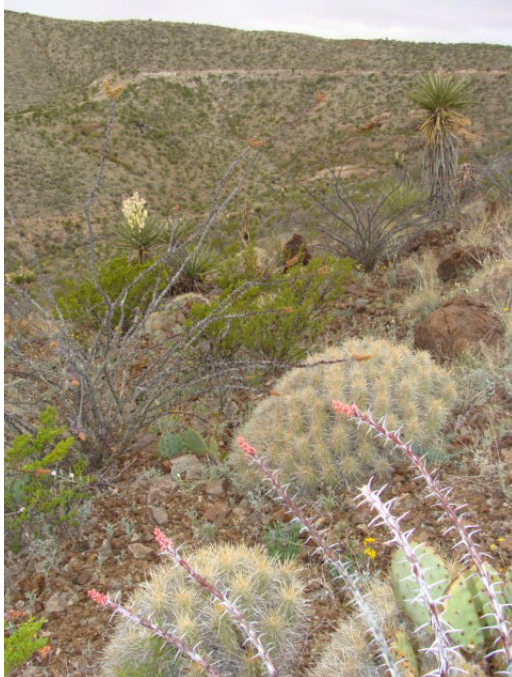
Photo below is looking SW across the permit area. The historic prospector diggings and some of the previous and permitted exploration digs can be seen.

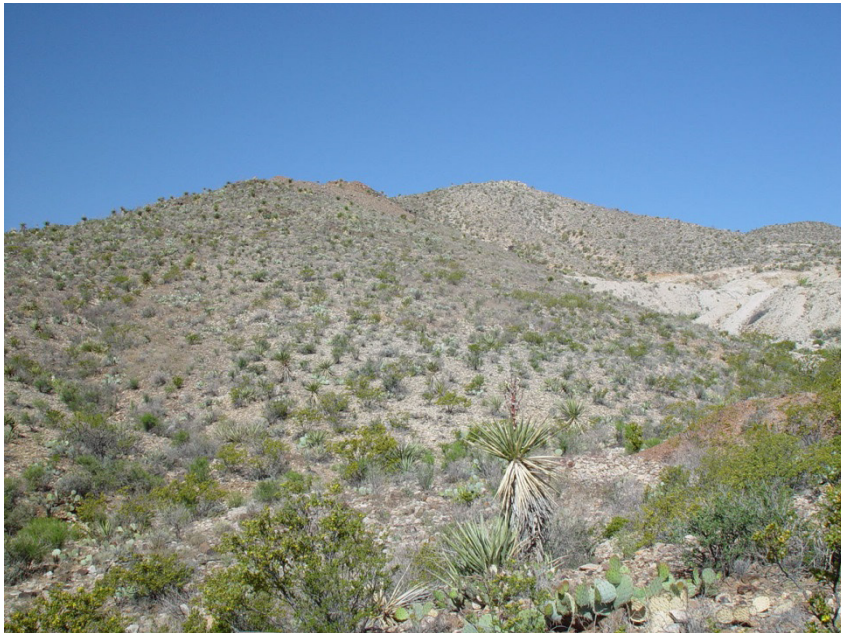
Photo below is looking SW across the permit area toward the access route to employed by drilling contractors.

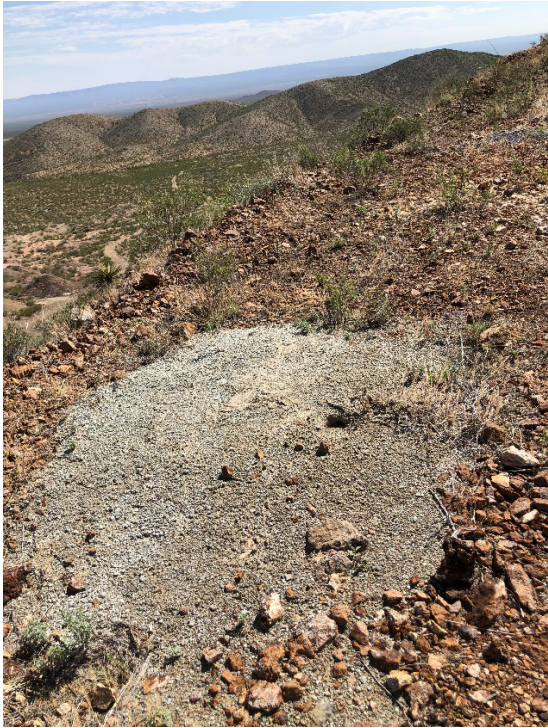
Prior to the site visit the operator was notified of our planned visit but they did not respond. There does not appear to be any new disturbance since the last inspection. Some of the abandoned boreholes were located. The concrete was visible and not covered with any soil.

Figure 2: Abandoned Exploration Hole (SE)

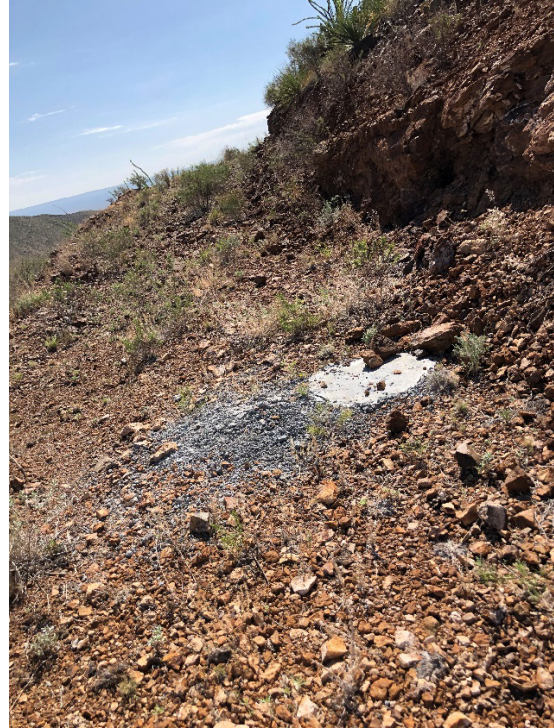
Figure 3: Abandoned Exploration Hole (SW)

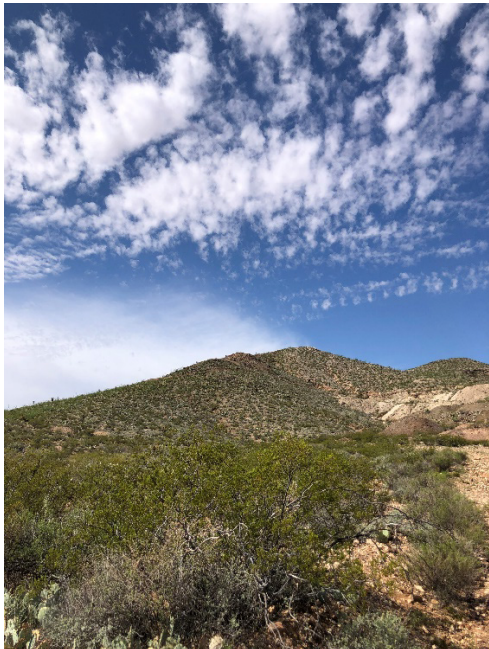
Figure 4: Garnet Body (W)

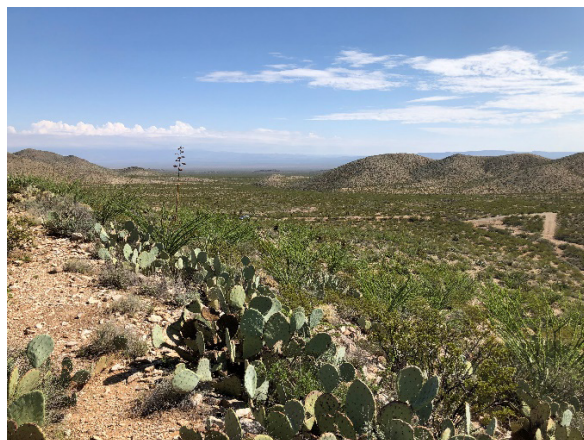
Figure 5: View from halfway up the hill (E)
