# Post Mine Land Use Building Inspections

**Freeport-McMoRan Inc.  
Chino Mines Company  
99 Santa Rita Mine Road  
Vanadium, New Mexico 88043**

**Telesto Solutions Inc.  
750 14<sup>th</sup> Street SW  
Loveland, Colorado 80537**

**March 2024**

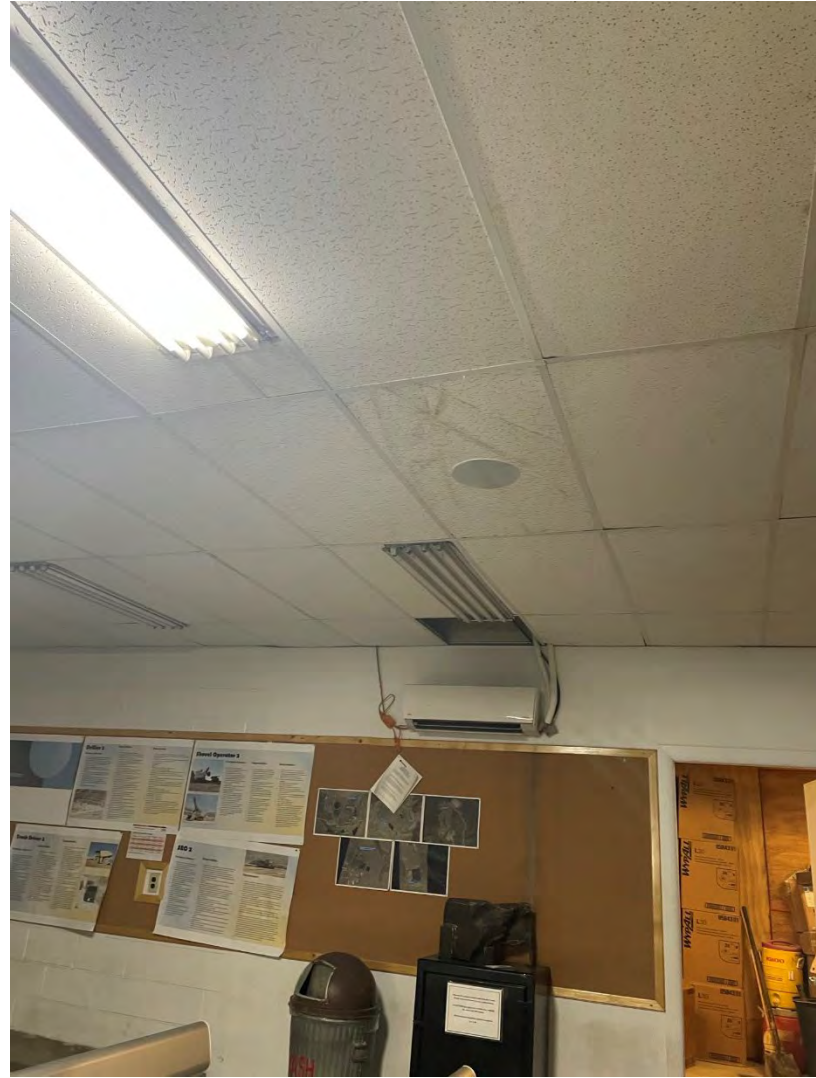
**MF-09**  
**Internal Damage**

<b>Electrical</b>						
Power supply	X			* electrical room, didn't inspect panel *		
Power distribution	X					
Lighting	X					
Other utilities if present						
<b>Architectural</b>						
Condition of Flooring	X			* replacement of <del>panels</del> panels needed		
Wall systems	X					
roofing	X					
ceilings	X					
doors	X					
windows	X					
points of egress	X
