PROJECT: 200450-001	TASK 03
PREPARED BY:

PMLU BUILDING INSPECTION FORM

Freeport-McMoran Chino Mine

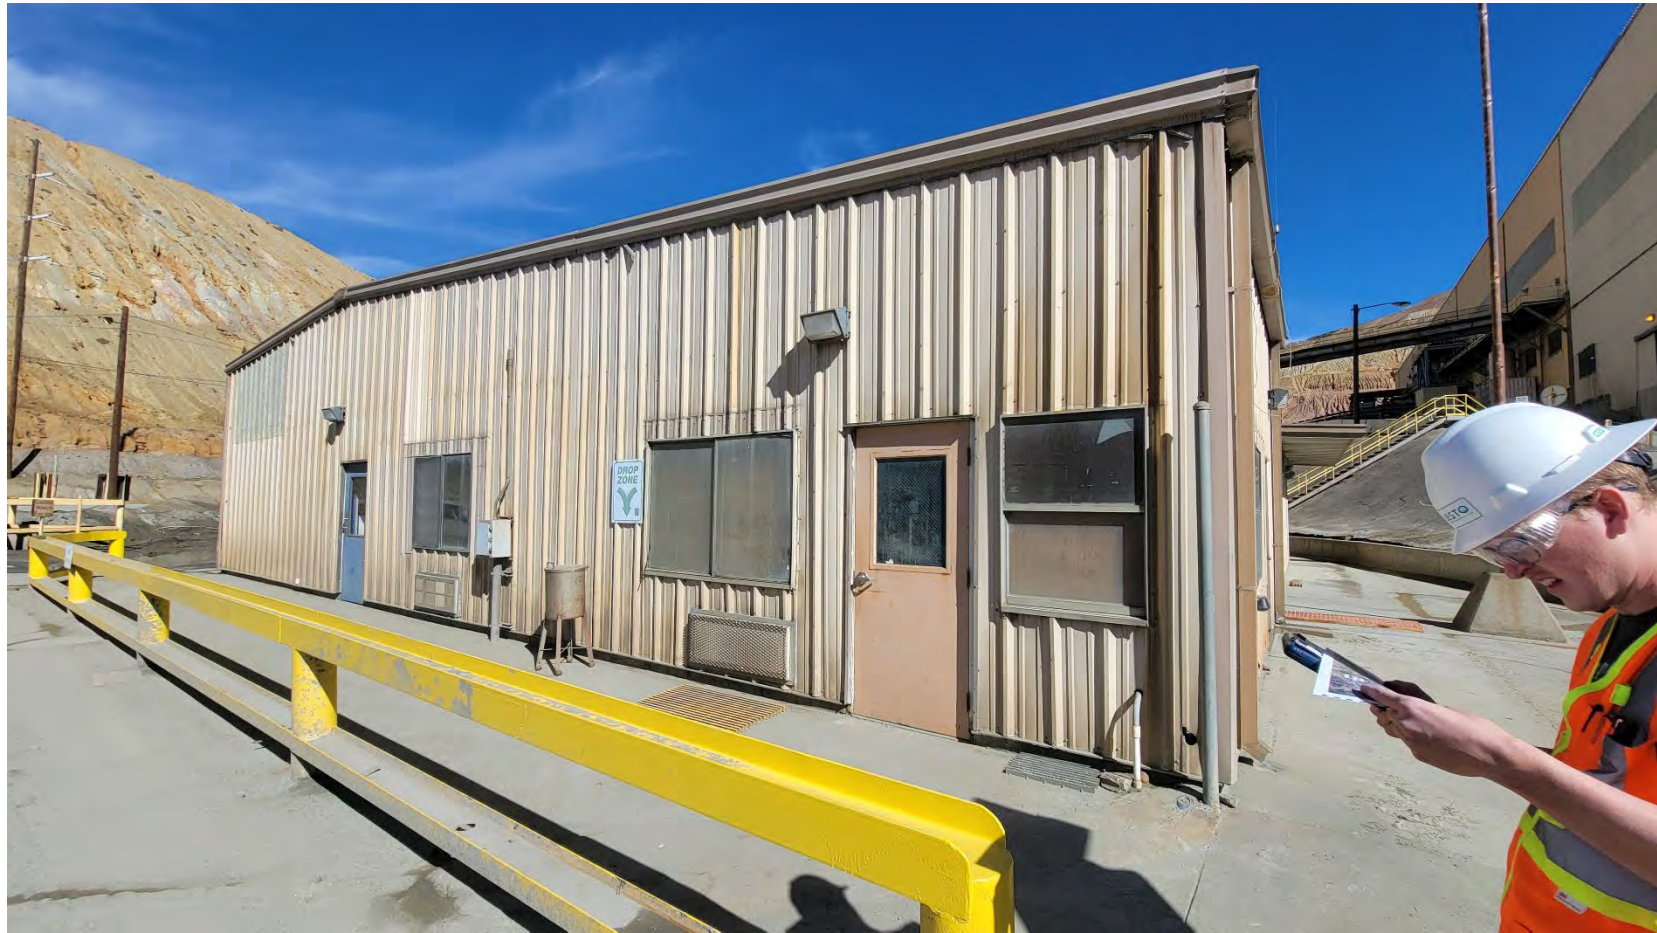
CP-01
External View

Category	Condition			Comments
	Good	Fair	Poor	
Civil				
Condition of Site	X			
Drainage Around Facility		X		rusty gutters, water ponding
Access to Facility	X			
Building Parking				nn
Fencing or Security				
Foundation				
Foundation	X			
Floor Slabs	X			
If process Facility: Cond of equip fnds				
Structure				
Framing: Walls		X		Dented walls, hole in wall
Framing: Roofs	X			
Framing: Internal	X			
If Concrete structure				
Mechanical				
HVAC if present	X			
Water Supply if present	X			
Waste water if present	X			
Other utilities if present				
Fire protection if present				nn
Piping				
if facility is not building				
if facility is process				
Electrical				
Power supply	X			
Power distribution	X			
Lighting	X			
Other utilities if present				
Architectural				
Condition of Flooring	X			
Wall systems	X			
roofing	X			
ceilings	X			
doors	X			
windows	X			
points of egress	X

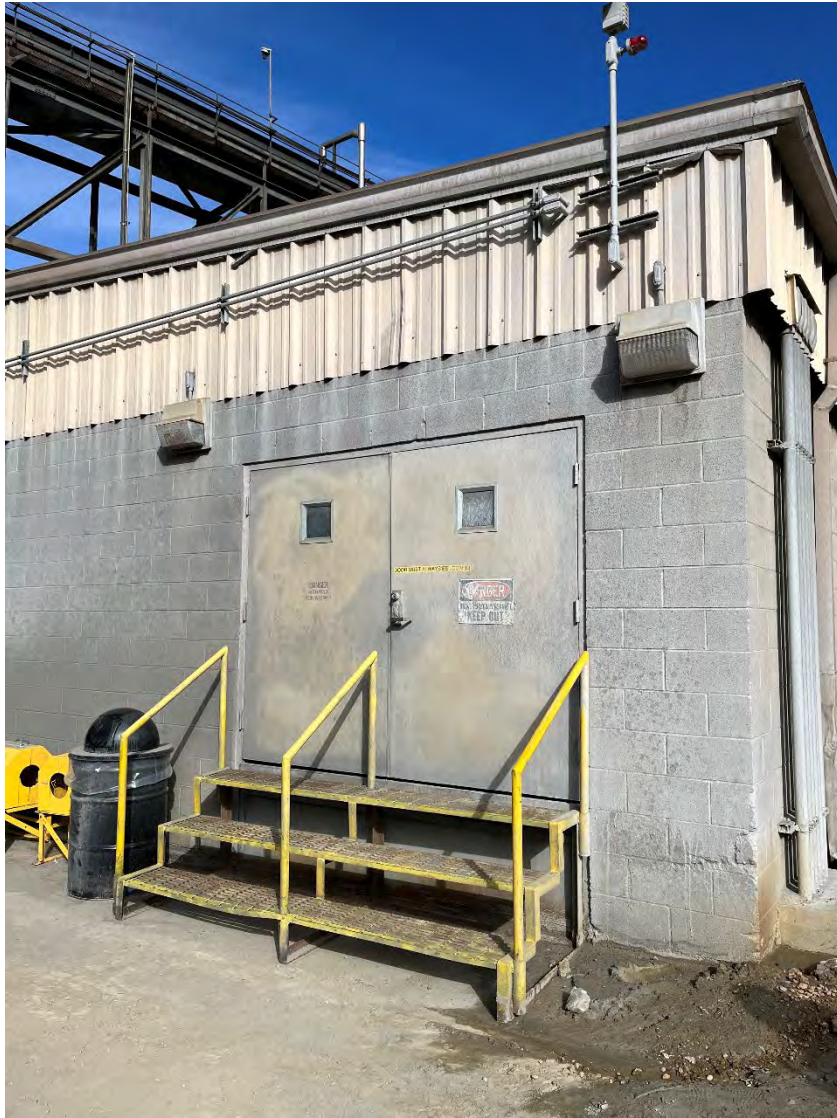
CP-05
External View & Damage

Category	Condition			Comments
	Good	Fair	Poor	
Civil				
Condition of Site	X			Pooling along eastern edge
Drainage Around Facility		X		
Access to Facility	X			
Building Parking		X		
Fencing or Security	X			
Foundation				
Foundation	X			
Floor Slabs	X			
If process Facility: Cond of equip fnds				
Structure				
Framing: Walls	X			
Framing: Roofs	X			
Framing: Internal	X			
If Concrete structure				
Mechanical				
HVAC if present				↑ ↓
Water Supply if present				
Waste water if present				
Other utilities if present				
Fire protection if present				
Piping				
if facility is not building				
if facility is process				
Electrical				
Power supply	X			
Power distribution	X			
Lighting	X			
Other utilities if present				
Architectural				
Condition of Flooring				
Wall systems				
roofing				
ceilings				
doors				
windows				
points of egress

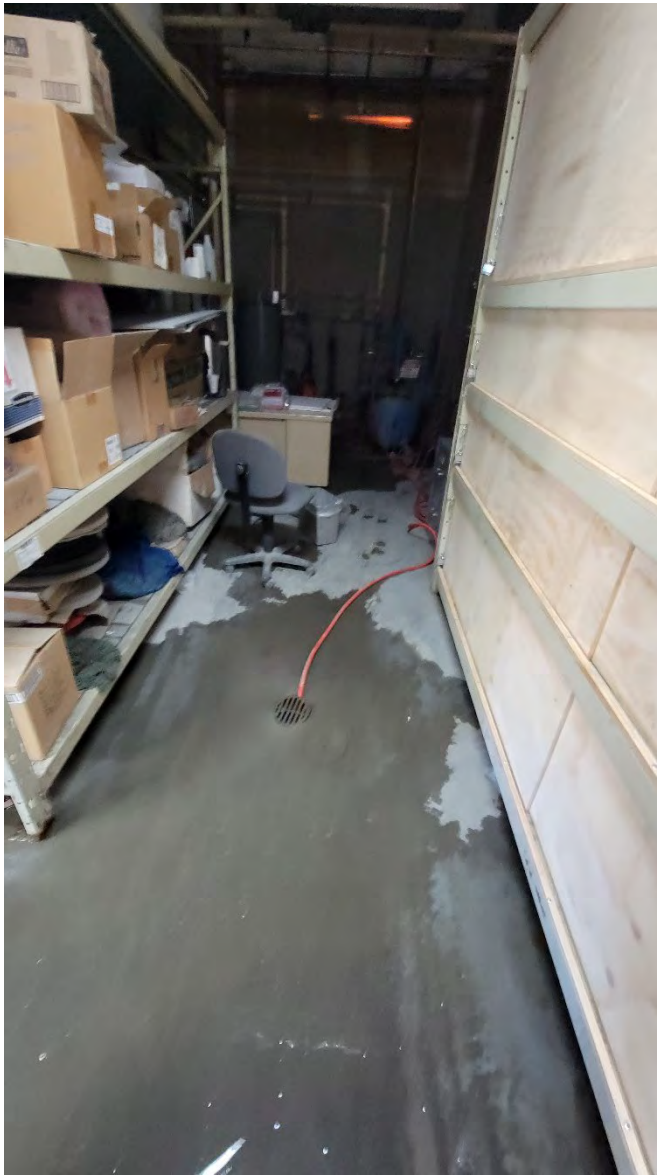
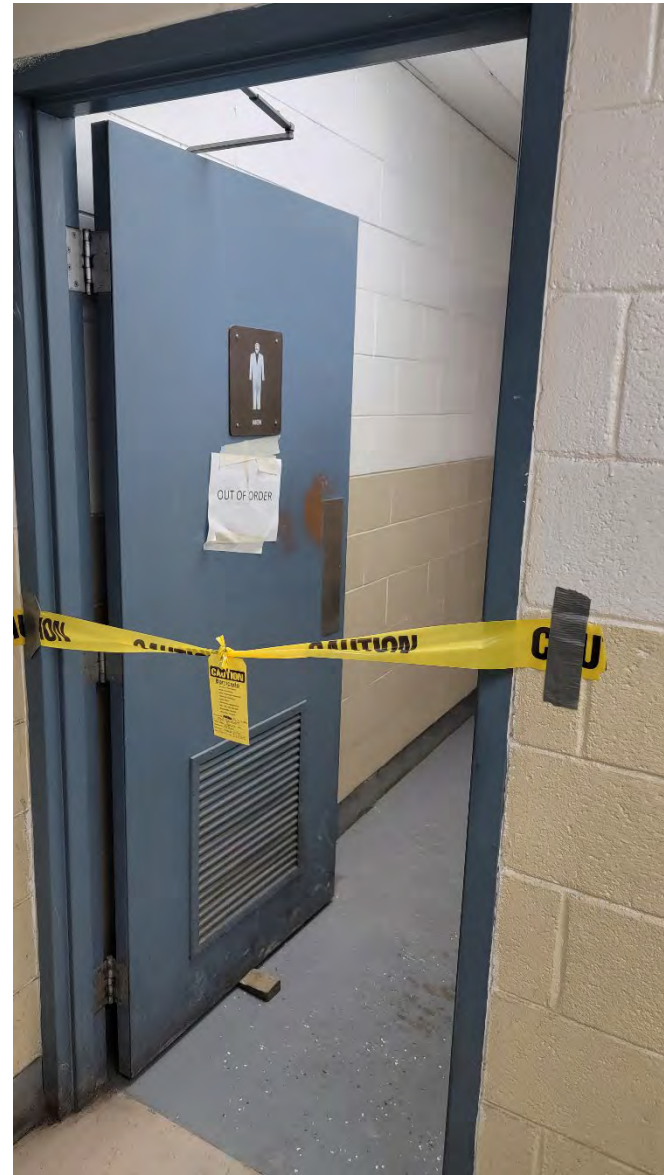
CP-12
Internal Damage

Category	Condition			Comments
	Good	Fair	Poor	
Civil				
Condition of Site	X			Improper Drainage inside
Drainage Around Facility		X		
Access to Facility	X			
Building Parking	X			
Fencing or Security				
Foundation				
Foundation	X			
Floor Slabs	X			
If process Facility: Cond of equip fnds				
Structure				
Framing: Walls	X			
Framing: Roofs		X		
Framing: Internal	X			
If Concrete structure				
Mechanical				
HVAC if present	X			Eye wash stations
Water Supply if present	X			
Waste water if present	X			
Other utilities if present	X			
Fire protection if present	X			
Piping				
if facility is not building				
if facility is process				
Electrical				
Power supply	X			Fume hood vacuum fair + overs
Power distribution	X			
Lighting	X			
Other utilities if present	X			
Architectural				
Condition of Flooring	X			water Damage
Wall systems	X			
roofing		X		
ceilings	X	X		
doors	X			
windows	X			
points of egress	X

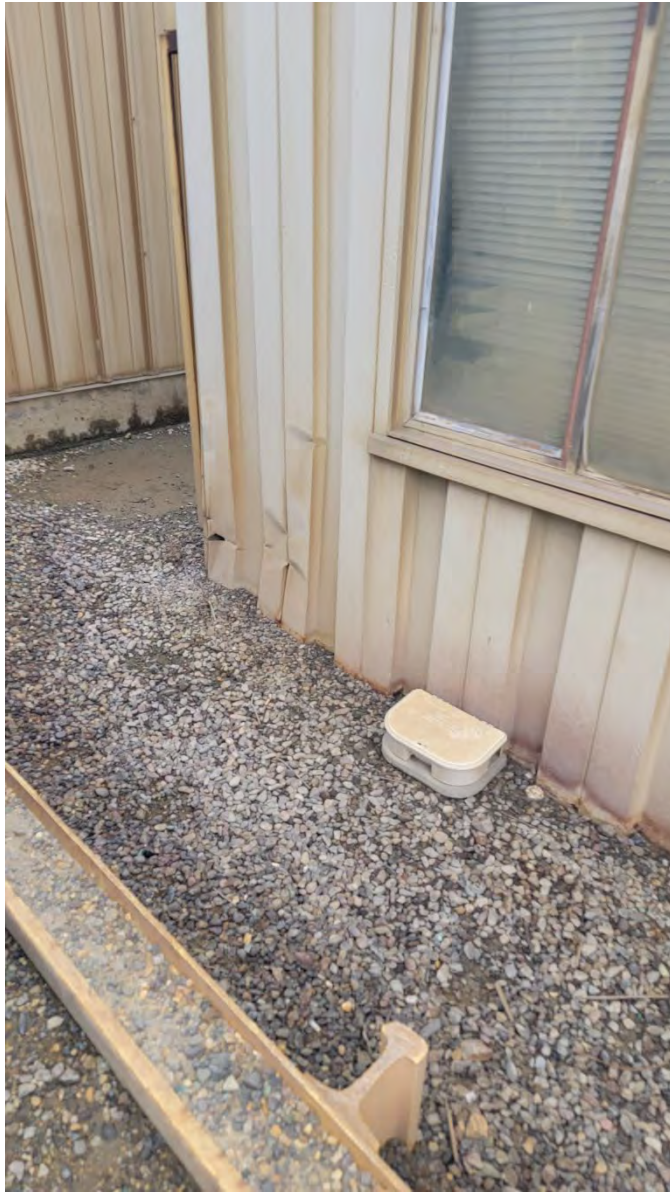
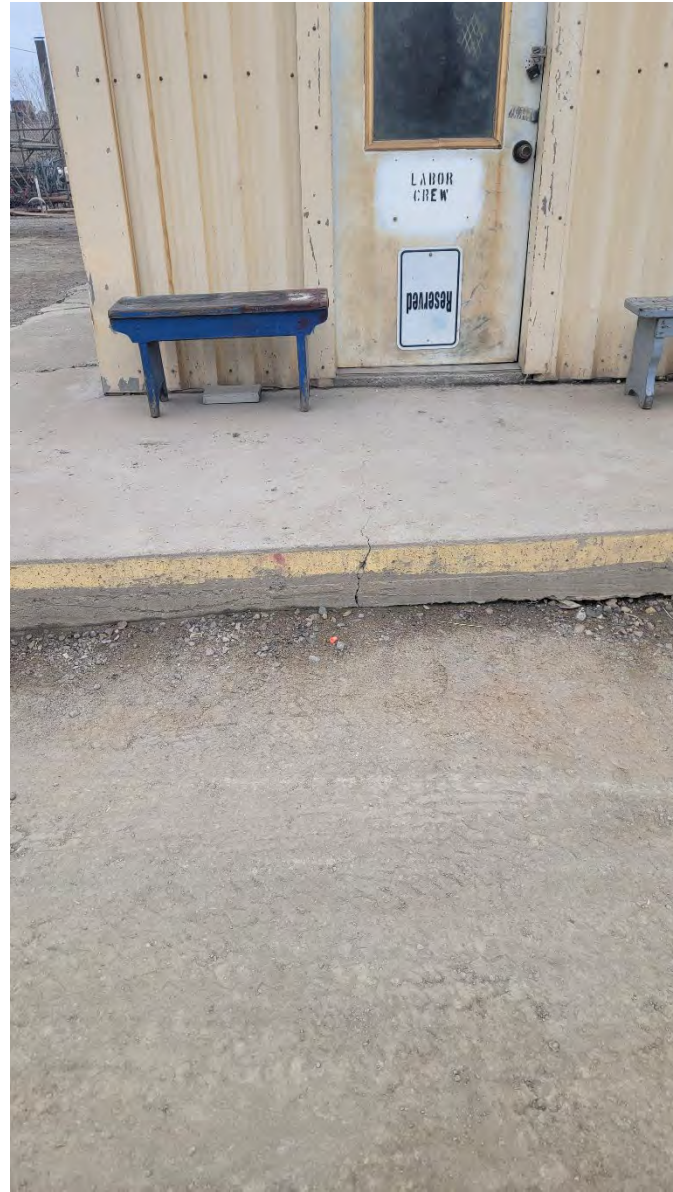
CP-28
External Damage

Category	Condition			Comments
	Good	Fair	Poor	
Civil				
Condition of Site	X			Roofing between buildings
Drainage Around Facility		X		
Access to Facility	X			
Building Parking	X			
Fencing or Security				
Foundation				
Foundation		X		Cracks in foundations and flooring
Floor Slabs		X		
If process Facility: Cond of equip fnds				
Structure				
Framing: Walls	X			
Framing: Roofs	X			
Framing: Internal	X			
If Concrete structure				
Mechanical				
HVAC if present				n
Water Supply if present	X			
Waste water if present	X			n
Other utilities if present				
Fire protection if present				
Piping				
if facility is not building				
if facility is process				
Electrical				
Power supply	X			
Power distribution	X			
Lighting	X			
Other utilities if present				
Architectural				
Condition of Flooring	X			
Wall systems	X			
roofing	X			
ceilings	X			
doors	X			
windows	X			
points of egress	X

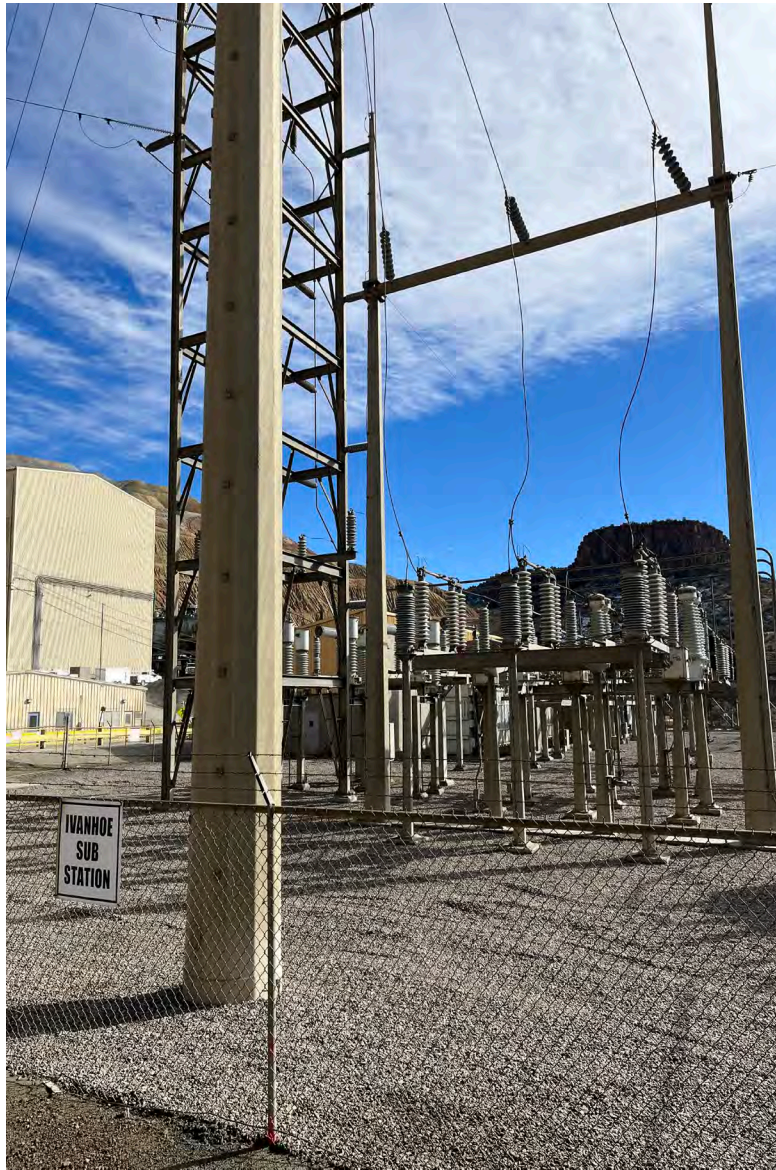
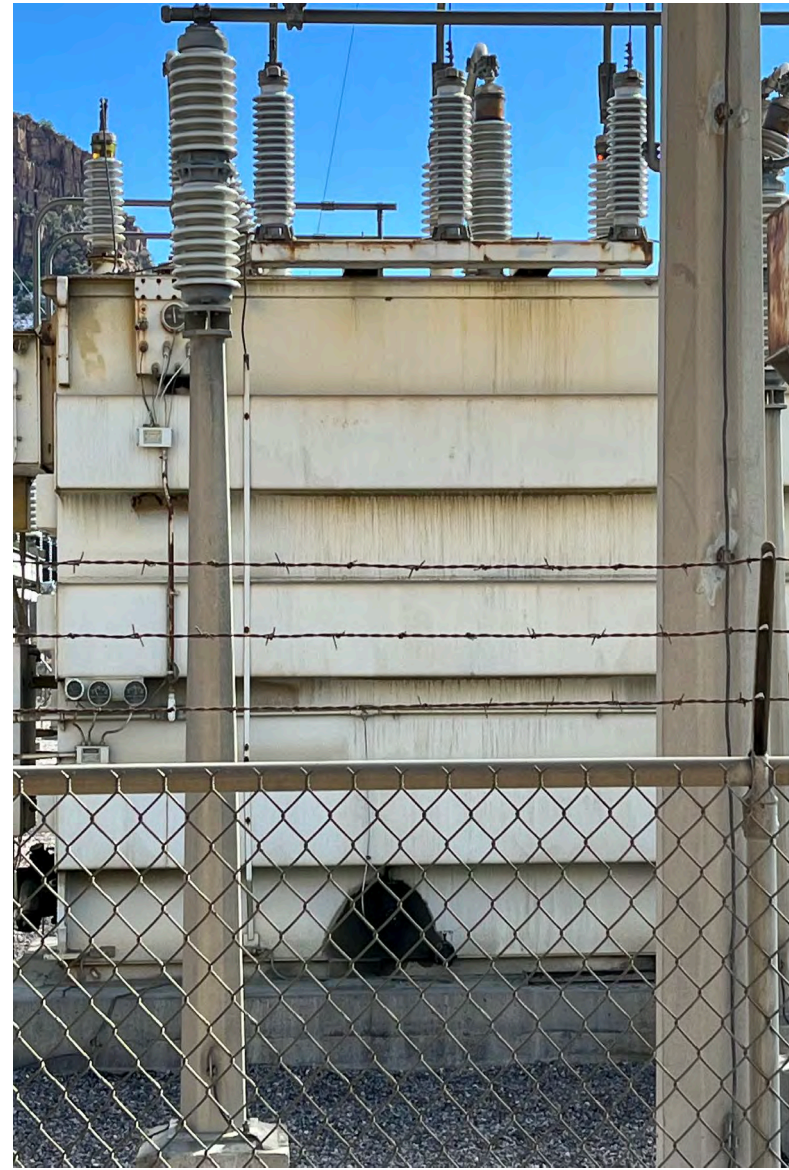
CP-31
External View & Damage

Category	Condition			Comments
	Good	Fair	Poor	
Civil				
Condition of Site	X			No entry photo inspect from outside
Drainage Around Facility	X			
Access to Facility	X			
Building Parking				
Fencing or Security	X			
Foundation				
Foundation	X			- plenty of clearance between bolts and concrete edge N/A
Floor Slabs				
If process Facility: Cond of equip fnds				
Structure				
Framing: Walls				N/A
Framing: Roofs				
Framing: Internal				
If Concrete structure				
Mechanical				
HVAC if present				↓
Water Supply if present				
Waste water if present				
Other utilities if present				
Fire protection if present				
Piping				
if facility is not building	X			
if facility is process				
Electrical				
Power supply	X			N/A
Power distribution	X			
Lighting				
Other utilities if present				
Architectural				
Condition of Flooring				↓
Wall systems				
roofing				
ceilings				
doors				
windows				
points of egress

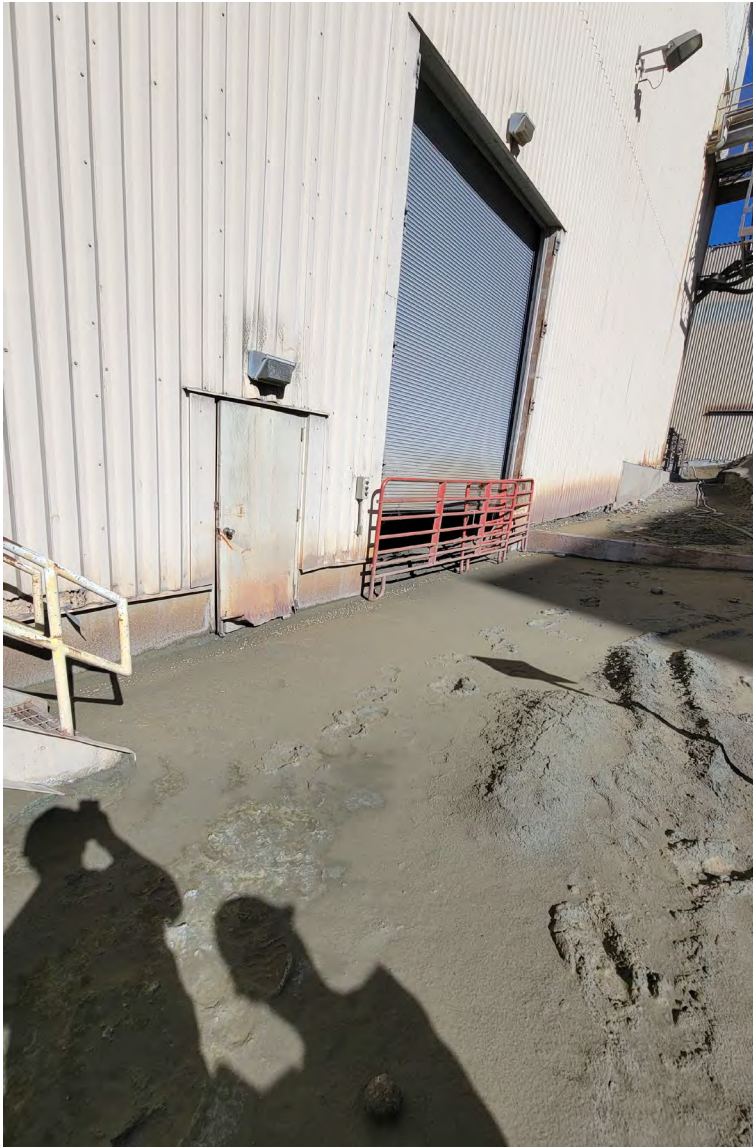
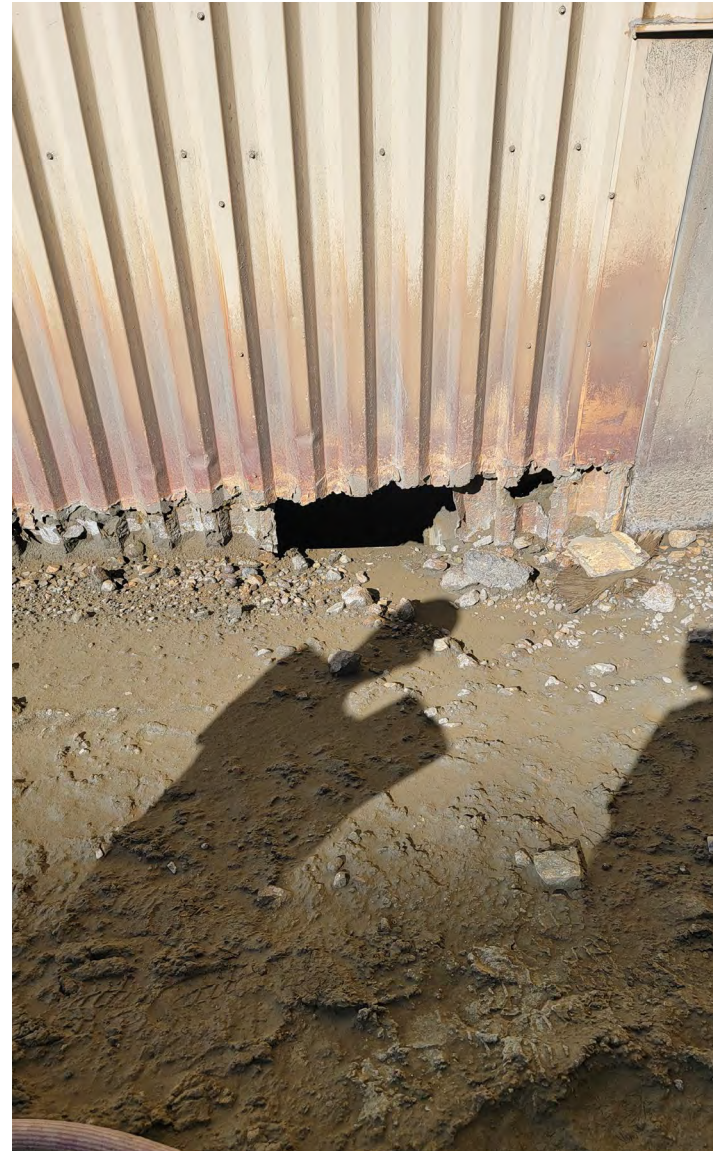
CP-32
External Damage

Category	Condition			Comments
	Good	Fair	Poor	
Civil				
Condition of Site	X			large Drainage issue up front na
Drainage Around Facility		X		
Access to Facility	X			
Building Parking				
Fencing or Security				
Foundation				
Foundation				cannot see foundation
Floor Slabs				
If process Facility: Cond of equip fnds				
Structure				
Framing: Walls		X		minor cracks, hole in wall, rusted siding
Framing: Roofs				
Framing: Internal				
If Concrete structure				
Mechanical				
HVAC if present				na
Water Supply if present	X			
Waste water if present	X			
Other utilities if present				
Fire protection if present				
Piping				
if facility is not building				
if facility is process				
Electrical				
Power supply	X			
Power distribution	X			
Lighting	X			
Other utilities if present				
Architectural				
Condition of Flooring				doors rusted
Wall systems				
roofing	X			
ceilings	X			
doors		X		
windows				
points of egress	X

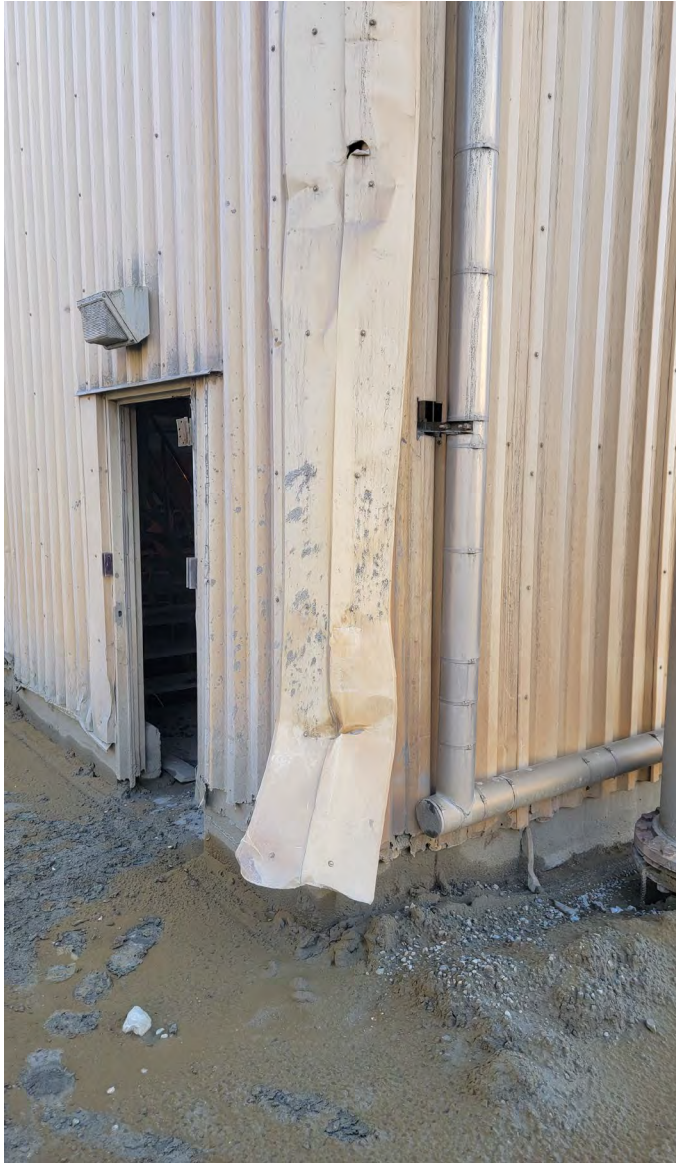
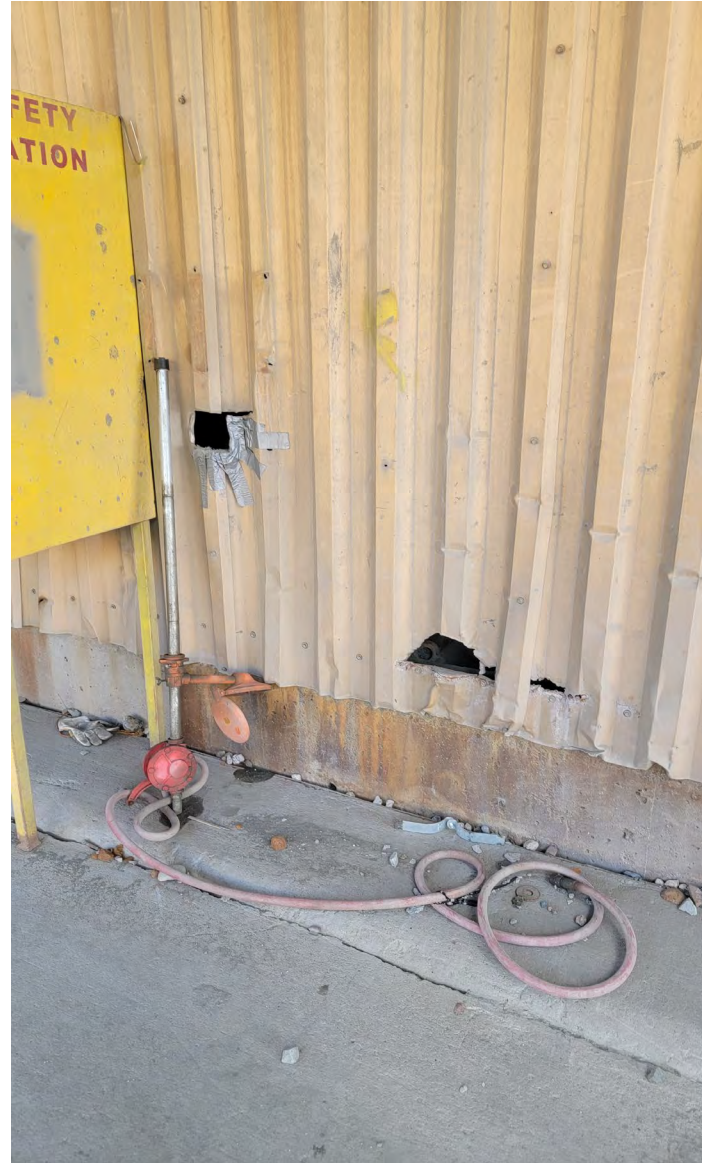
CP-33
External damage

Category	Condition			Comments
	Good	Fair	Poor	
Civil				
Condition of Site	X			water pooling below machines m m
Drainage Around Facility		X		
Access to Facility		X		
Building Parking				
Fencing or Security				
Foundation				
Foundation	X			
Floor Slabs				
If process Facility: Cond of equip frnds				
Structure				
Framing: Walls	X			
Framing: Roofs	X			
Framing: Internal	X			
If Concrete structure				
Mechanical				
HVAC if present				
Water Supply if present				
Waste water if present				
Other utilities if present				
Fire protection if present				
Piping				
if facility is not building				
if facility is process				
Electrical				
Power supply				
Power distribution				
Lighting				
Other utilities if present				
Architectural				
Condition of Flooring				
Wall systems				
roofing				
ceilings				
doors				
windows				
points of egress

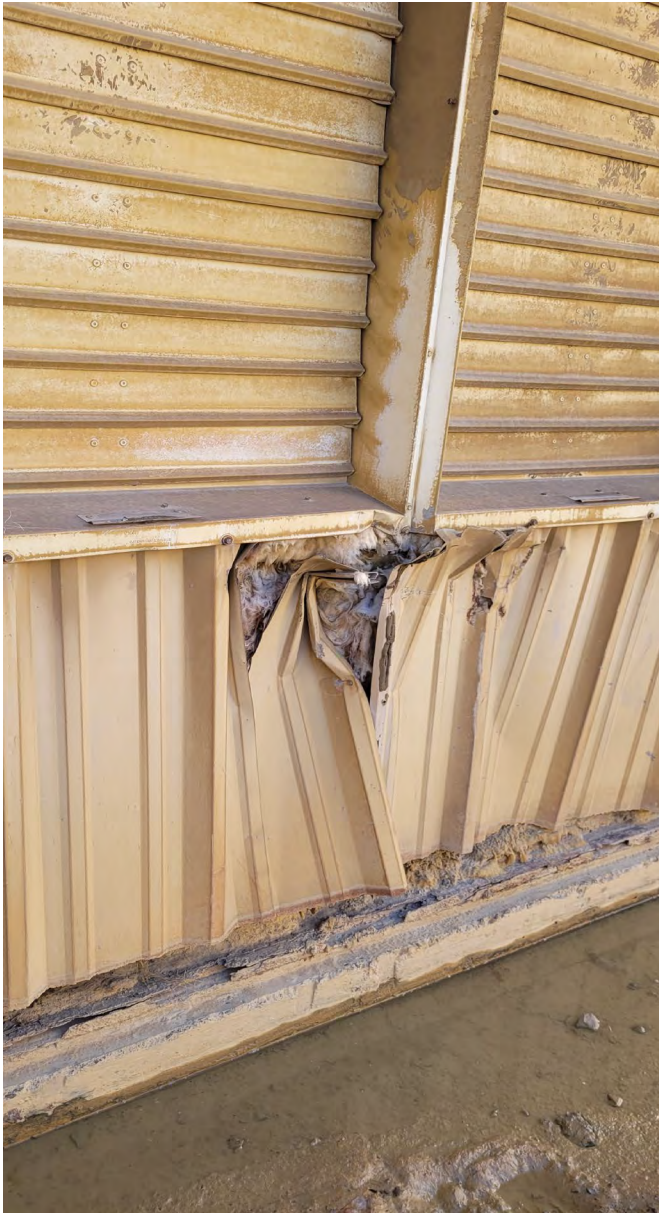
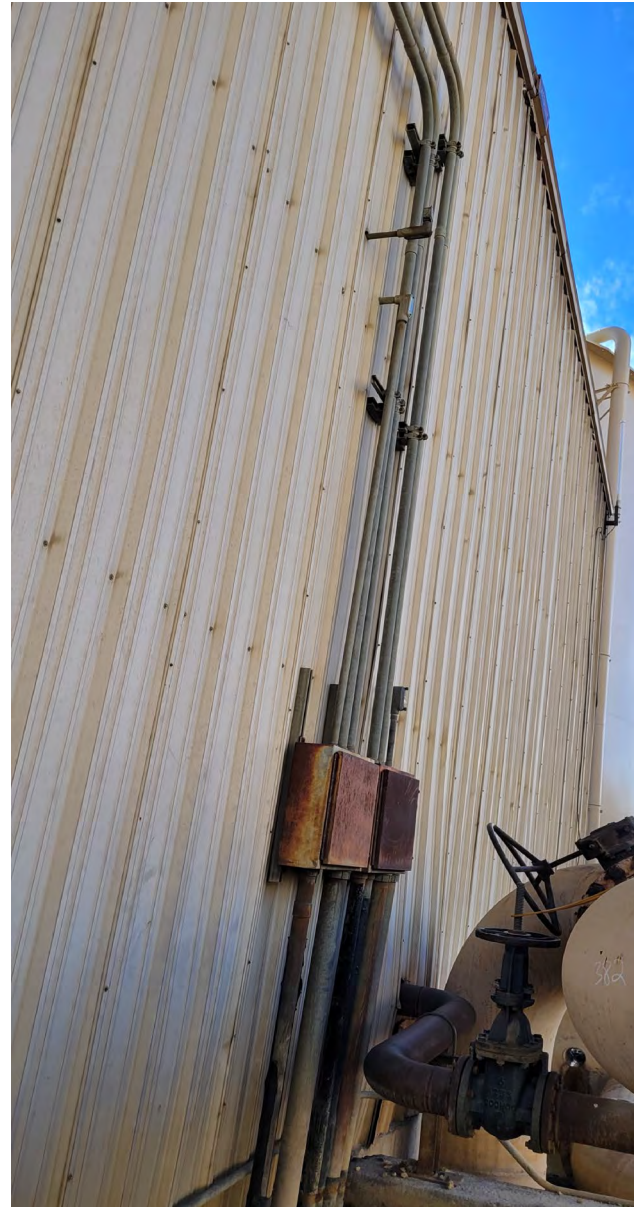
CP-38
External Damage

Category	Condition			Comments
	Good	Fair	Poor	
Civil				
Condition of Site	X			<p>pooling & rusting of sheeting</p> <p>Water Tank + containment all good</p> <p>Add containment as separate feat.</p>
Drainage Around Facility			X	
Access to Facility	X			
Building Parking	N/A			
Fencing or Security	N/A			
Foundation				
Foundation	X			
Floor Slabs	X			
If process Facility: Cond of equip fnds	X			
Structure				
Framing: Walls	MD		X	<p>Sheeting @ foundation contact is rusted away</p>
Framing: Roofs	X			
Framing: Internal	X			
If Concrete structure	N/A			
Mechanical				
HVAC if present	N/A			
Water Supply if present	X			
Waste water if present	N/A		N/A	
Other utilities if present	X		N/A	
Fire protection if present				
Piping				
if facility is not building				
if facility is process	X			
Electrical				
Power supply	X			
Power distribution	X			
Lighting	X			
Other utilities if present				
Architectural				
Condition of Flooring				<p>N/A</p> <p>↓</p>
