# MK015PR MARQUEZ MINE

**Prior Reclamation Inspections**

# PRIOR RECLAMATION INSPECTION REPORT AND RECOMMENDATION FOR RELEASE OR PERMIT REQUIREMENT

Santa Fe Pacific Gold Corporation

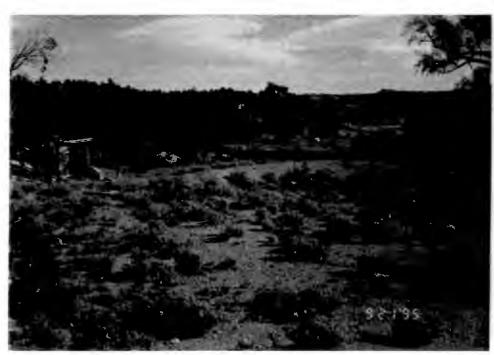
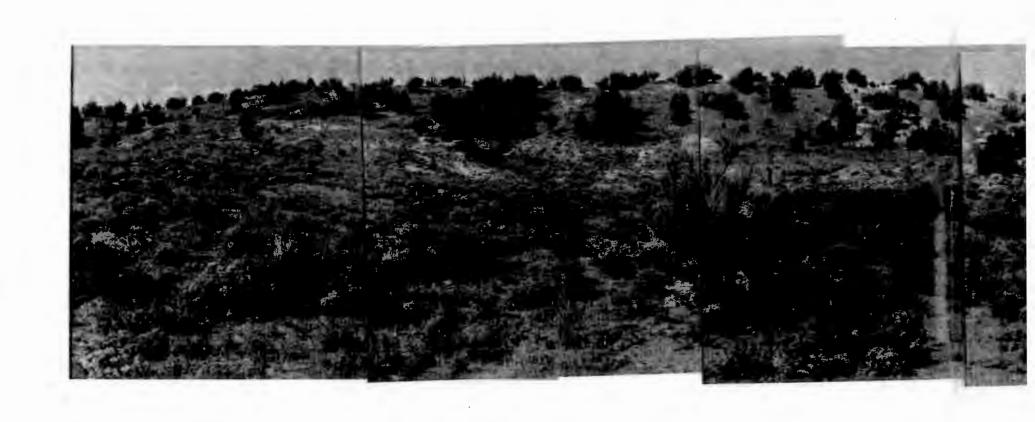
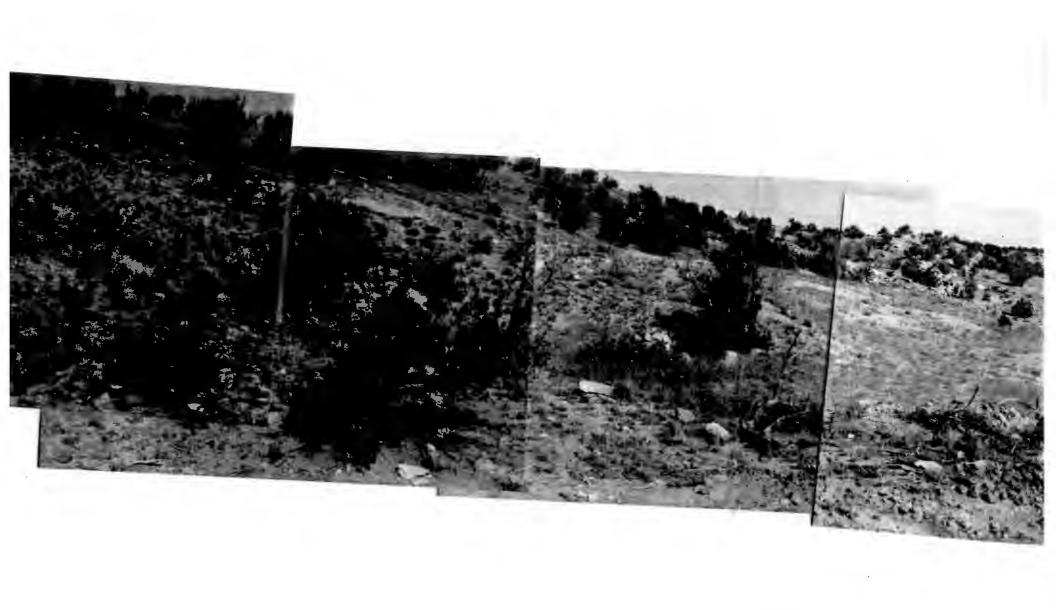
While it was difficult to locate the mine site, there were several small waste piles. Natural vegetation had successfully reestablished itself such that the waste piles were nearly indistinguishable from the natural mounds and ridges along the canyon. The location of the mine was located by a red clay that had been uncovered in one pit and was out of place. There was moderate erosion, but the erosion was consistent with that of the surrounding area. A powder magazine, circa 1970's, was left as a mining relic. All other structures, trash and junk had been removed. There were no piles or accumulations of toxic or waste material. There were no apparent hazards that could effect public health or safety.

The site and surrounding area showed signs of grazing impacts. Plant diversity, however, was good with more than 21 native plant species identified on the site. It was very difficult to distinguish this site from the adjacent undisturbed areas, so no transect evaluation was deemed necessary. Photographs documenting vegetation and the general condition of the site are presented in Appendix B. Because of the quality of cover and diversity of plants found on the site, it qualifies for release.

Section 13 T1N R6W, Mine Site from East, September 21, 1995

Section 13 T1N R6W, Powder Magzine, September 21, 1995

Section 13 T1N R6W, Mine Site From East

Section 13 T1N R6W, Mine Site From South

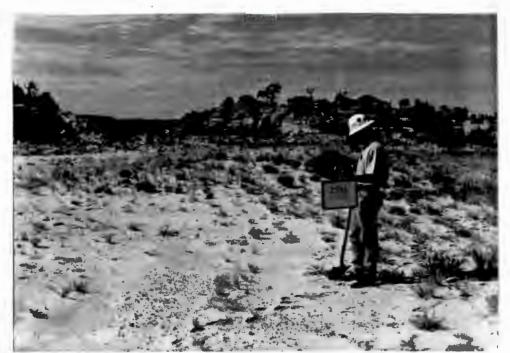
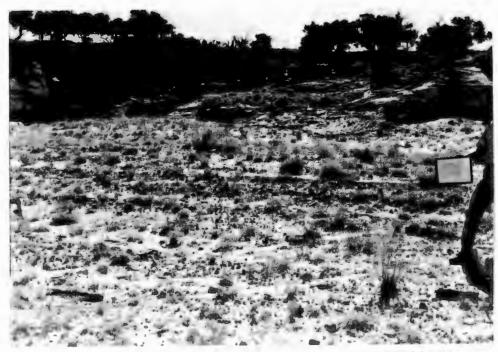
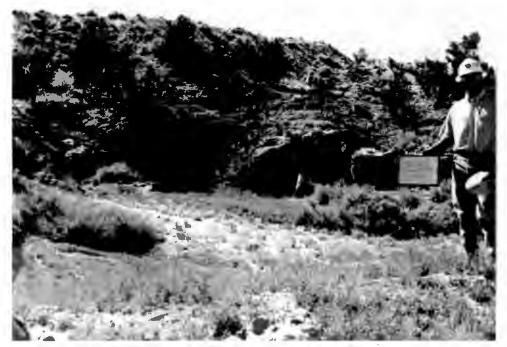
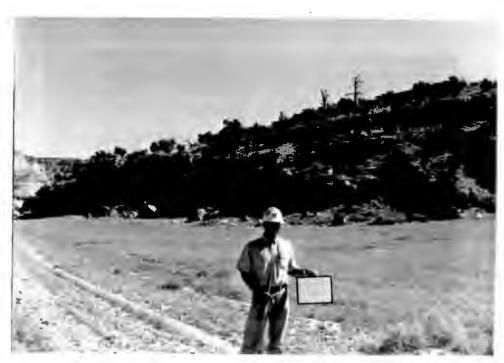
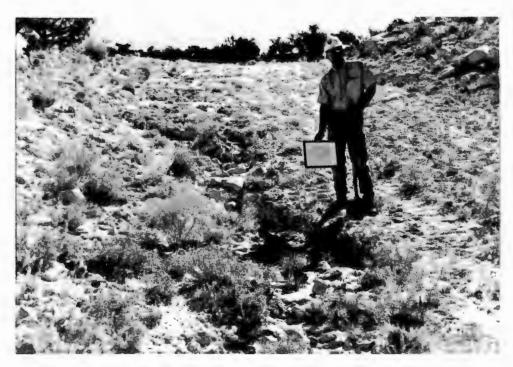
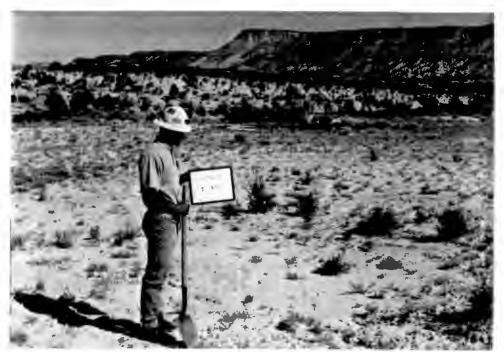
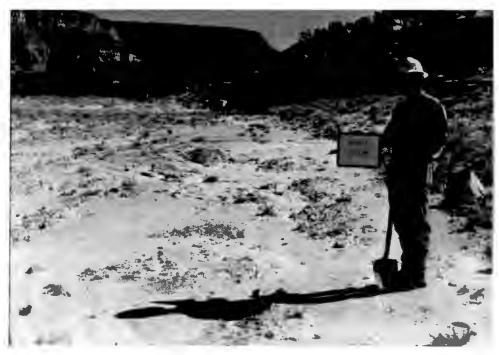
Essentially, the site had been safeguarded but not topsoiled or reseeded. The site is characterized by white fine grained sandstone covered by a few inches of fine white sand. The sand is subsequently being eroded away by wind and water. A mine access road had significant erosion. An impoundment had been constructed to impound sediment from the mine site, however, erosion from the access road was bypassing the impoundment and was entering the mine site. Photographs documenting vegetation and the general condition of the site are presented in Appendix C.

Some native plant species from adjoining areas were invading the disturbance area. Line-intercept transects indicated vegetation cover to be approximately 29 percent (Young, 1995). Vegetation measurements are presented in Table III. Vegetation on this site is dominated by hairy goldenaster (*Heterotheca villosa*), an unpalatable increaser. Indian ricegrass (*Oryzopsis hymenoides*), was also found growing sparsely on the site. Given the sandy nature of these soils, stands of Indian ricegrass and sand dropseed (*Sporobolus cryptandrus*) should be more prevalent here. Because of the overall lack of diversity and the poor establishment of perennial grasses and forbs, this site does not qualify for release.

Section 1 T13N R9W, Shaft Site looking South, 9/13/95

Section 1 T13N R9W, Shaft Site Looking West, 9/13/95

Section 1 T13N R9W, Sediment Pond, 9/13/95

Section 1 T13N R9W, Looking Up at Mine Site, 9/13/95

Section 1 T13N R9W, Access Road, 9/13/95

Section 1 T13N R9W, South Side Looking North, 9/13/95

Section 1 T13N R9W, North Side Looking South, 9/13/95

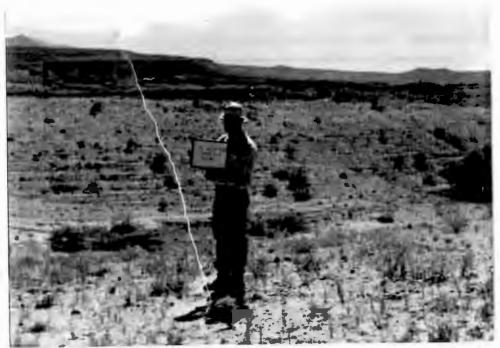
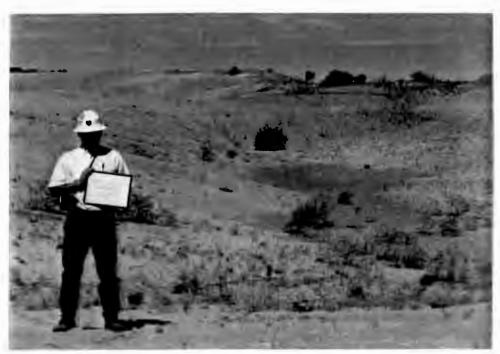
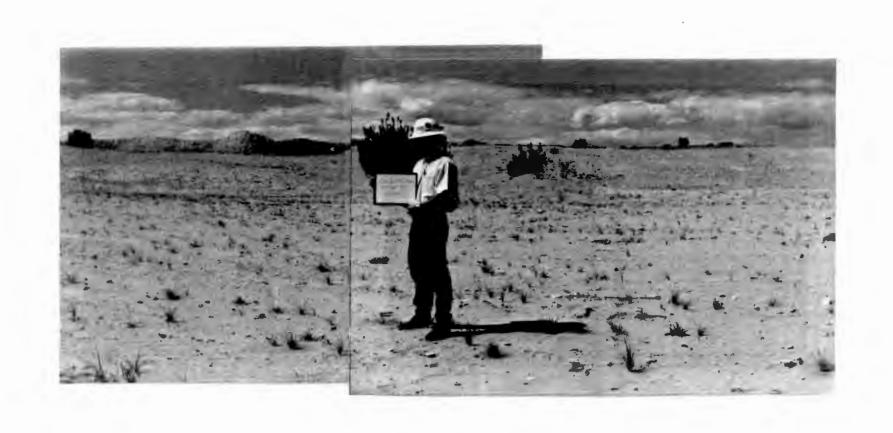
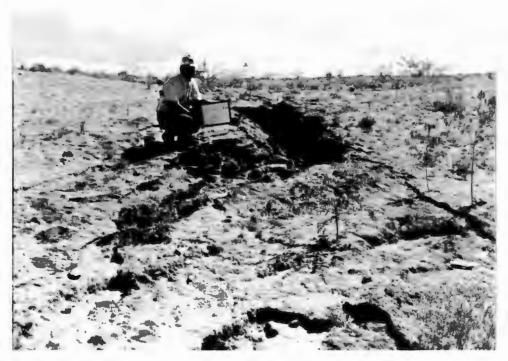
Portions of the reclaimed vegetation have heavily grazed by wildlife and domestic livestock. However, native plant species were invading the area. Twenty-six native species of plants were identified. Line-intercept transects showed average perennial vegetation cover to be approximately 22 percent (Young, 1995). Vegetation measurements are presented in Table V. Despite the slight increase in the number of perennial species invading this site from adjacent areas, there was poor establishment of the perennial grasses, forbs, and shrubs on the slopes of the depressions and topsoil mounds. Because of the lack of adequate cover, this site does not qualify for release at this time.

Section 25 Mine, West Side Looking West, 9/12/95

Section 25 Mine, Middle Looking East, 9/12/95

Section 25 Mine, Erosion Feature, 9/12/95

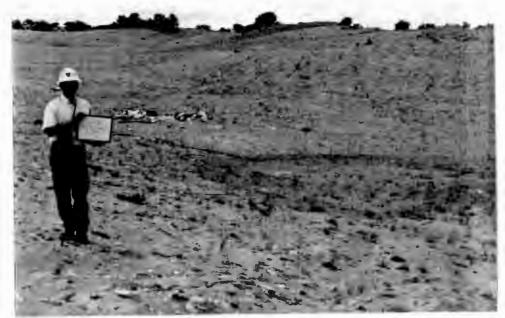
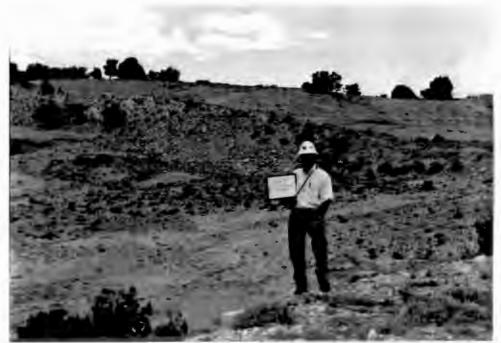
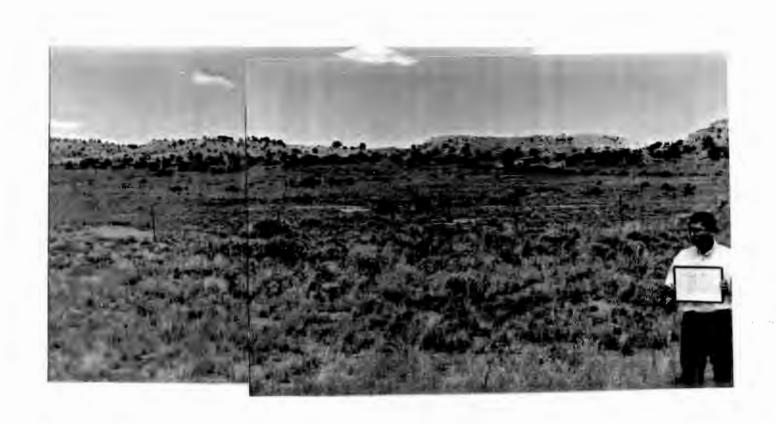
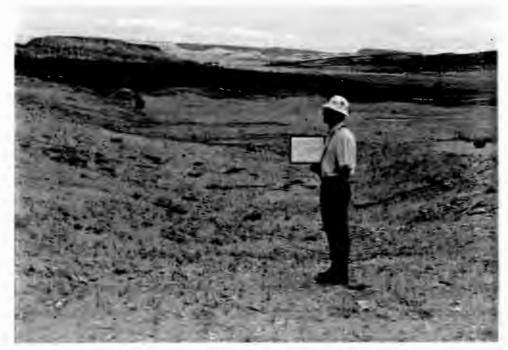
There was evidence of grazing by livestock and wildlife on this site. Vegetation also showed signs of drought stress. Line-intercept transects showed vegetation cover to be approximately 12 percent (Young, 1995). The results of these vegetation measurements are presented in Table VI. Because of the lack of cover and diversity, staff does not recommend this site for release.

Section 31 T13N R9W, North End Looking South, 9/12/95

Section 31 T13N R9W, Northeast Side Looking West, 9/12/95

Section 31 T13N R9W, Reconstructed Limestone Bluffs, 9/12/95

Section 31 T13N R9W, Southeast Side looking North

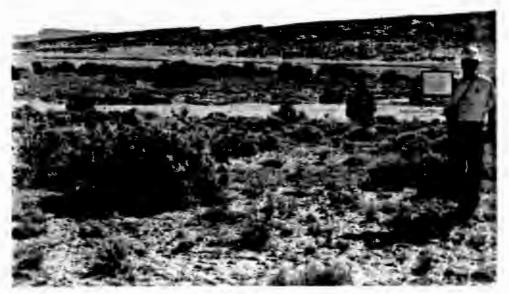
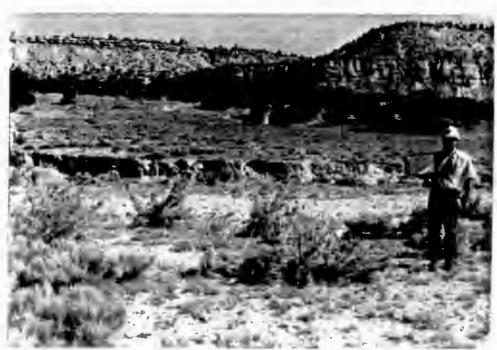
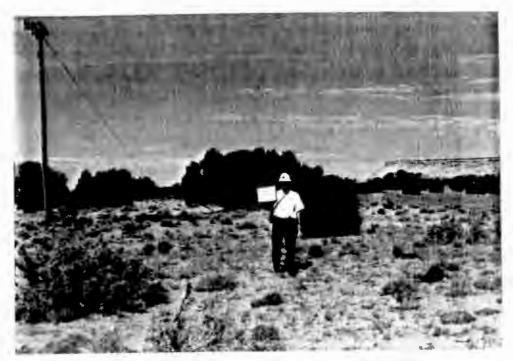
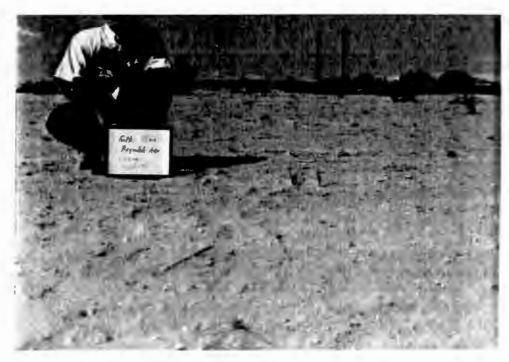
As with the other mines, the vegetation had been grazed by wildlife and domestic livestock. The vegetation also showed signs of drought stress. However, the adequate plant cover and diversity deemed it unnecessary to perform transect evaluations of the plant community. Staff recommends this site of release. The plant

Faith Mine Shaft Site, Looking East, 9/12/95 Regraded Area in Background

Faith MIne Shaft Site, Looking North, 9/12/15

Faith Mine Shaft Site, Looking West, 9/12/95

Faith Mine Regraded Area, 9/12/95

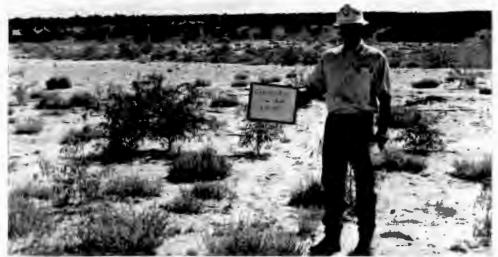
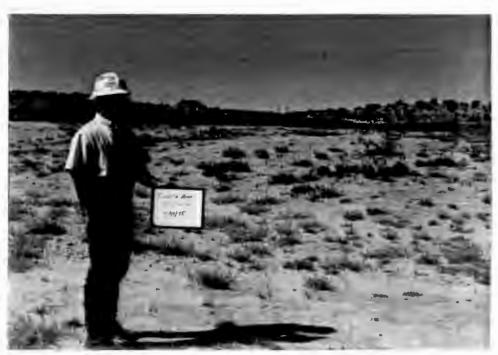
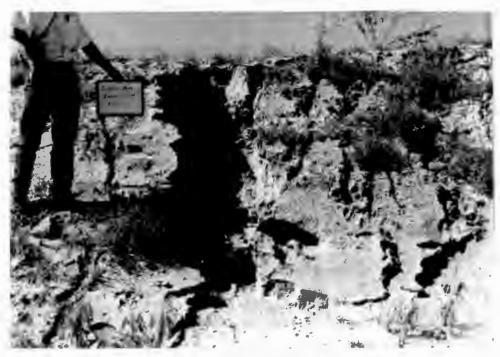
Again, the mine site had been grazed by livestock and wildlife. Similarly, vegetation showed signs of drought stress. Line-intercept transects indicated that vegetation cover was approximately 15 percent (Young, 1995). Results of vegetation measurements are presented in Table VII. Because of the lack of plant cover, this site is not recommended for release.

Isabella Mine, From North, 9/12/95

Isabella Mine, From South, 9/12/95

Isabella Mine, Erosion Feature, 9/12/95

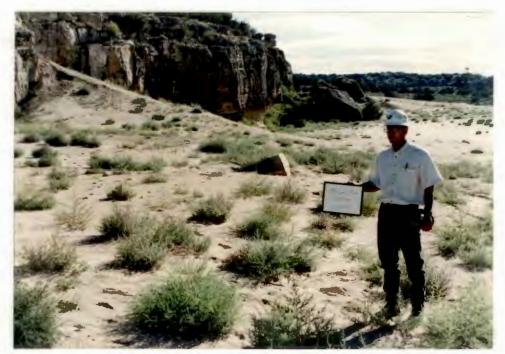
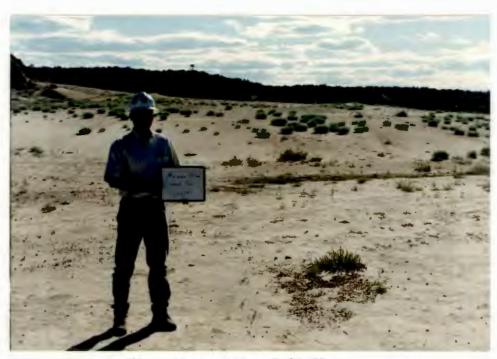
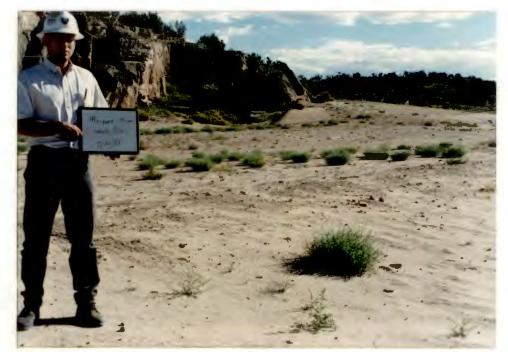
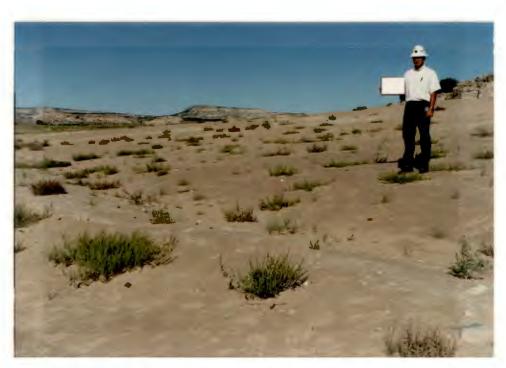
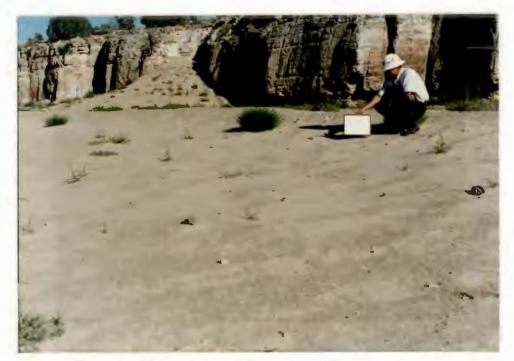
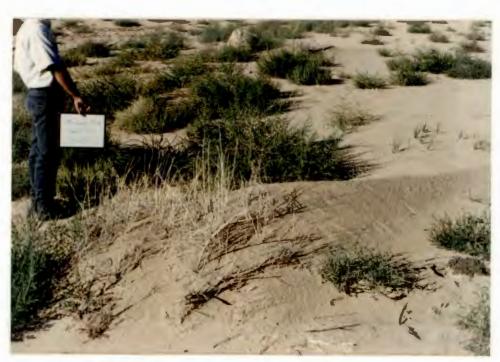
Topsoil depths across the site were greater than 12 inches, but consisted entirely of windblown sand. This area was essentially barren with most of the seed and mulch blown away before vegetation could be established. Native species such as Indian ricegrass (*Oryzopsis hymenoides*), from adjoining areas were starting to invade he disturbance area (Young, 1995). Because of the obvious lack of plant cover at the site no transects were attempted. Staff does not recommend release of this site.

Marquez Mine, Reclaimed Declined Shaft, 9/12/95

Marquez Mine, Waste Pile, 9/12/95

Marquez Mine Waste Pile, 9/12/95

Marquez Mine, Sand Dune, 9/12/95

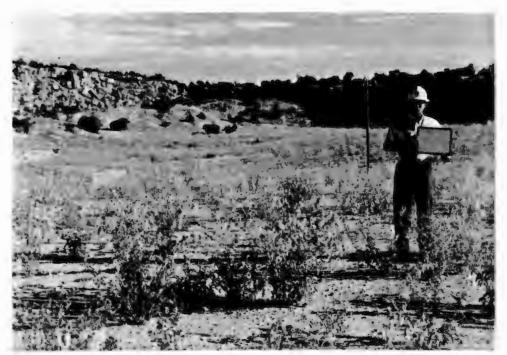
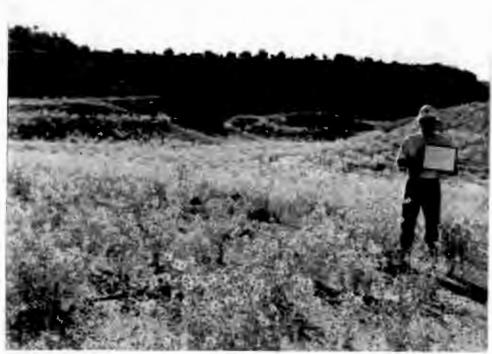
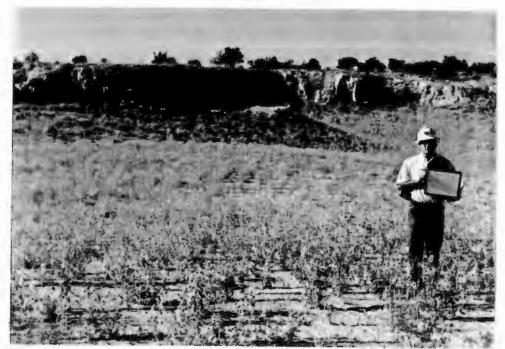
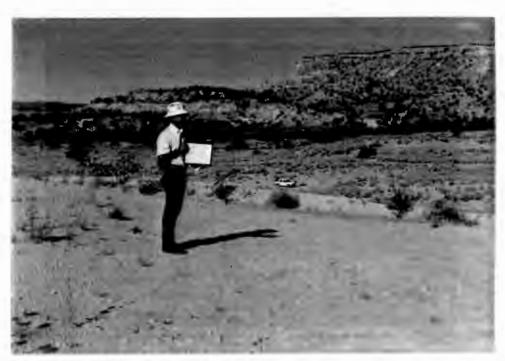
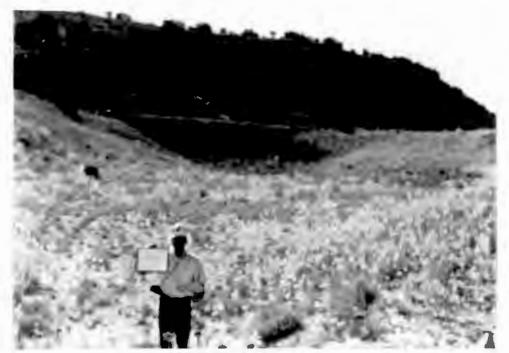
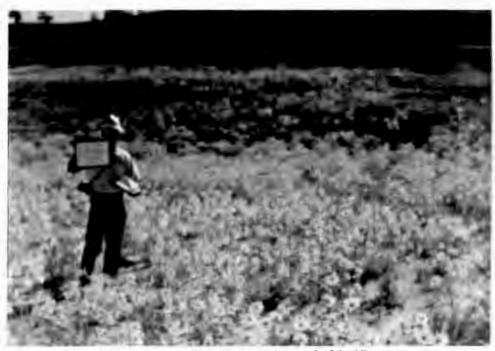
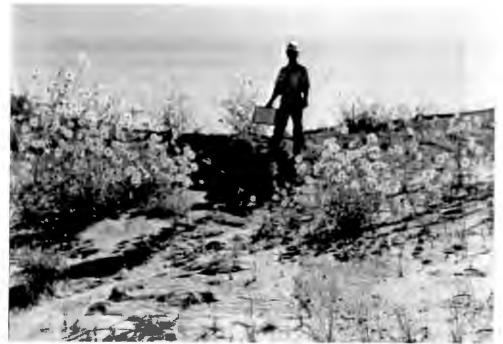
This site is characterized by an abundance of sunflowers and locoweed. The locoweed is probably a selenium accumulator for which the canyon (also known as 'Sheep Kill Canyon') was named. Reserve Oil and Minerals operated the mine under a lease from Santa Fe Pacific Minerals Corporation. Open mine features were backfilled and the mine reclaimed in 1987 upon termination of the lease. Additional reclamation of the site was conducted in 1993 and 1994 (Santa Fe, 1994). A barbed wire fence surrounded the site. All structures, trash or junk had been removed from the site. There were no piles or accumulations of toxic or waste material on the site. There were a few erosion features including one that was significant. Photographs documenting vegetation and general condition of the site are presented in Appendix K. An inclined shaft portal had been backfilled with nontoxic mine waste material (Santa Fe, 1994). The regrading of this site included construction of mounds, berms, terraces and depressions that impounded rainwater for livestock.

Topsoil depths across the site were approximately 4 inches. Line-intercept transects indicated that perennial vegetative cover was approximately 31 percent. The results of these vegetation measurements are presented in Table VIII.

Poison Canyon Mine, Middle Looking North, 9/12/95

Poison Canyon Mine, Middle Looking East, 9/12/95

Poison Canyon Mine, Middle Looking South, 9/12/95

Poison Canyon Mine, Middle Looking West, 9/12/95

Poison Canyon Mine, Reclaimed Declined Shaft, 9/12/95

Poison Canyon Mine, Small Depression, 9/12/95

Poison Canyon Mine, Erosion Feature, 9/12/95
