**RE:**  
**Prior Reclamation Inspections**

**PRIOR RECLAMATION INSPECTION REPORT  
AND  
RECOMMENDATION FOR RELEASE OR PERMIT  
REQUIREMENT**

**Santa Fe Pacific Gold Corporation**

**September 29, 1995**

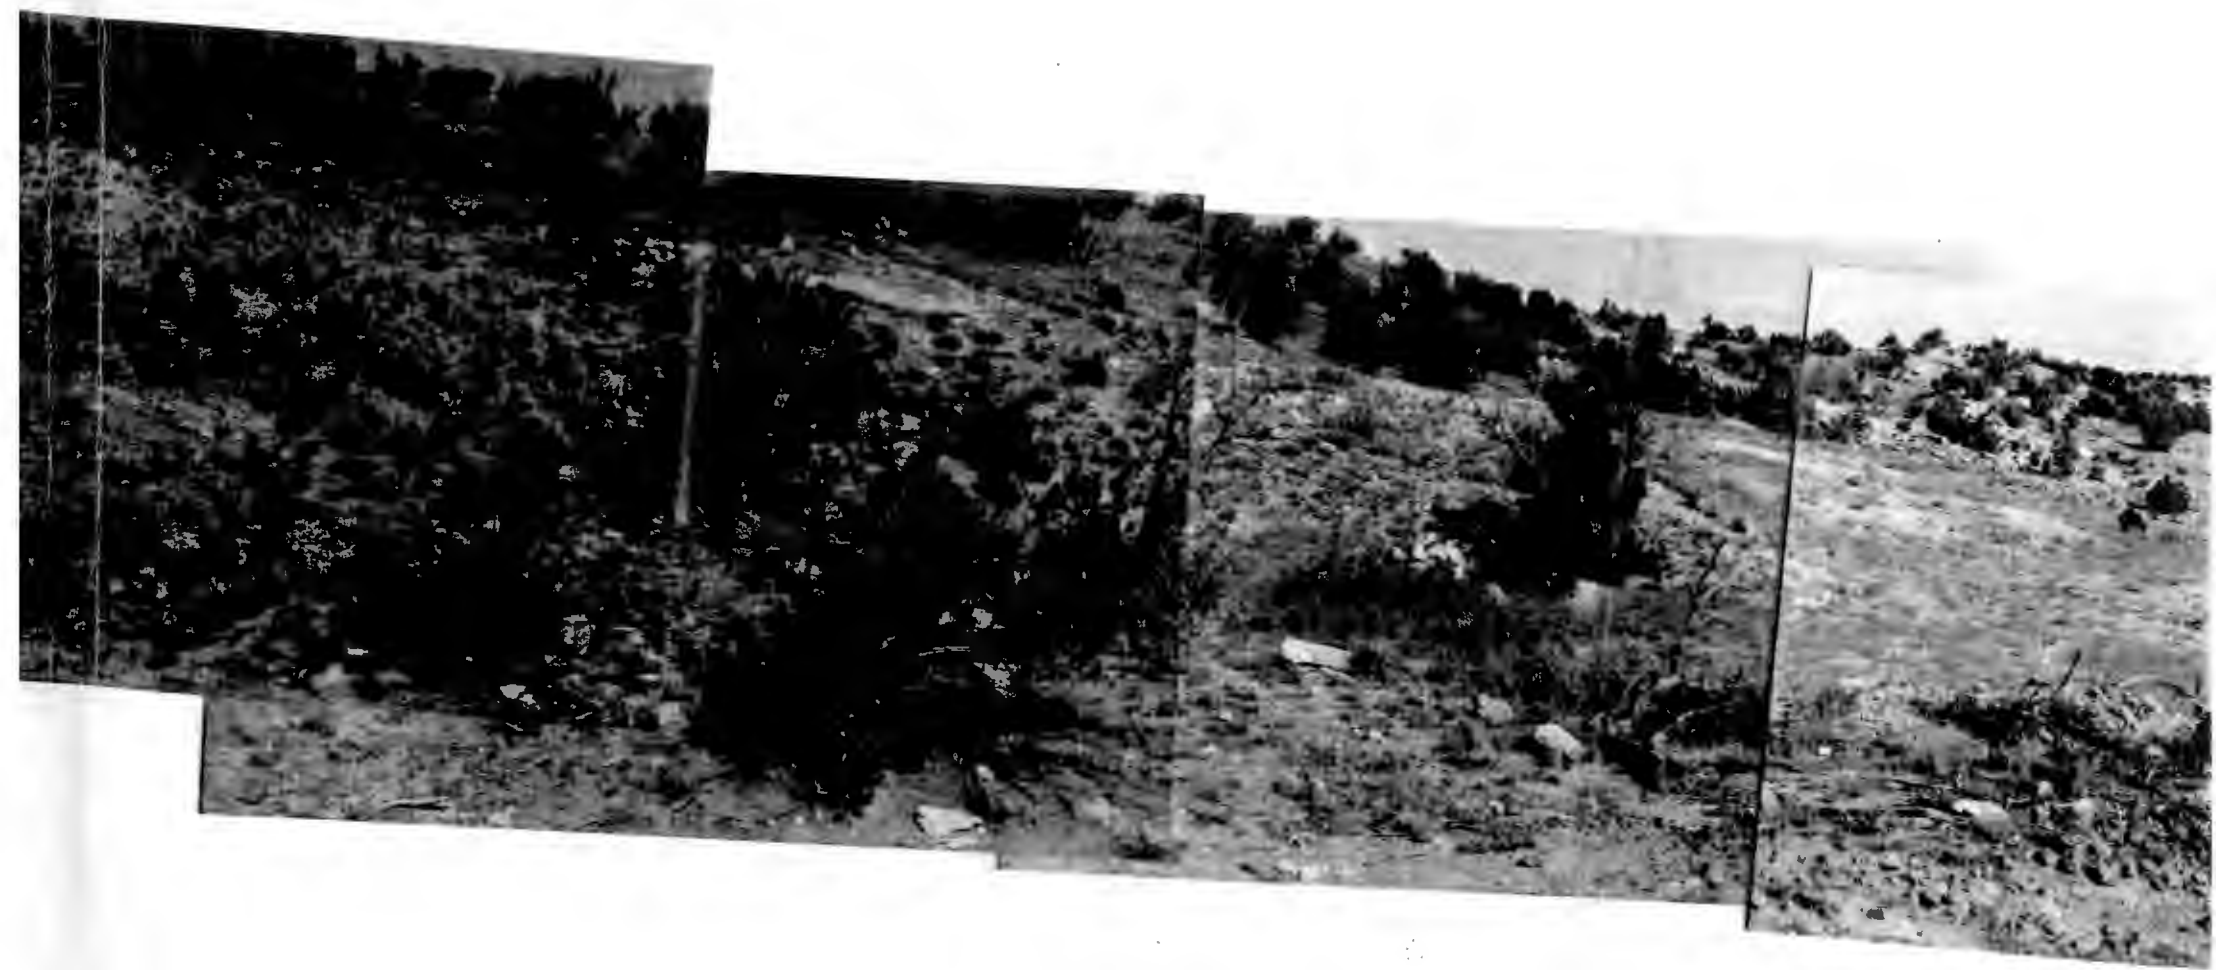
While it was difficult to locate the mine site, there were several small waste piles. Natural vegetation had successfully reestablished itself such that the waste piles were nearly indistinguishable from the natural mounds and ridges along the canyon. The location of the mine was located by a red clay that had been uncovered in one pit and was out of place. There was moderate erosion, but the erosion was consistent with that of the surrounding area. A powder magazine, circa 1970's, was left as a mining relic. All other structures, trash and junk had been removed. There were no piles or accumulations of toxic or waste material. There were no apparent hazards that could effect public health or safety.

The site and surrounding area showed signs of grazing impacts. Plant diversity, however, was good with more than 21 native plant species identified on the site. It was very difficult to distinguish this site from the adjacent undisturbed areas, so no transect evaluation was deemed necessary. Photographs documenting vegetation and the general condition of the site are presented in Appendix B. Because of the quality of cover and diversity of plants found on the site, it qualifies for release.

Section 13 T1N R6W, Mine Site From South

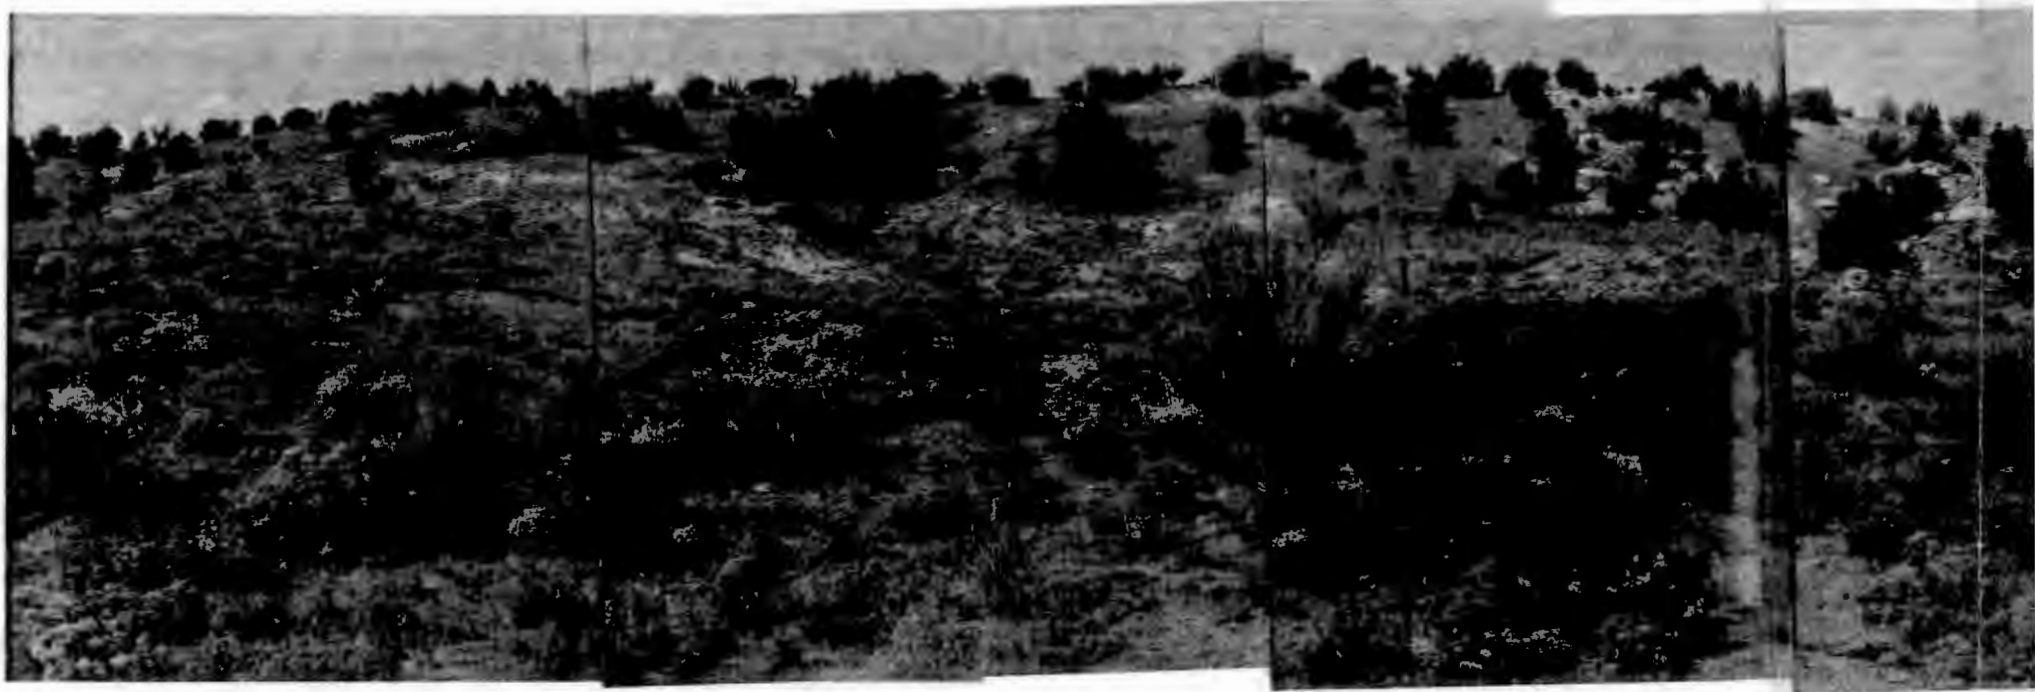
Section 13 T1N R6W, Mine Site From East

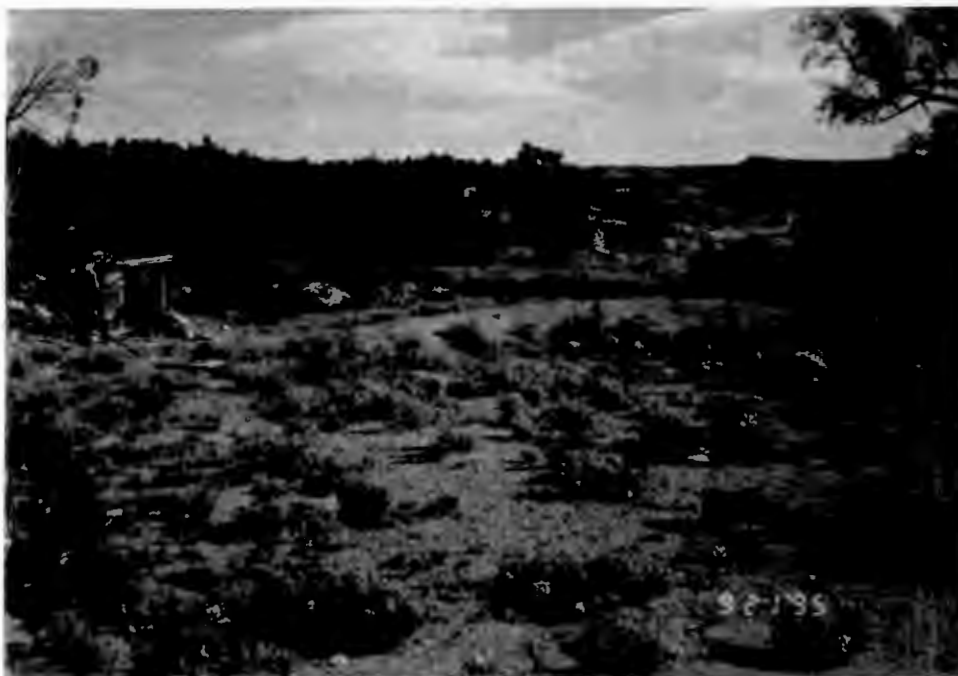
Section 13 T1N R6W, Powder Magazine, September 21, 1995

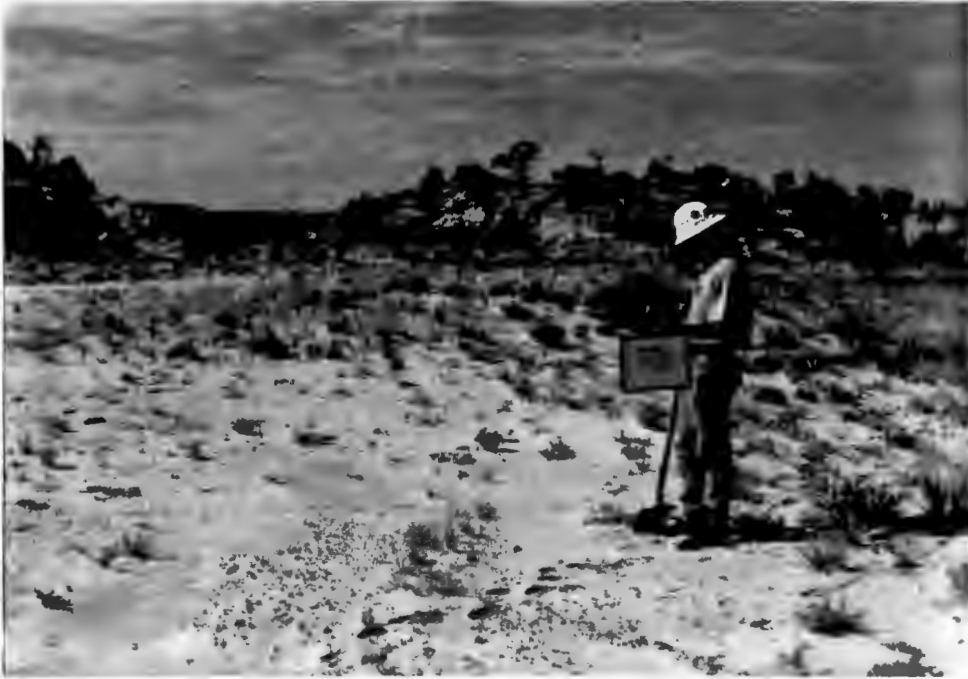
Essentially, the site had been safeguarded but not topsoiled or reseeded. The site is characterized by white fine grained sandstone covered by a few inches of fine white sand. The sand is subsequently being eroded away by wind and water. A mine access road had significant erosion. An impoundment had been constructed to impound sediment from the mine site, however, erosion from the access road was bypassing the impoundment and was entering the mine site. Photographs documenting vegetation and the general condition of the site are presented in Appendix C.

Section 1 T13N R9W, Shaft Site Looking South, 9/13/95

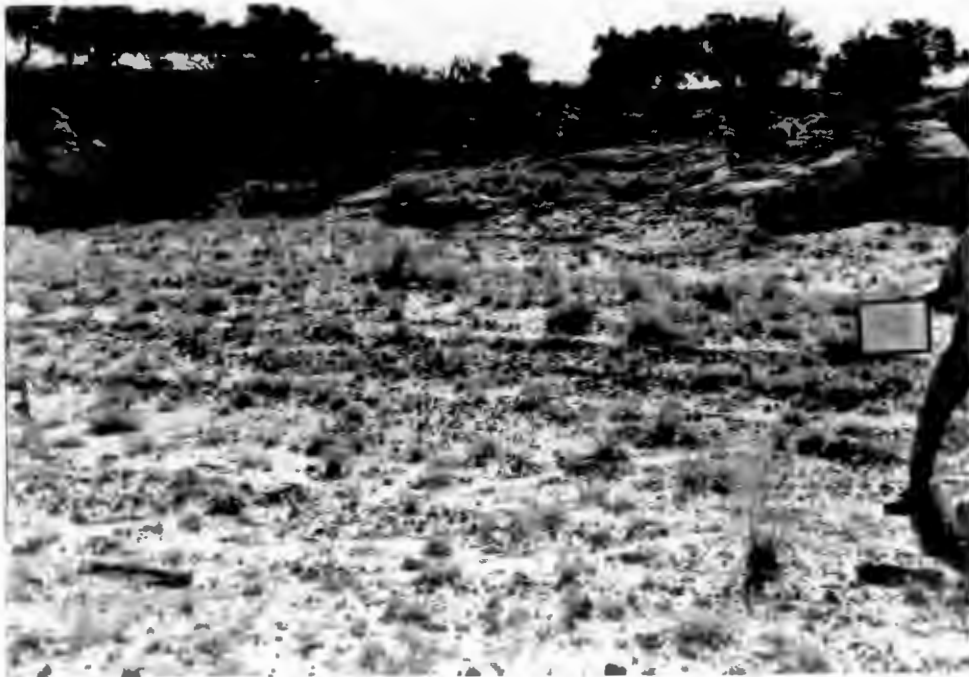
Section 1 T13N R9W, Shaft Site Looking West, 9/13/95

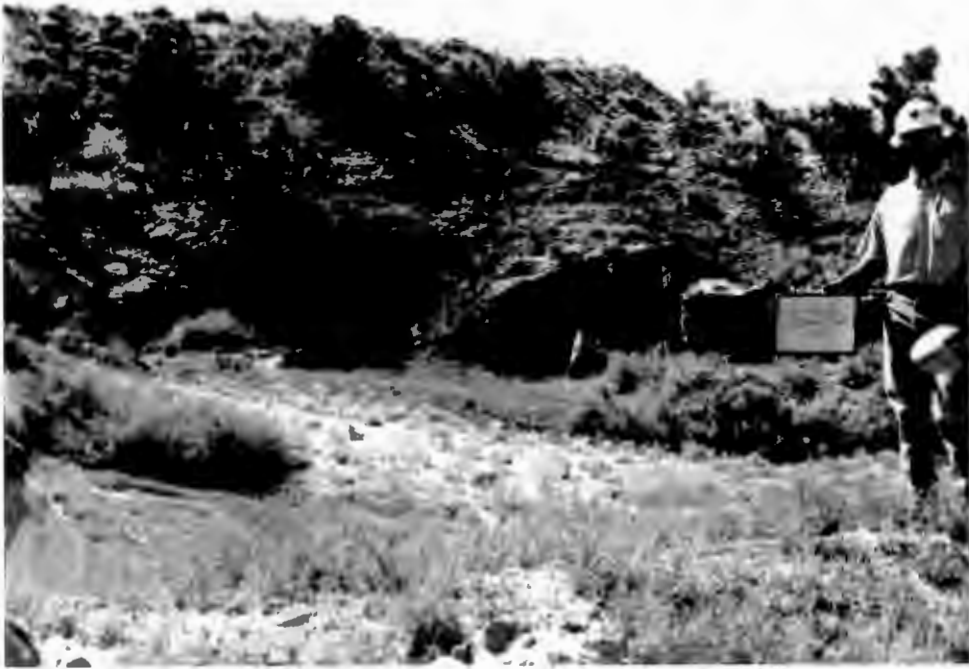
Section 1 T13N R9W, Sediment Pond, 9/13/95

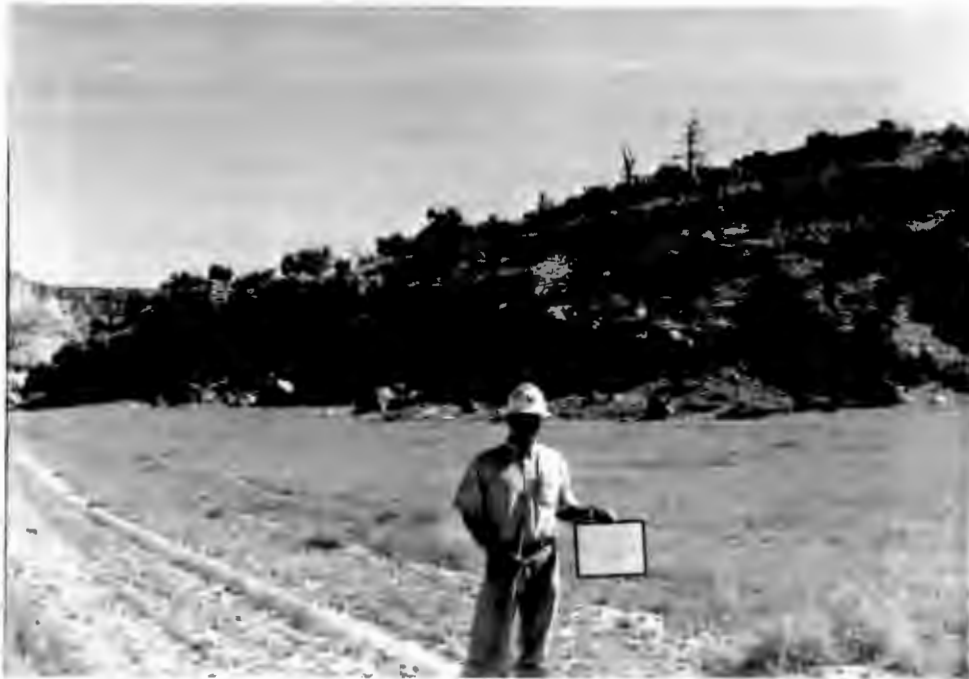
Section 1 T13N R9W, Looking Up at Mine Site, 9/13/95

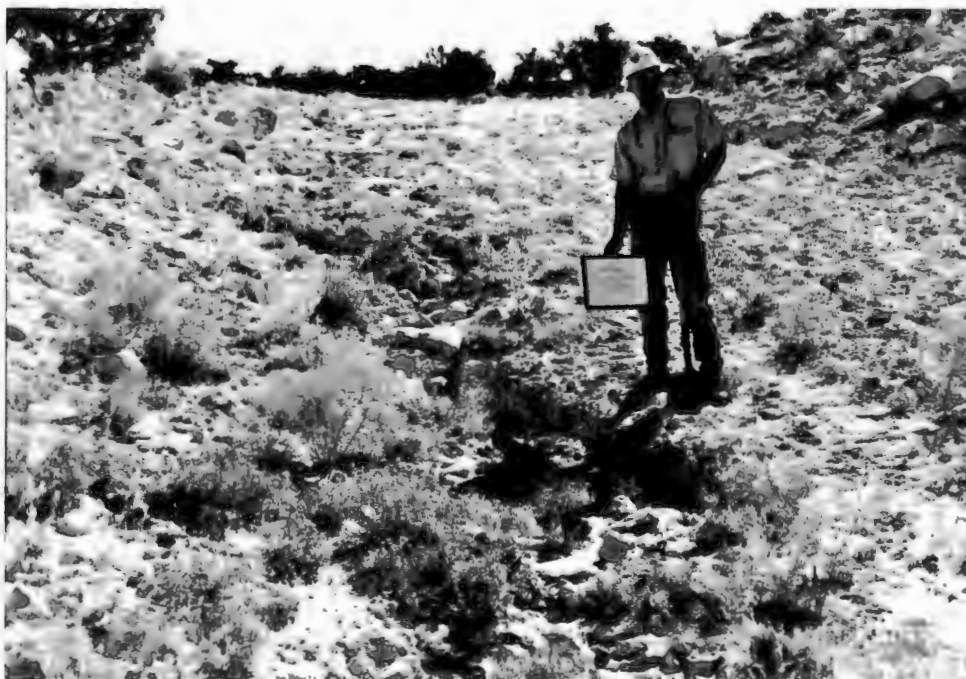
Section 1 T13N R9W, Access Road, 9/13/95

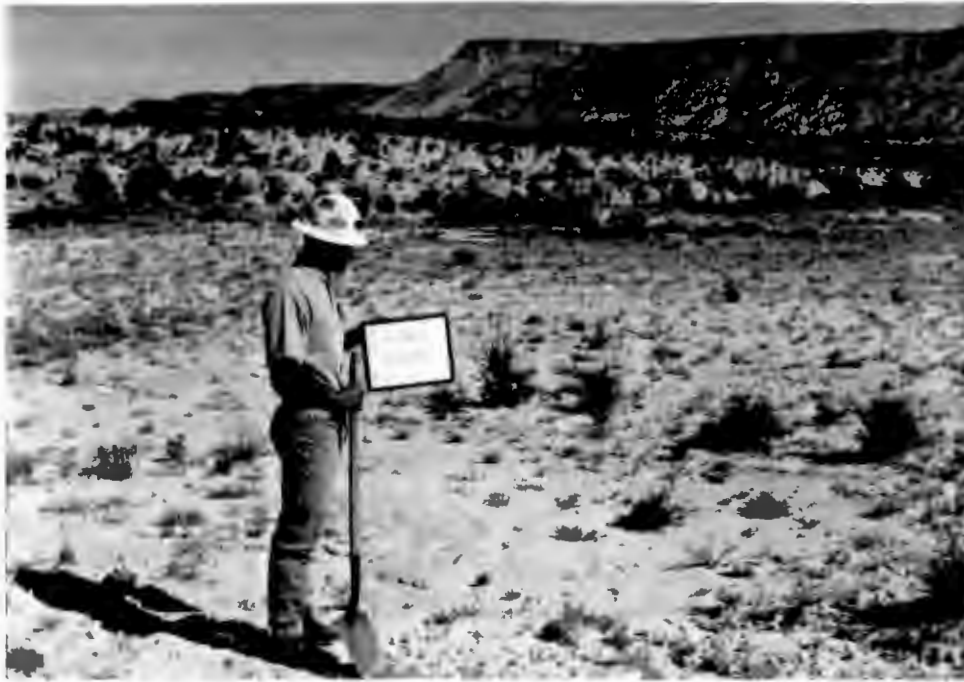
Section 1 T13N R9W, South Side Looking North, 9/13/95

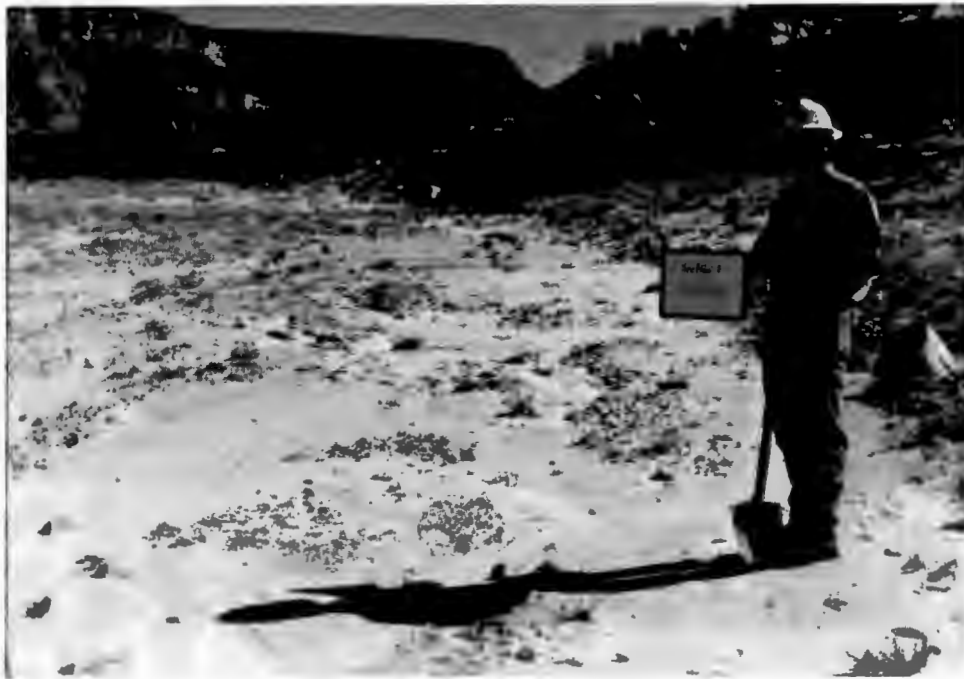
Section 1 T13N R9W, North Side Looking South, 9/13/95

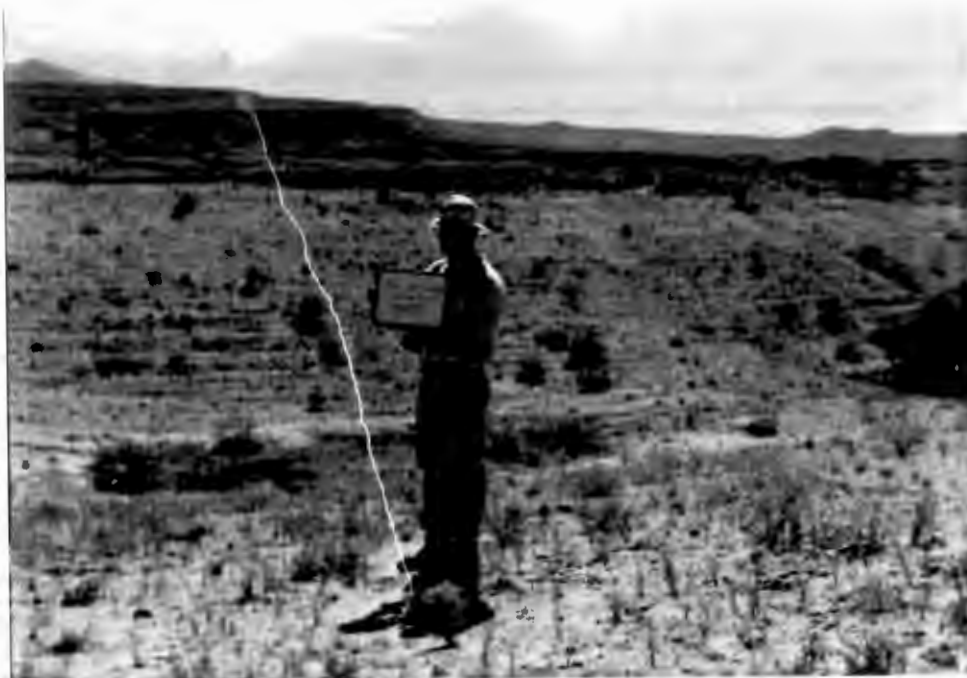
Portions of the reclaimed vegetation have heavily grazed by wildlife and domestic livestock. However, native plant species were invading the area. Twenty-six native species of plants were identified. Line-intercept transects showed average perennial vegetation cover to be approximately 22 percent (Young, 1995). Vegetation measurements are presented in Table V. Despite the slight increase in the number of perennial species invading this site from adjacent areas, there was poor establishment of the perennial grasses, forbs, and shrubs on the slopes of the depressions and topsoil mounds. Because of the lack of adequate cover, this site does not qualify for release at this time.

Section 25 Mine, West Side Looking West, 9/12/95

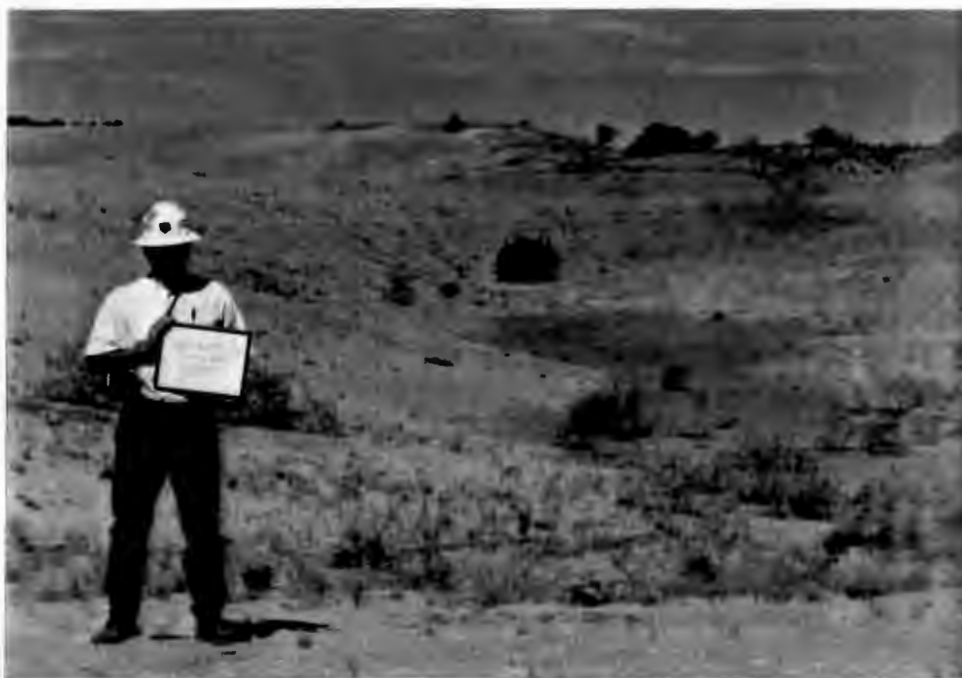
Section 25 Mine, Middle Looking East, 9/12/95

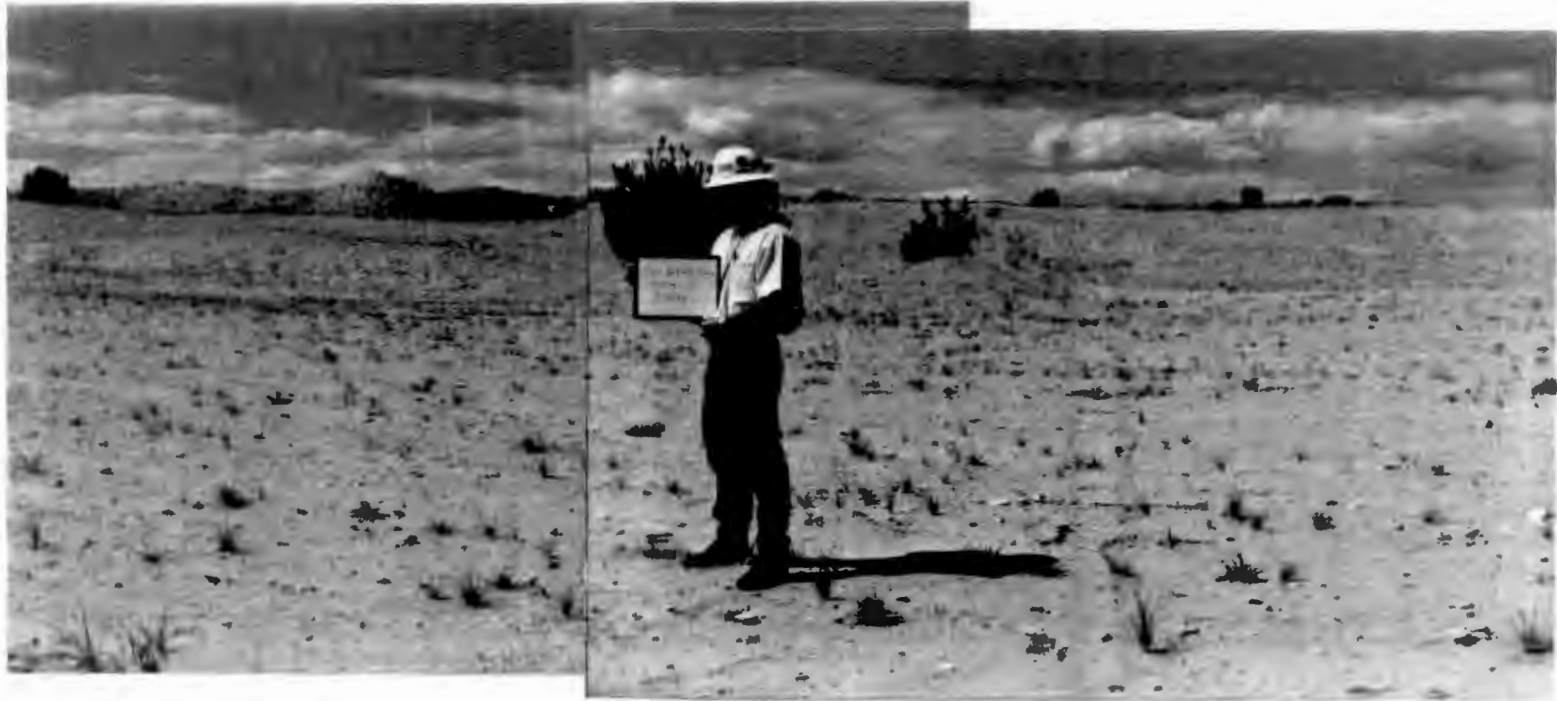
Section 25 Mine, East Side Looking Southwest, 9/12/95

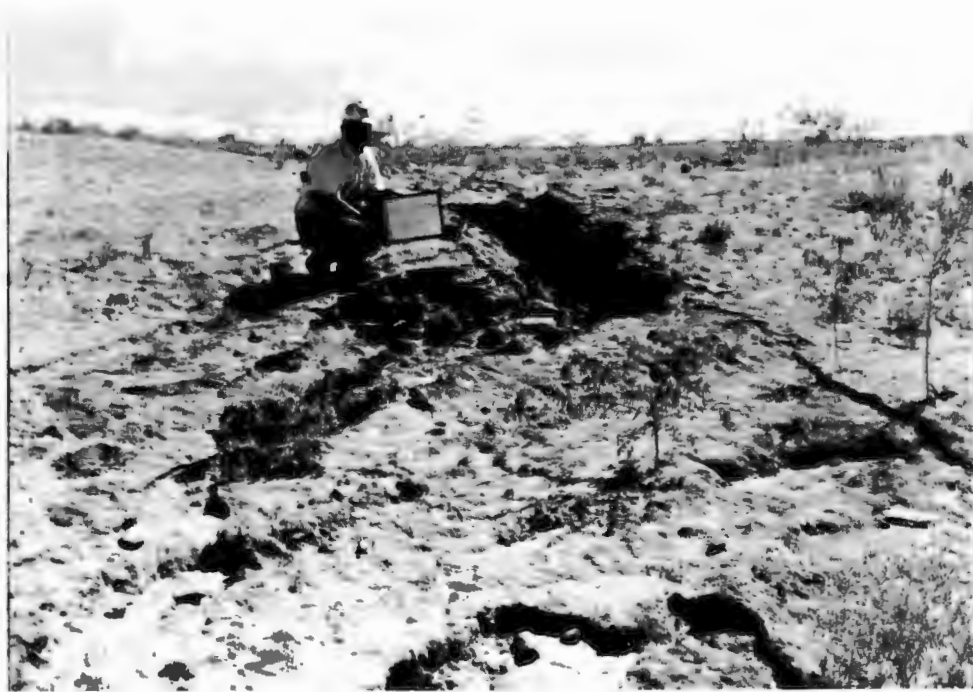
Section 25 Mine, Erosion Feature, 9/12/95

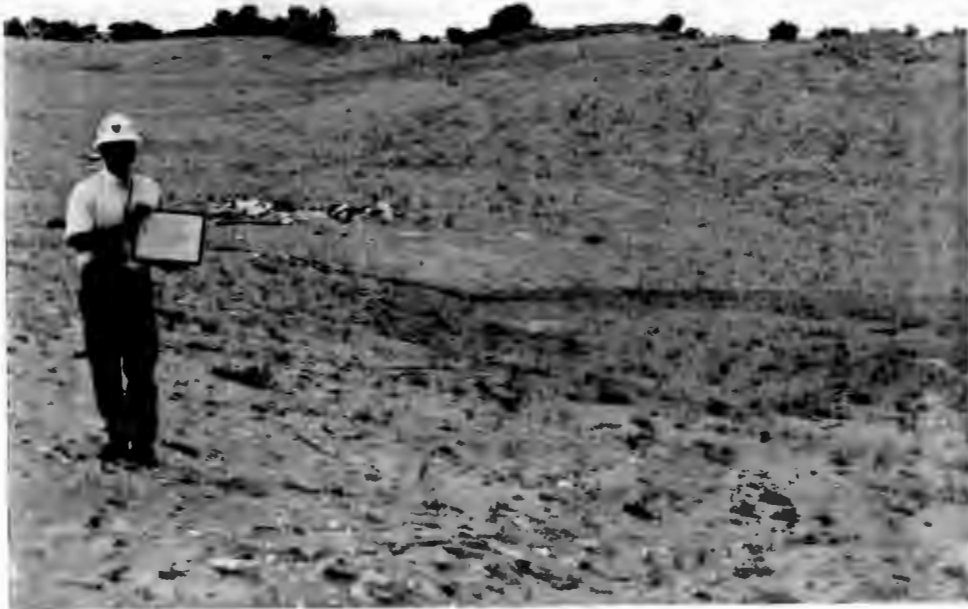
There was evidence of grazing by livestock and wildlife on this site. Vegetation also showed signs of drought stress. Line-intercept transects showed vegetation cover to be approximately 12 percent (Young, 1995). The results of these vegetation measurements are presented in Table VI. Because of the lack of cover and diversity, staff does not recommend this site for release.

Section 31 T13N R9W, North End Looking South, 9/12/95

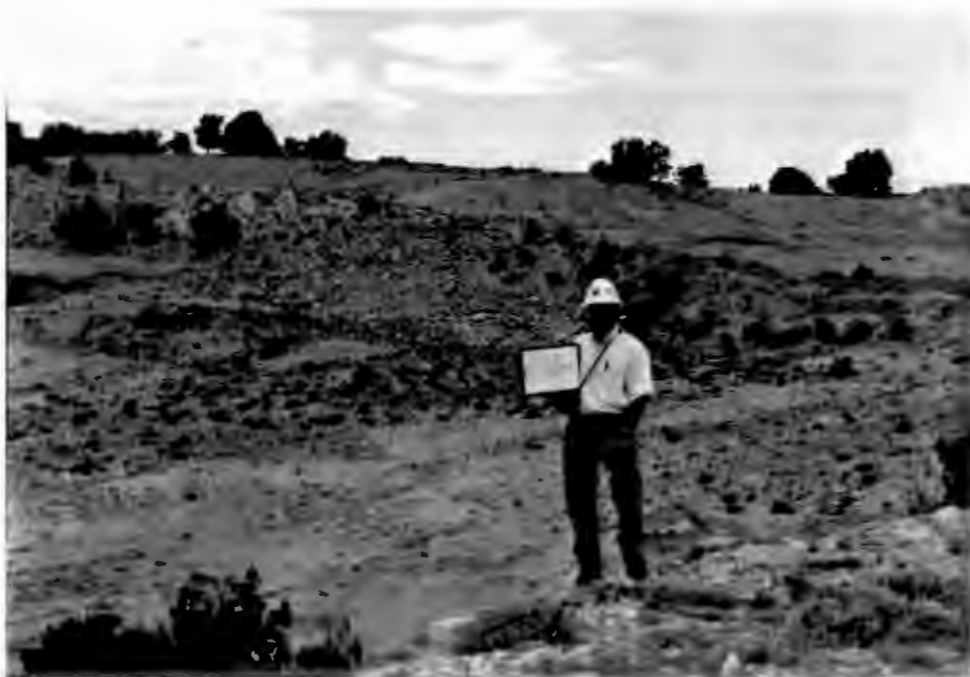
Section 31 T13N R9W, Northeast Side Looking West, 9/12/95

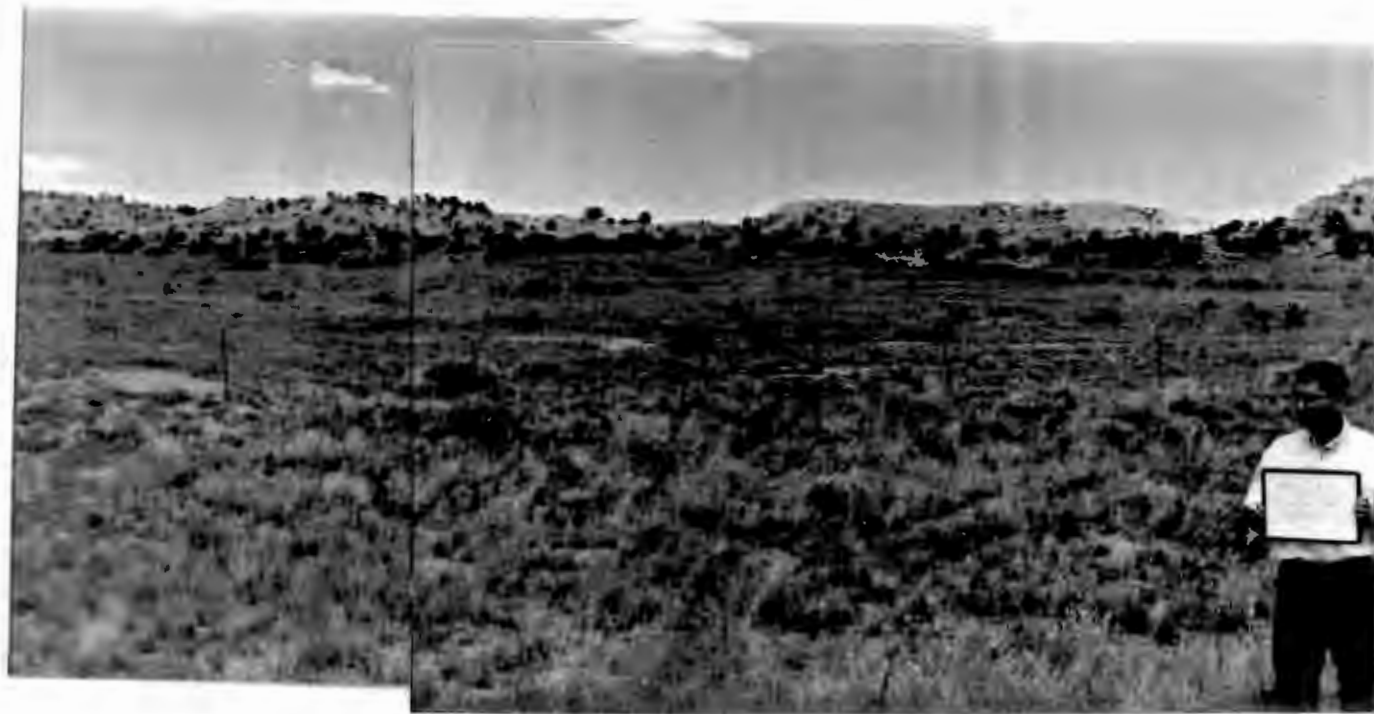
Section 31 T13N R9W, Reconstructed Limestone Bluffs, 9/12/95

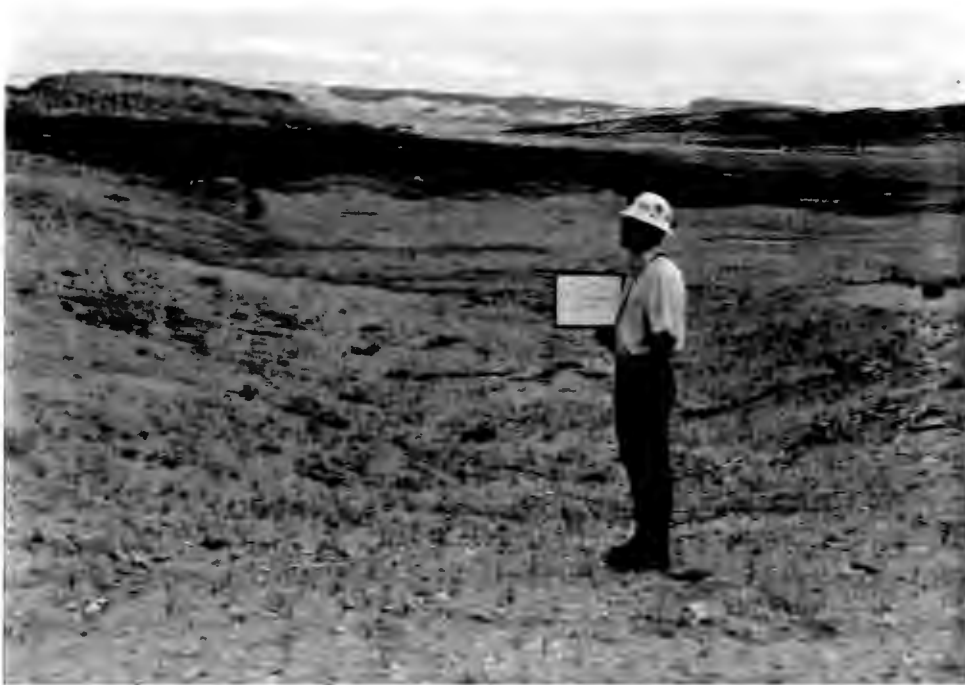
Section 31 T13N R9W, Southeast Side looking North

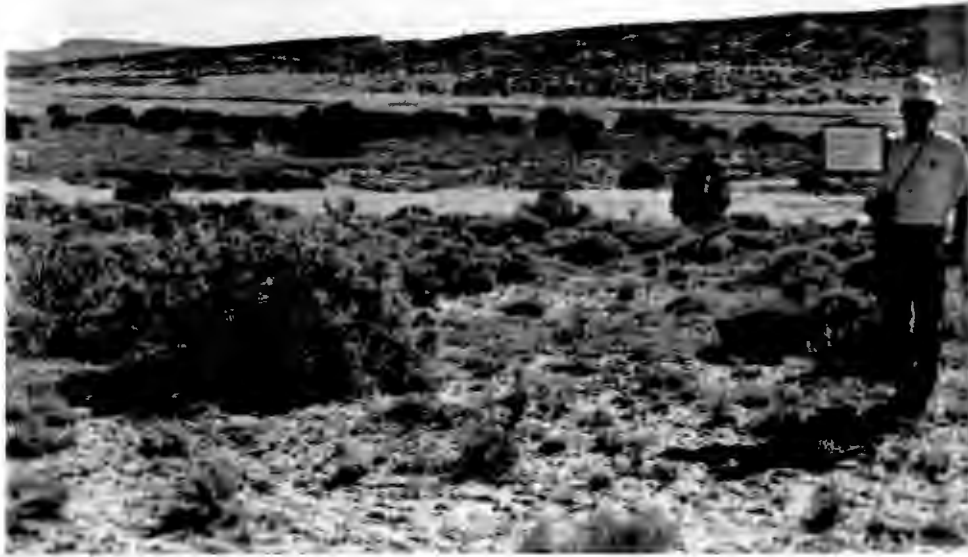
This underground mine was reclaimed in 1986 (Eby, 1995). Native vegetation from adjoining undisturbed lands had invaded the site and it was difficult to tell that a mine had previously existed on this site. Approximately one acre had recently been regraded and reclaimed, the only other indication of the mine presence was a revegetated mound where a vertical shaft had been backfilled with nontoxic mine waste material (Eby, 1995). All structures, trash or junk had been removed from the site. There were no piles or accumulations of toxic or waste material on the site. Similarly, there were no erosion features. Photographs documenting vegetation and general condition of the site are presented in Appendix H. Topsoil depths across the site ranged from 4 to 6 inches.

Faith Mine Shaft Site, Looking East, 9/12/95  
Regraded Area in Background

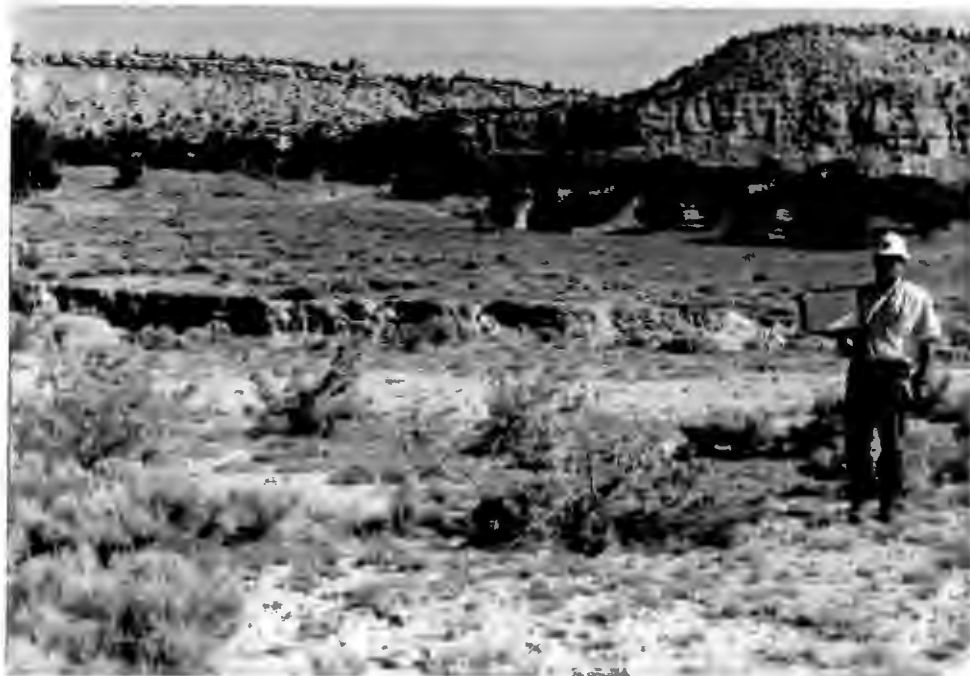
Faith Mine Shaft Site, Looking North, 9/12/95

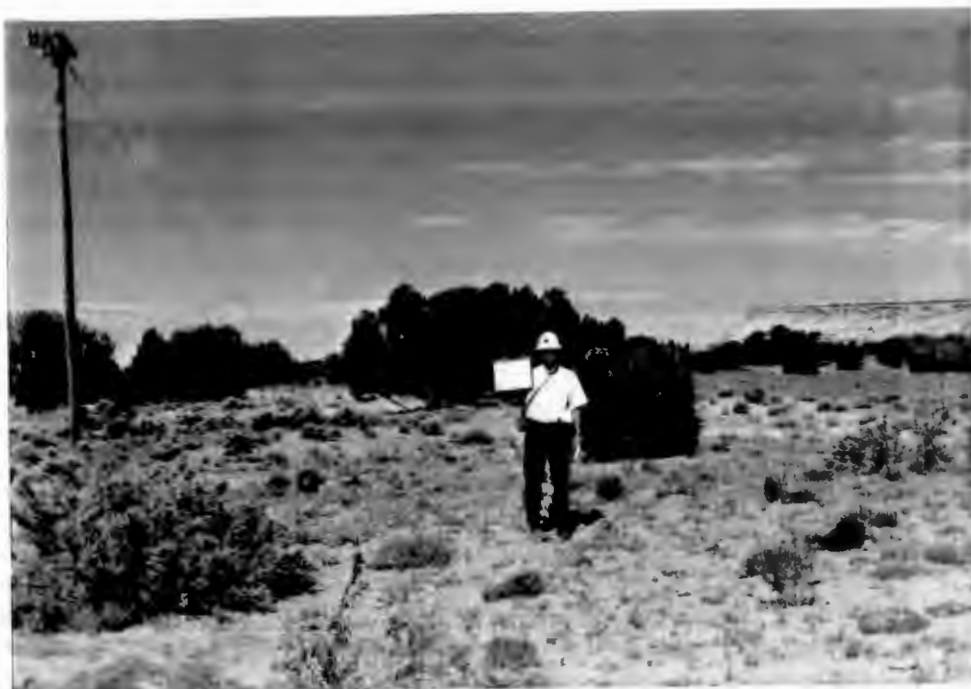
Faith Mine Shaft Site, Looking West, 9/12/95

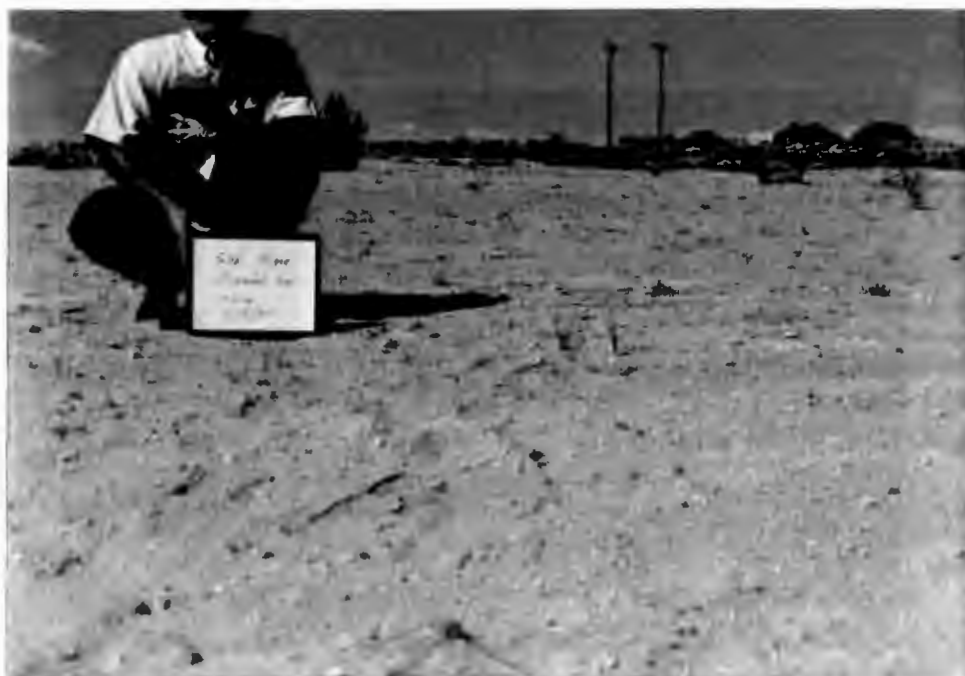
Faith Mine Regraded Area, 9/12/95

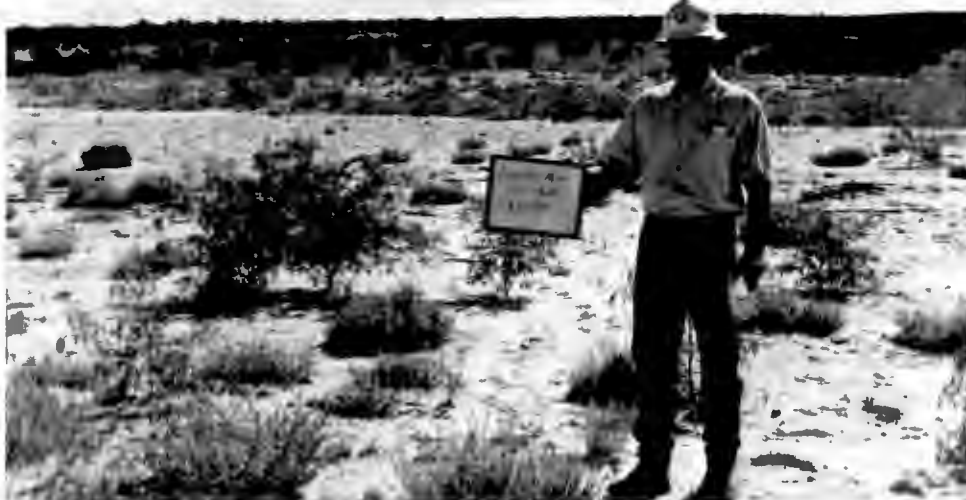
Again, the mine site had been grazed by livestock and wildlife. Similarly, vegetation showed signs of drought stress. Line-intercept transects indicated that vegetation cover was approximately 15 percent (Young, 1995). Results of vegetation measurements are presented in Table VII. Because of the lack of plant cover, this site is not recommended for release.

Isabella Mine, From North, 9/12/95

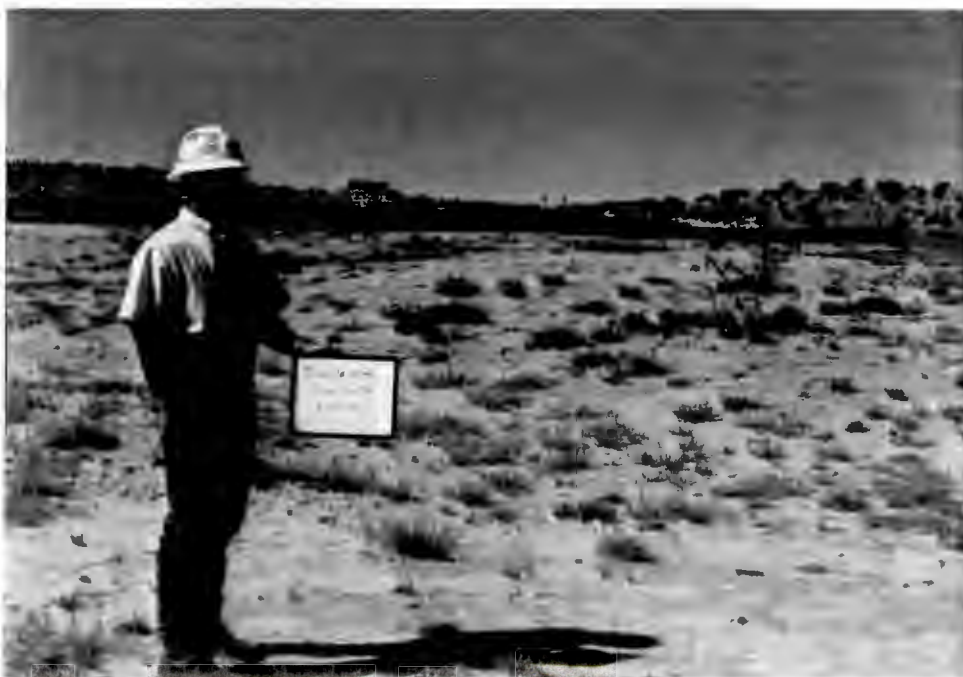
Isabella Mine, From South, 9/12/95

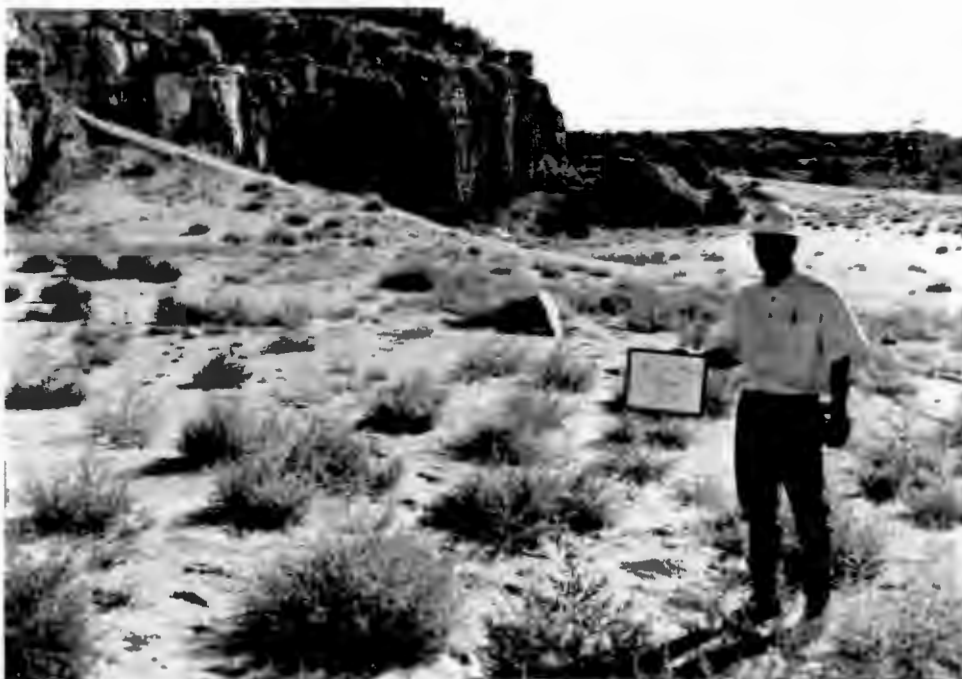
Topsoil depths across the site were greater than 12 inches, but consisted entirely of windblown sand. This area was essentially barren with most of the seed and mulch blown away before vegetation could be established. Native species such as Indian ricegrass (*Oryzopsis hymenoides*), from adjoining areas were starting to invade the disturbance area (Young, 1995). Because of the obvious lack of plant cover at the site no transects were attempted. Staff does not recommend release of this site.

Marquez Mine, Reclaimed Declined Shaft, 9/12/95

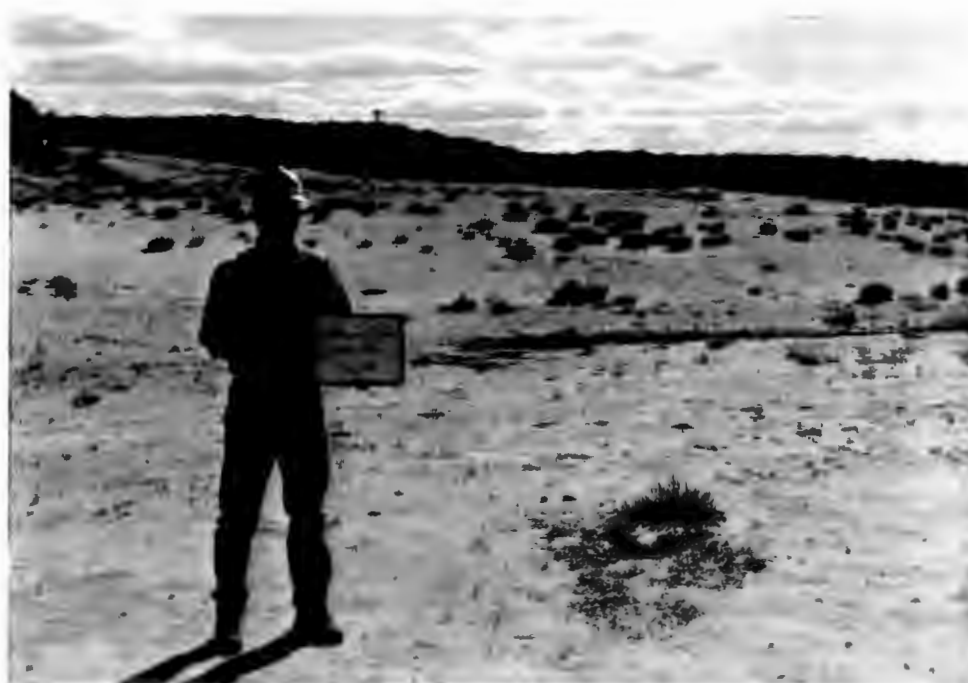
Marquez Mine, Waste Pile, 9/12/95

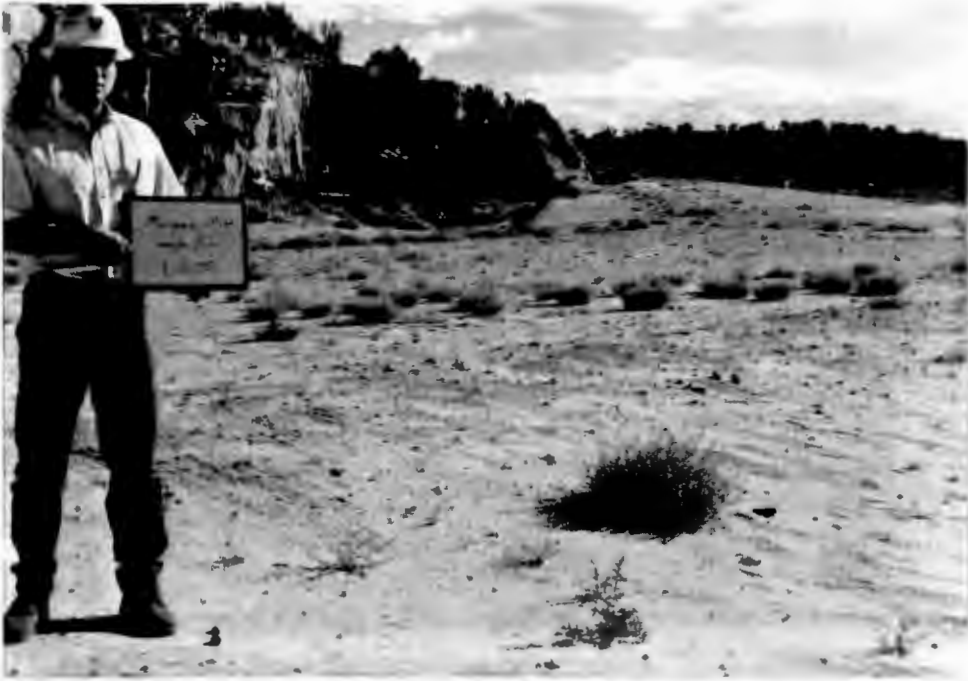
Marquez Mine Waste Pile, 9/12/95

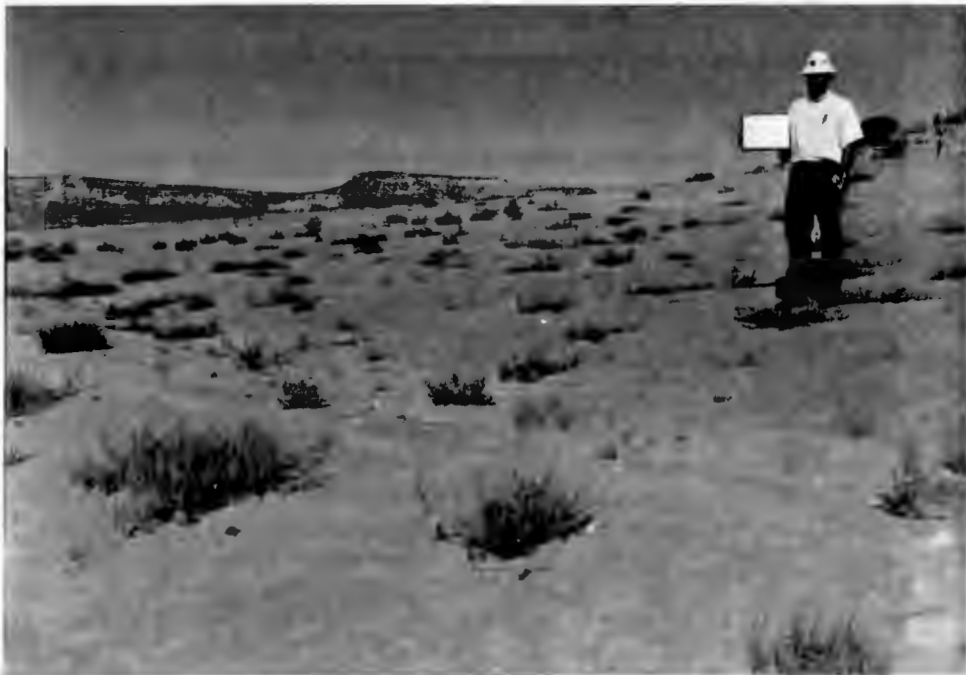
Marquez Mine, Waste Pile, 9/12/95
