**RE:**  
**Prior Reclamation Inspections**

**PRIOR RECLAMATION INSPECTION REPORT  
AND  
RECOMMENDATION FOR RELEASE OR PERMIT  
REQUIREMENT**

**Santa Fe Pacific Gold Corporation**

**September 29, 1995**

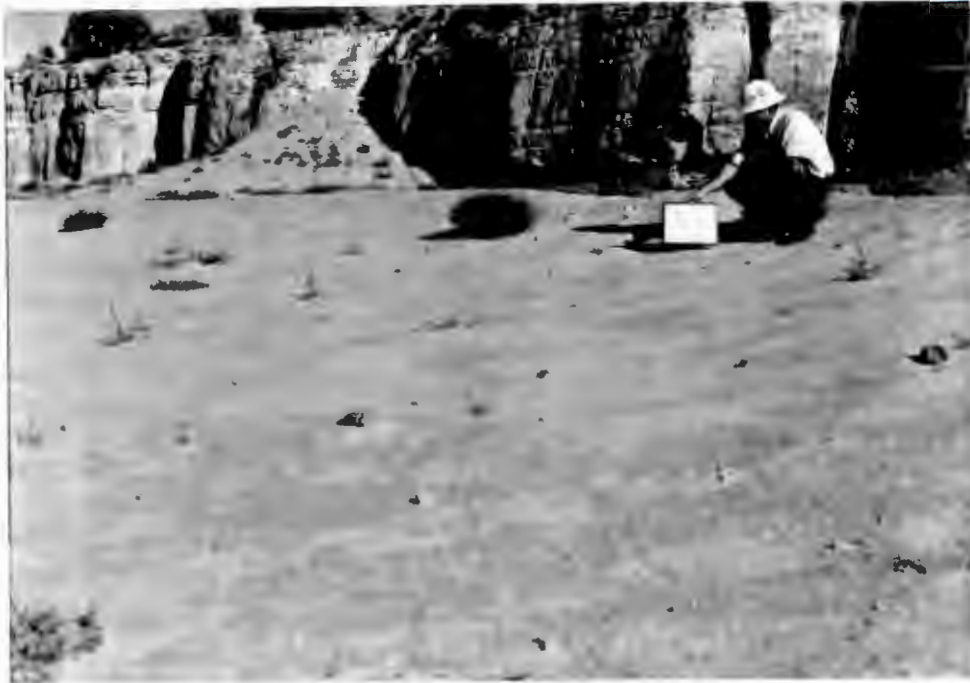
Marquez Mine, Waste Pile, 9/12/95

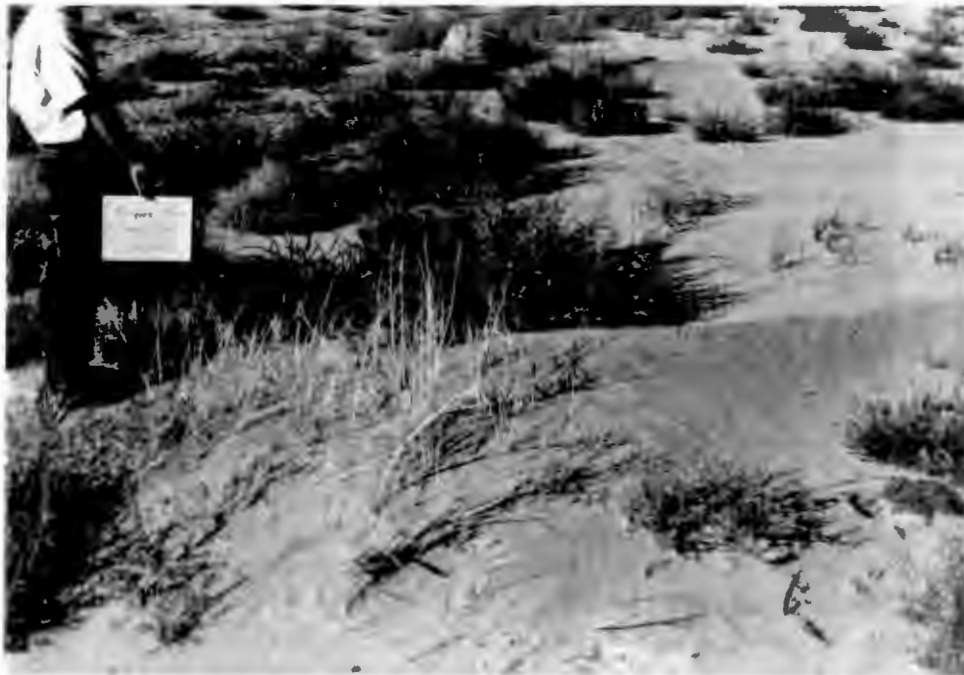
Marquez Mine, Sand Dune, 9/12/95

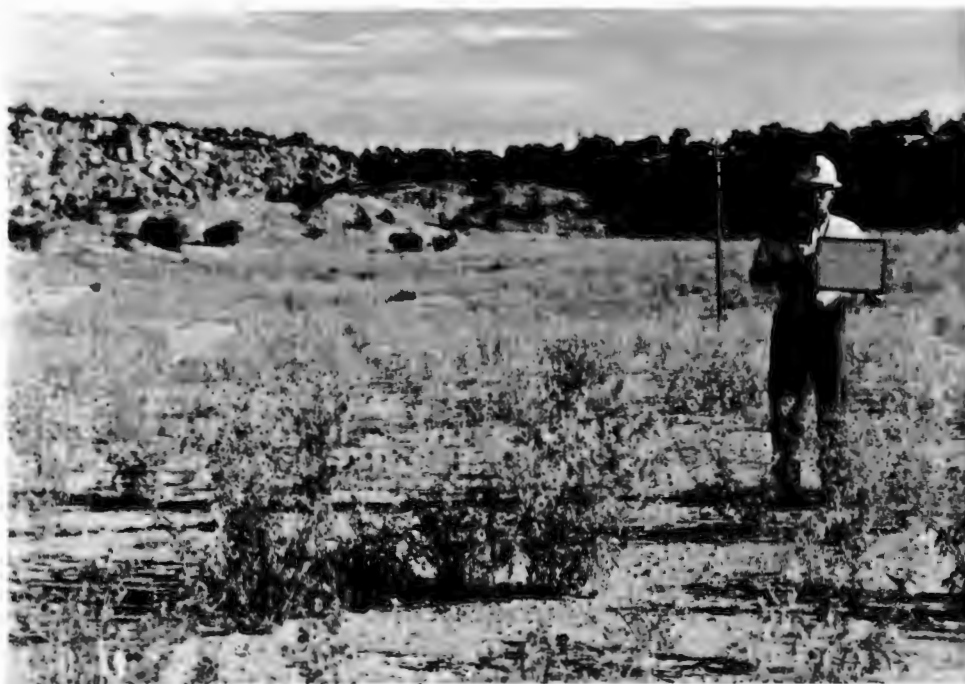
Topsoil depths across the site were approximately 4 inches. Line-intercept transects indicated that perennial vegetative cover was approximately 31 percent. The results of these vegetation measurements are presented in Table VIII.

Poison Canyon Mine, Middle Looking North, 9/12/95

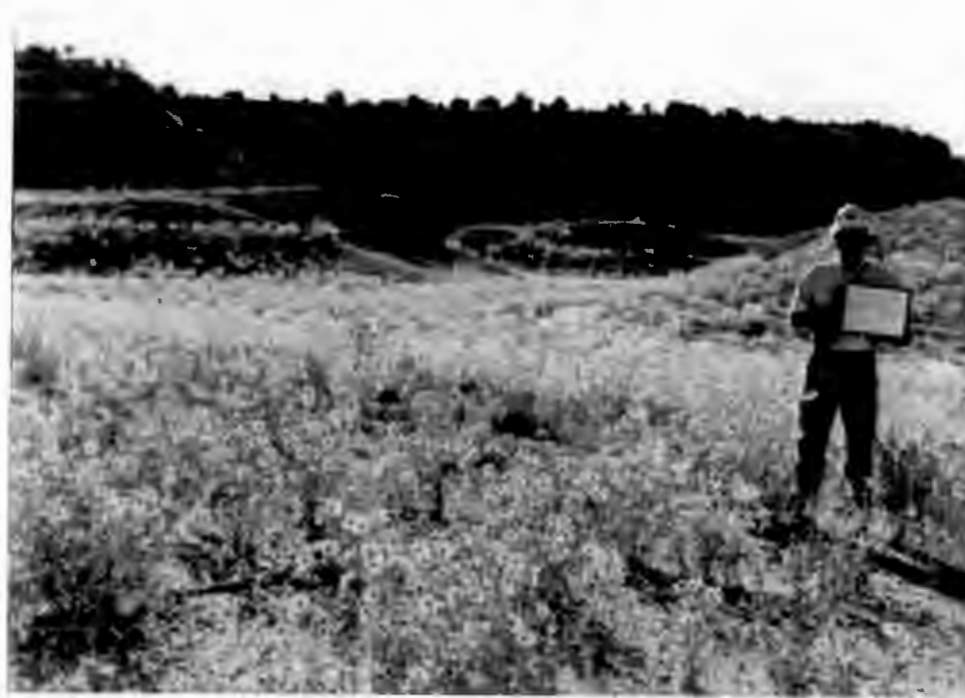
Poison Canyon Mine, Middle Looking East, 9/12/95

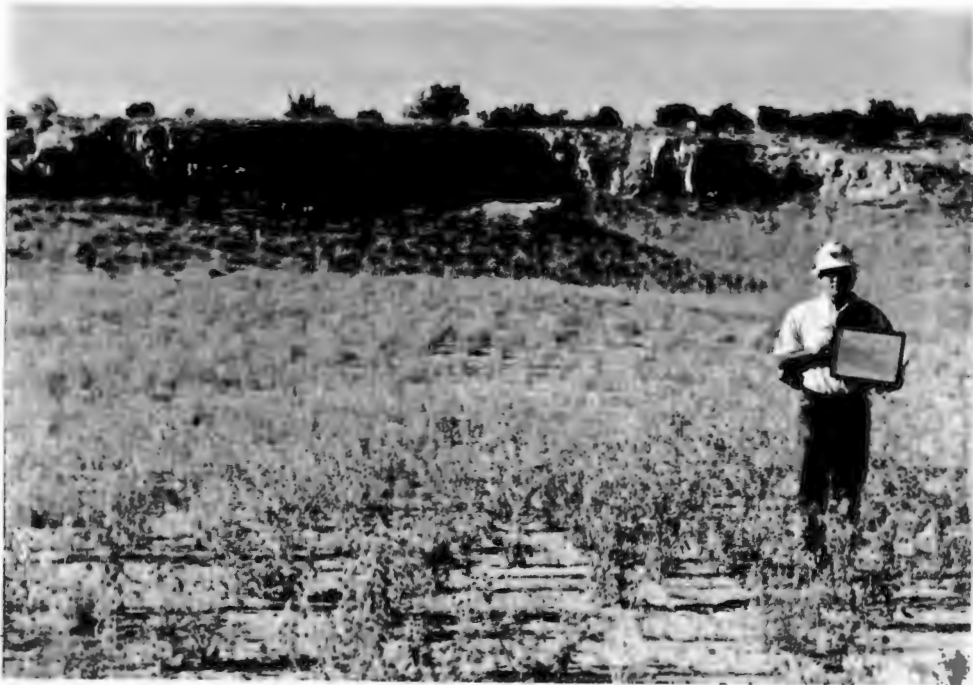
Poison Canyon Mine, Middle Looking South, 9/12/95

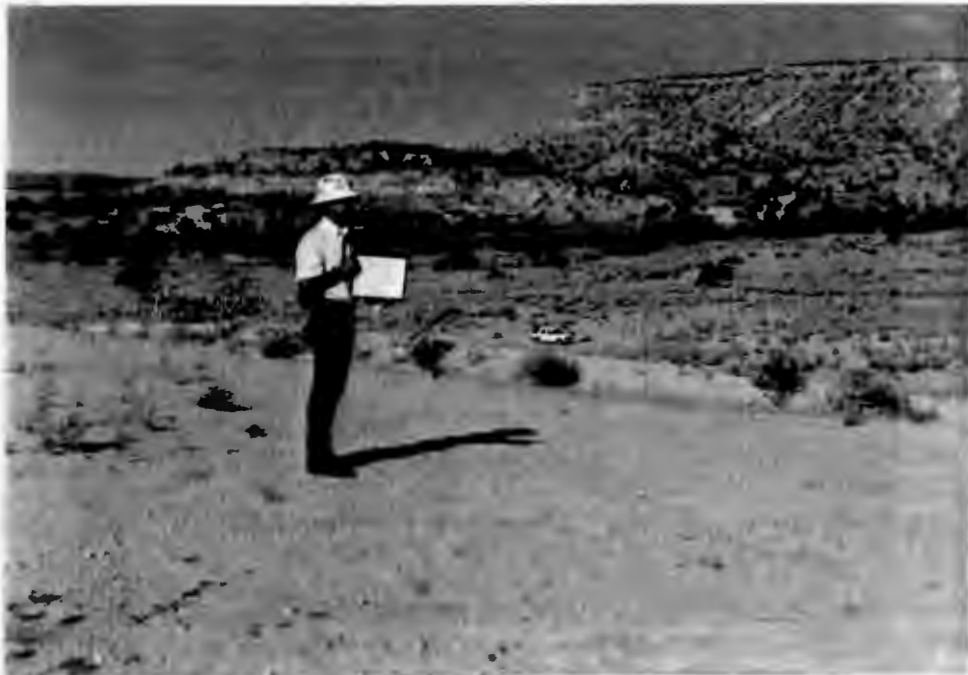
Poison Canyon Mine, Middle Looking West, 9/12/95

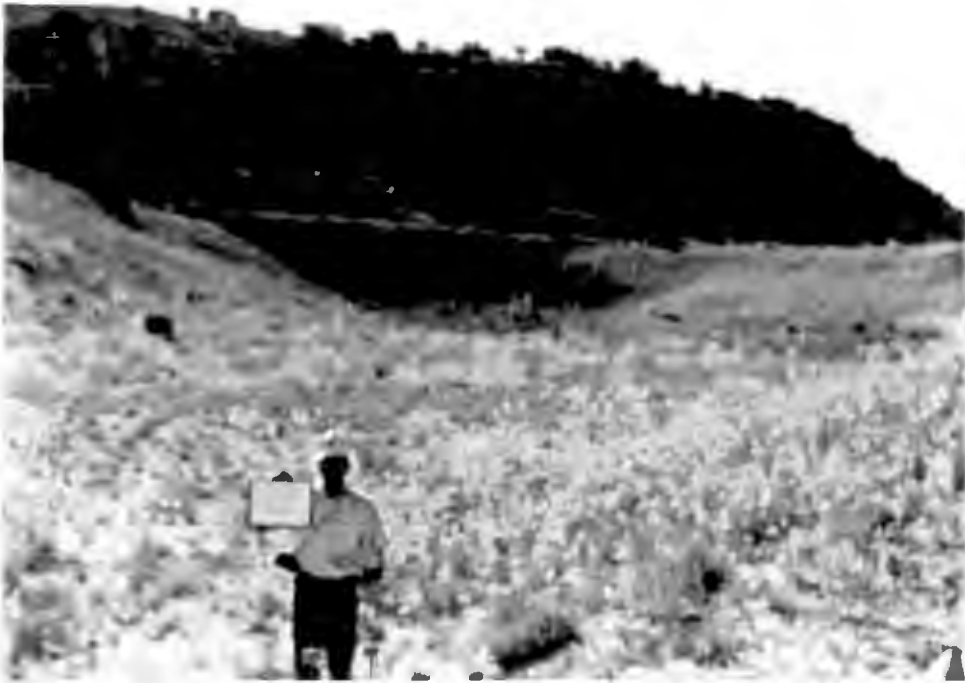
Poison Canyon Mine, Reclaimed Declined Shaft, 9/12/95

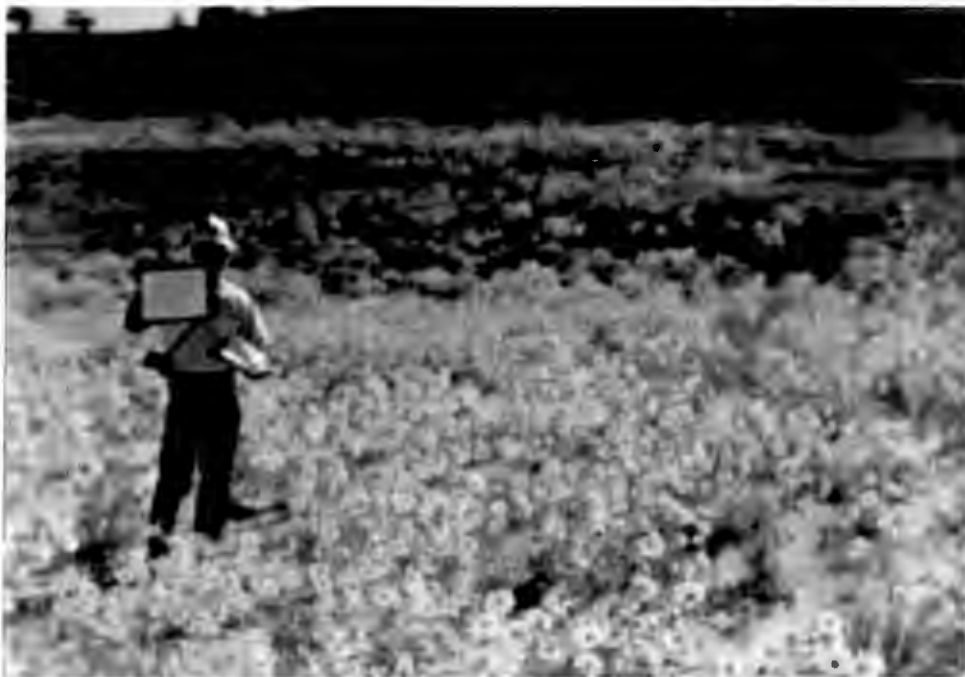
Poison Canyon Mine, Small Depression, 9/12/95

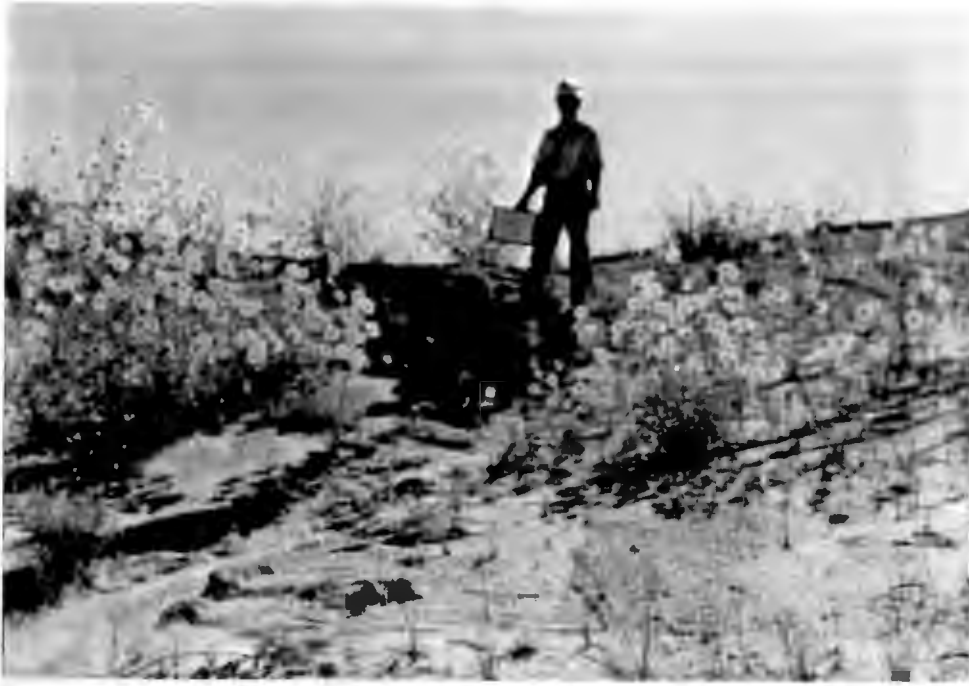
Poison Canyon Mine, Erosion Feature, 9/12/95
