**DEMING MILL AND TAILINGS  
REISSUED PERMIT NO. LU009RE**

**RECLAMATION AND UTILIZATION PLAN**

**DEMING MILL & MILL TAILINGS  
DEMING, NEW MEXICO**

**Reclamation for Tailings Identified by Test Pitting**

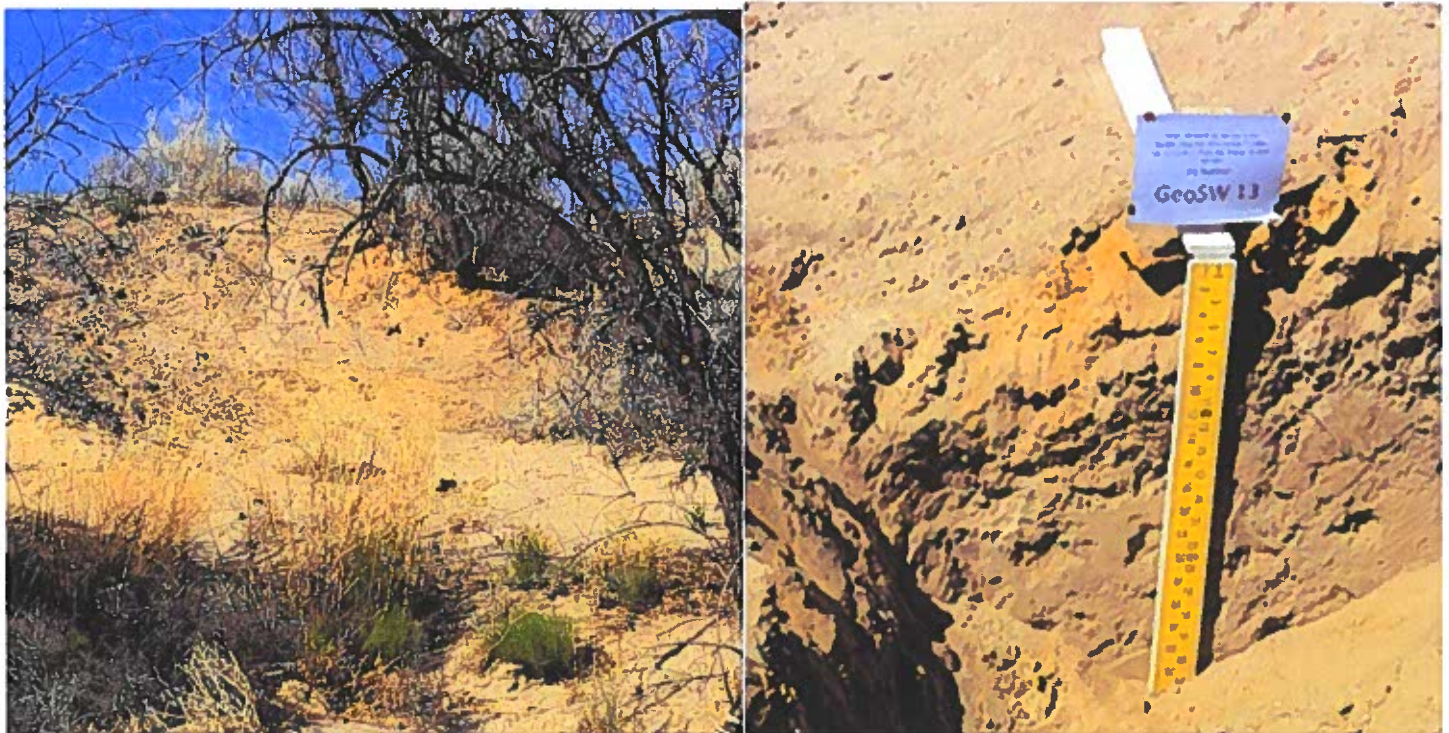
Figure 4. Tailings on Mimbres Riverbank at A – A' Longitudinal Section

“Limited testing in this area immediately adjacent to the river channel revealed only one site where the tailings are present. Here 15 inches of weakly cemented interbedded fine grained sand tailings mixed with medium to coarse alluvial sand was encountered at the surface, in the bank but not in the river channel. There is little evidence to indicate that the tailings are being transported downstream in the river channel but rather are related to slope wash. It is estimated that only 1,837 square feet of this material is present here.” See Figure 3.

1. Trees will be removed from areas underlain by mill tailings.
2. A backhoe with an extended arm and a one-yard bucket will be used to peel back the surface where tailings are present in six-inch layers until undisturbed, natural sediments, without tailings are encountered. Tailings to be excavated is estimated to be less than 600 cu yds.

3. The material removed from the bank will be relocated northward and positioned south of the existing berm for Recovered Tailings. See Figures 5 & 6.
4. The area beneath the relocated tailings may also contain mill tailings. If so they will be left undisturbed beneath the relocated tailings.

5. These areas where tailings are present will be covered with 3 feet of clay, sand, and gravel from the borrow pit. Figure 6.
6. Finished slopes will be less than 3 to 1 horizontal to vertical ratio.

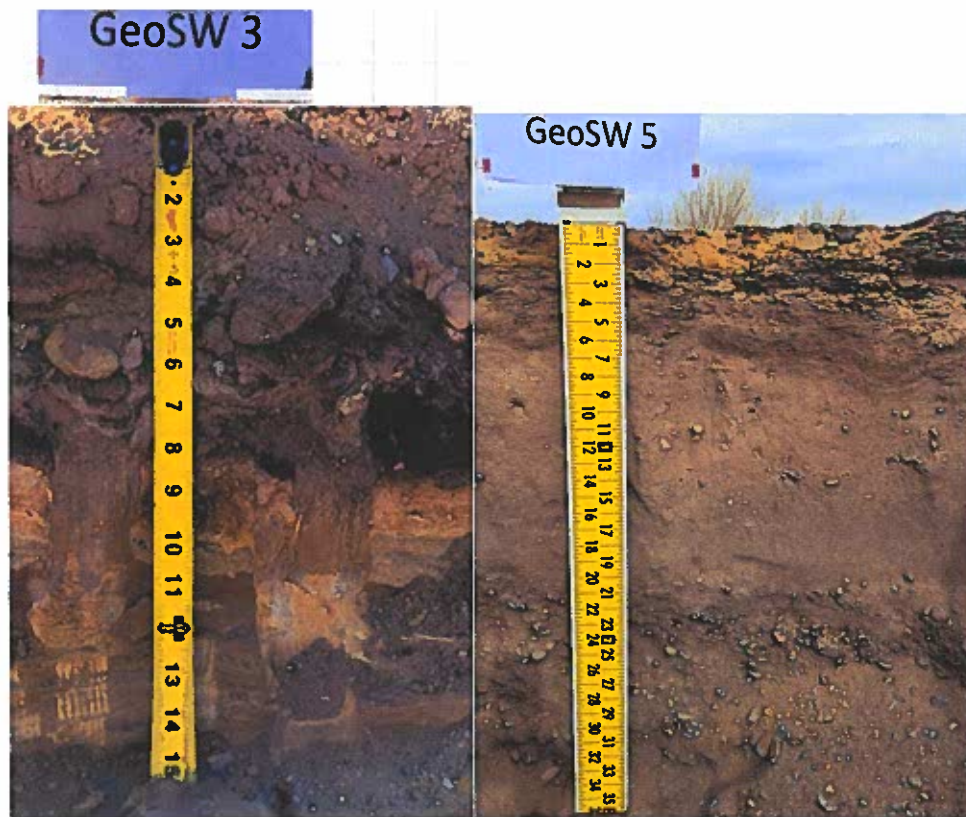
Figure 8. Tailings in Middle Flat Area at B – B' Longitudinal Section

Only three pits in this area intersected tailings. The most notable occurrence was in pit GEOSW3 where very well cemented tailings prevented excavation beyond 19 inches. The tailings consisted of 10 inches of well cemented sandstone comprised of tailings overlain by 5 inches of Interbedded loosely cemented light gray and black medium grained sand with root fragments. Further study revealed that the cementing agent here is gypsum. In an adjacent pit, GEOSW5, the tailings covered soil containing root material. Leaching from the tailings above was sufficient to produce 4 inches of soil with a pH of 3.78. This area is estimated to contain 1.51 acres of tailings.

1. Much of the area outlined for Middle Flat is underlain by mill tailings. They will not be moved or disturbed.
2. The entire area, which varies only 2 feet in elevation, will be covered with 3 feet of clay, sand, and gravel from the borrow pit. This coverage will extend beyond areas underlain by visible mill tailings to ensure coverage. Figure 10.
3. Finished slopes at the edges of the cover material will be less than 3 to 1 horizontal to vertical ratio.
4. Areas disturbed or covered with pit material during this reclamation effort will be revegetated according to requirements cited in Section 9.F Reissued Permit No LU009RE – Permit Revision 14-1.

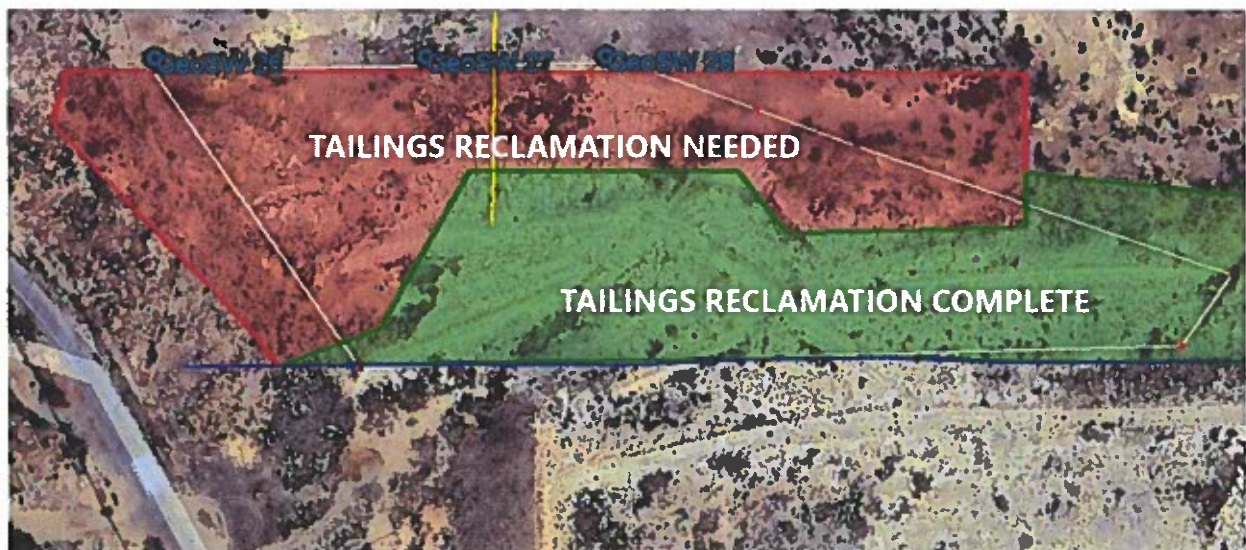
Figure 12. Cypress North Slope Reclamation Map

Detailed mapping completed during the current Alternatives Analysis has resulted in a more accurate understanding of the geographic distribution and nature of the mill tailings in this area. Much of the reclamation of the Cypress North Slope area included in Permit No LU009RE was completed by past operators and is still viable, covered with material from the borrow pit. Therefore, no additional efforts will be needed in this area. See Figure 12. Tailings Reclamation Complete

The area to the north (3.13 acres) with exposed mill tailings is still in need of reclamation. The reclamation of this area was also completed by previous operators, but subsequent erosion has exposed the underlying tailings and washed them down slope. The tailings at the toe of the original pile are several feet thick and do not lend themselves to relocation. Figure 12. Tailings Reclamation Needed.

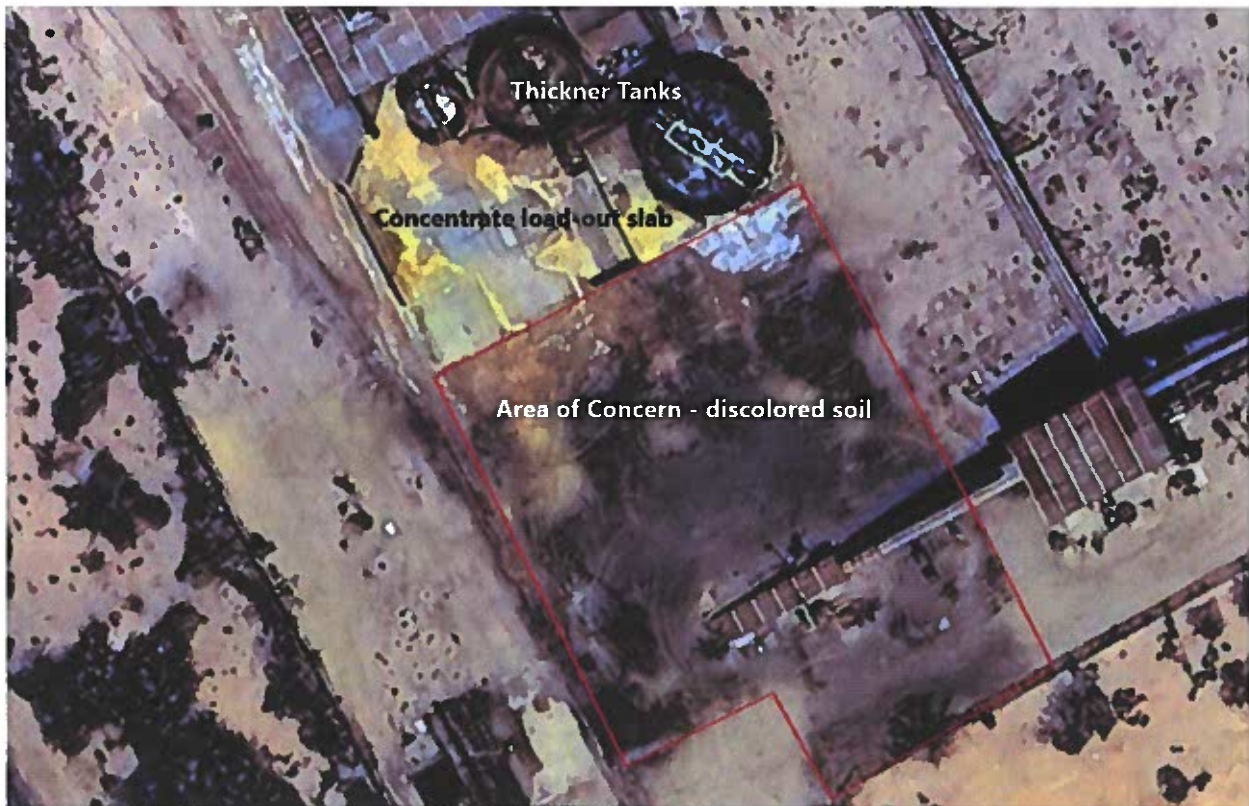
Several years ago, reclamation of this area was completed by ENVIRON. Subsequent rainwater leaching of the zinc/copper concentrates located in the large thickener tank followed by leakage and drainage to the south contaminated and discolored the soil. The concentrate is still present in the thickener tank. The following steps will be taken to complete the reclamation of this area:

1. Areas of contamination will be visually identified within the 0.56-acre area of concern.
2. Contaminated soil will be removed using a backhoe with an extended arm by scraping a few inches at a time, removing only the contaminated material.
3. The contaminated soil will be hauled by dump truck to the Mid Flat area and spread out in a thin layer where existing mill tailing will be in the process of reclamation.
4. The relocated contaminated soil will be covered with 3 feet of cover material from the borrow pit in due process as the Mid Flat area reclamation is completed.

5. Cover material from the borrow pit will be used to bring the soil surface in the thickener tanks south area back to its original level and grade for stormwater control using dump trucks and a road grader.
6. This is an active work area for the mill. Therefore, no attempt will be made to revegetate the area which will be finished as a graveled yard.
7. Estimated Cost: \$5,000
