MK006PR
SECTION 25
MINE

**PRIOR RECLAMATION INSPECTION REPORT
AND
RECOMMENDATION FOR RELEASE OR PERMIT REQUIREMENT**

**Section 13, (T 14N R 10W), Section 15 (T 14N, R 10W), Section 23 (T 14N, R 10W),
Section 25 (T 14N, R 10W) and Section 32 (T 14N, R 10W) Mines**

**New Mexico Energy, Minerals and Natural Resources Department
Mining and Minerals Division
Mining Act Reclamation Bureau**

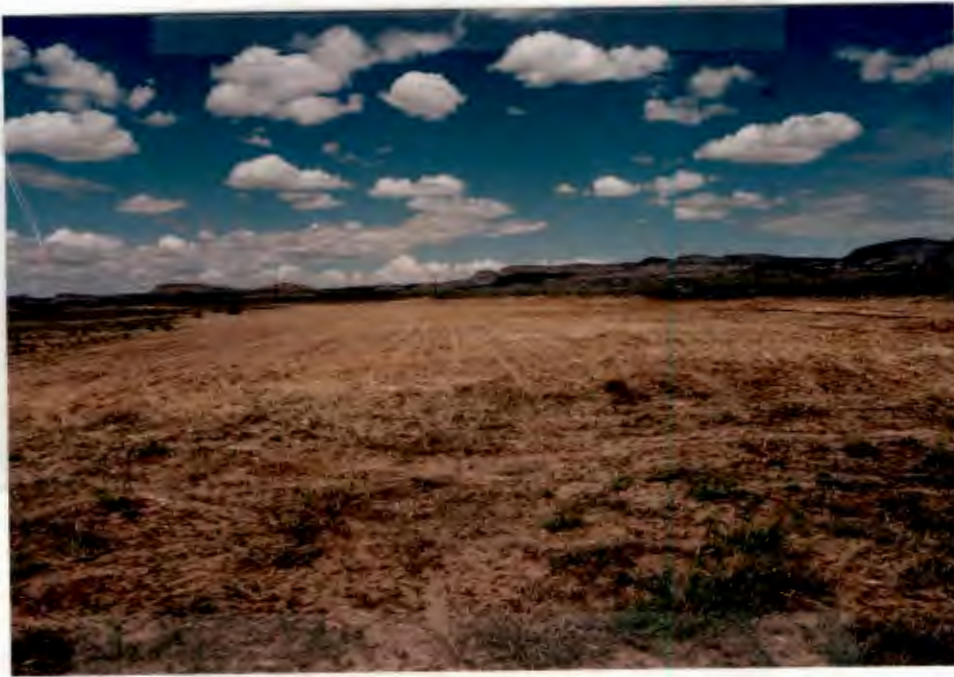
Photo 1 Looking north at soil barrow area which has been seeded and mulched after recontouring. July 19, 1995

I'm responding to your request for documentation that additional work was performed at Section 25 Mine, T14N, R10W. Homestake reviewed the prior reclamation activities at Section 25 Mine and determined that one small area of one waste pile had some wind erosion. On July 7, 1995 a contractor, employed by Homestake, started to reshape the portion of the pile from a 5 to 1 slope to a 10 to 1 slope. After reshaping, the disturbed areas were covered with approximately one foot of clean barrow soil. Earth work activities were completed July 12, 1995. On July 18 and 19, 1995 the 9.5 acres of disturbed ground, which was barrow area and waste pile, was disked, seeded and mulched. Seed was applied at 16 pounds live seed per acre and mulch at one ton per acre. See attachment for photos of seeding activities.

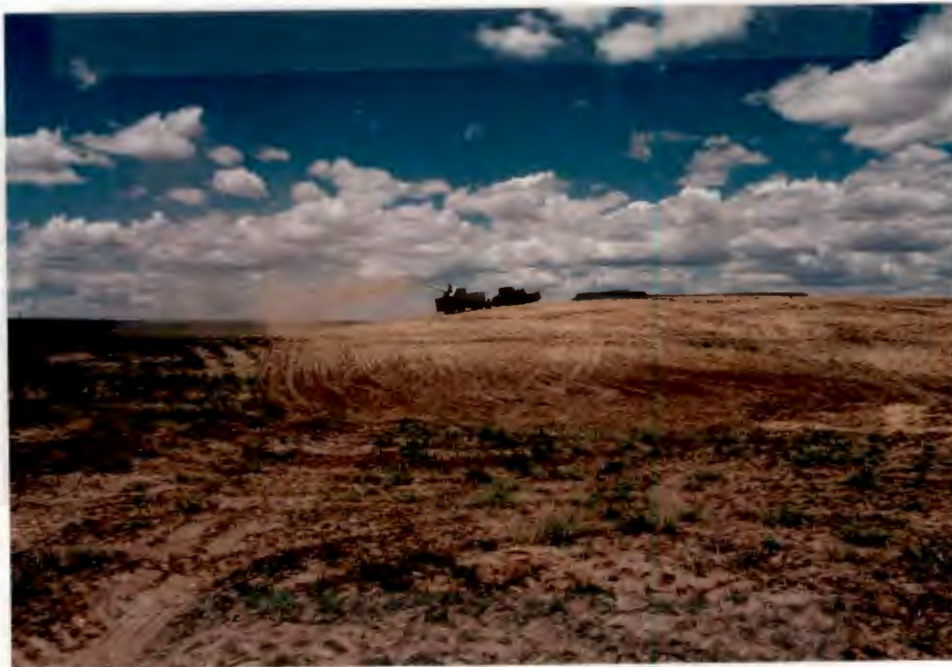
Photo 2 Looking west at south end of waste pile as mulch is applied to seeded area. July 19, 1995

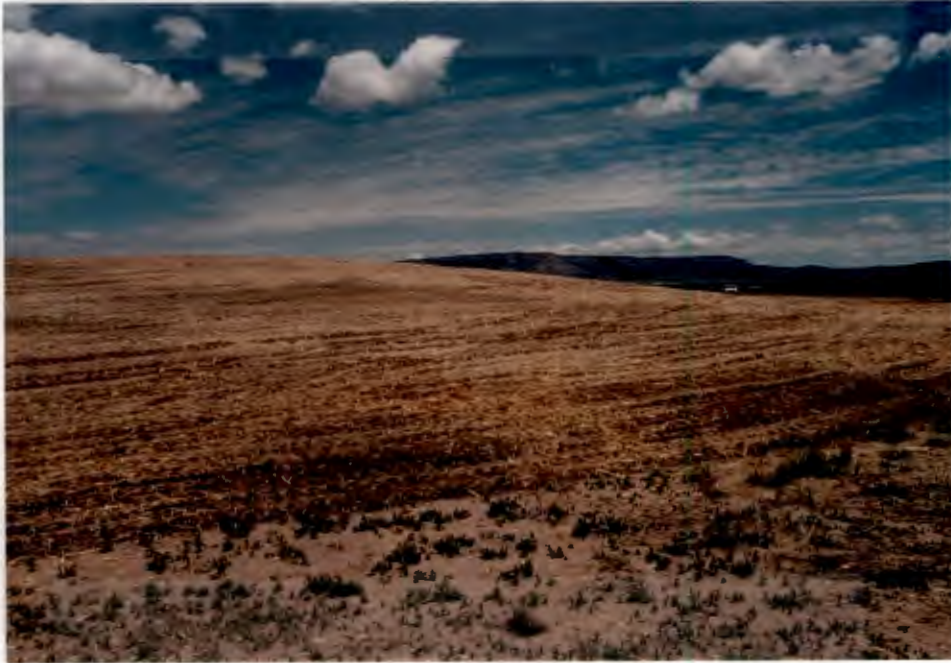
Photo 3 Looking east at west side of waste pile which has been seeded and mulched after recontouring. July 19, 1995

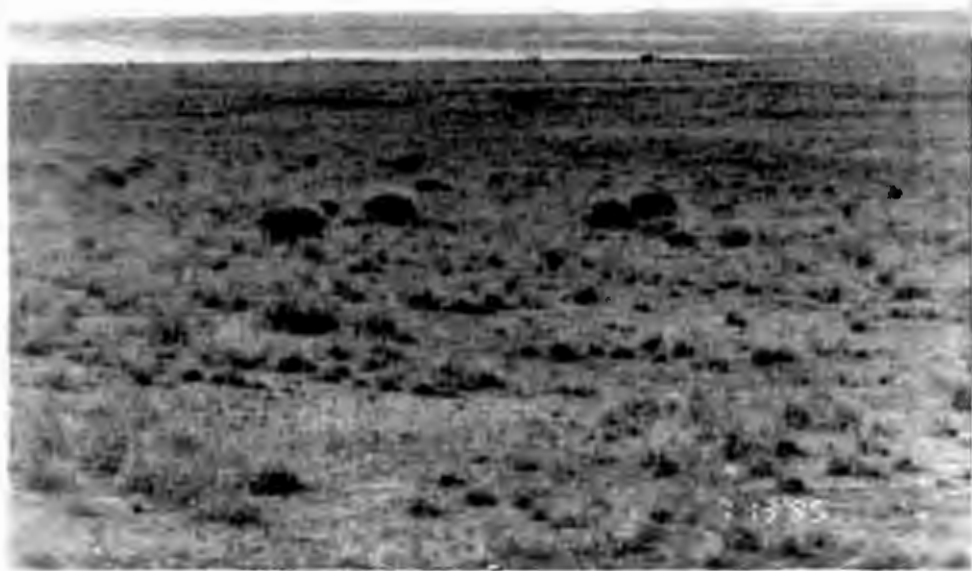
*Section 13, T14N, R10W
From middle of site looking southwest*

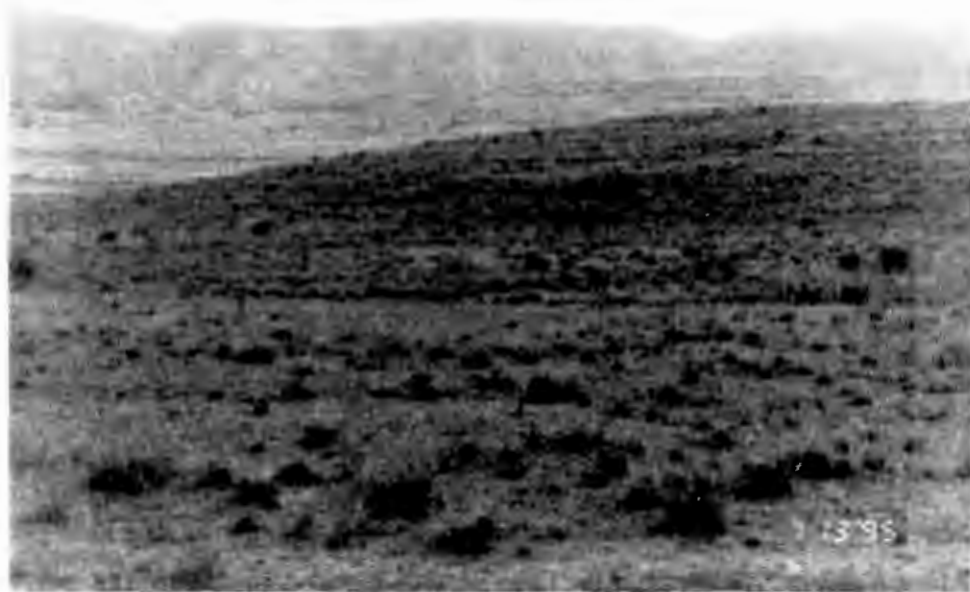
*Section 13, T14N, R10W
from south side of site looking west*

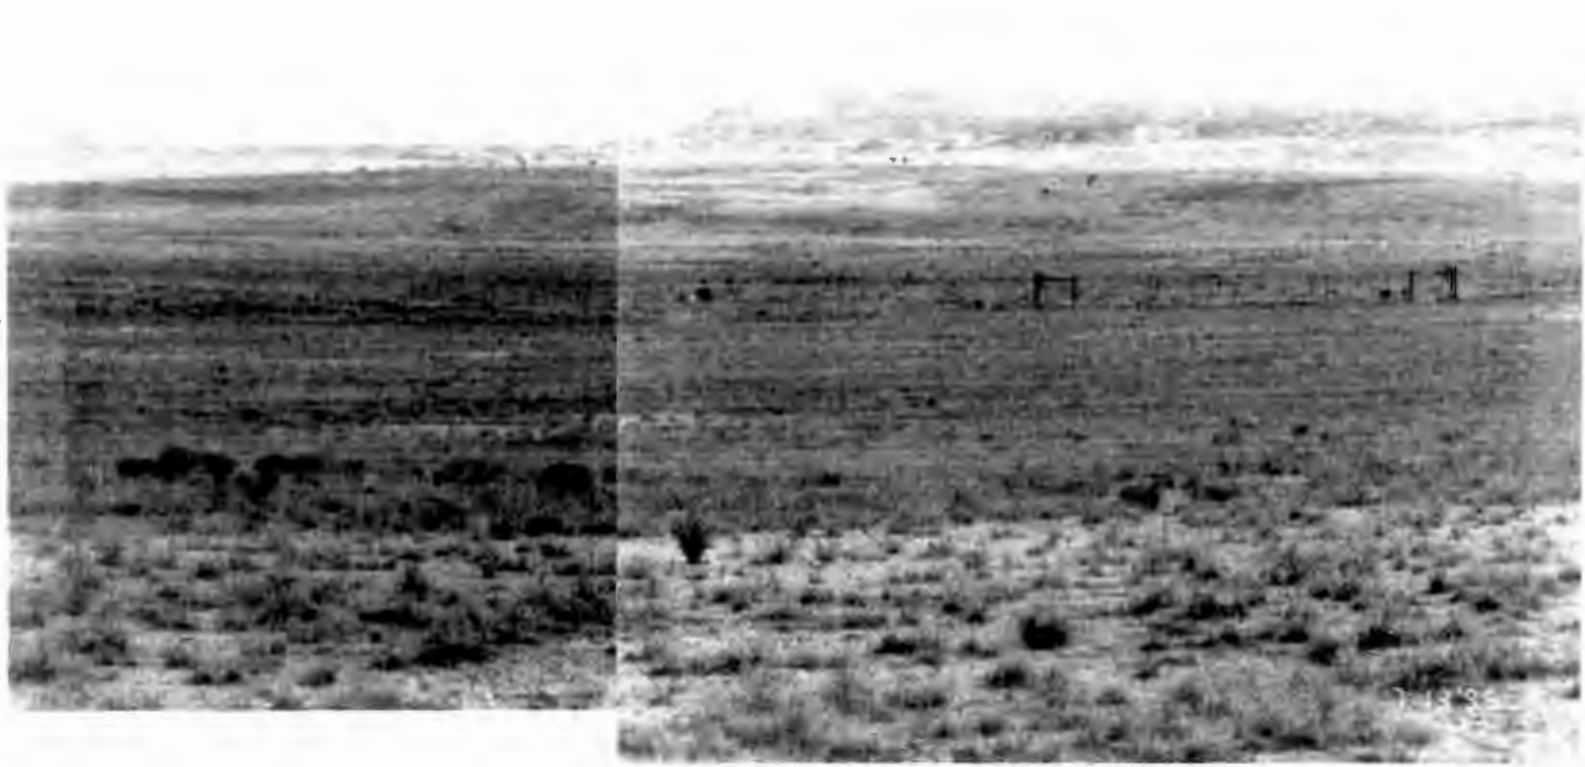
*Section 13, T14N, R10W
From middle of site looking northeast*

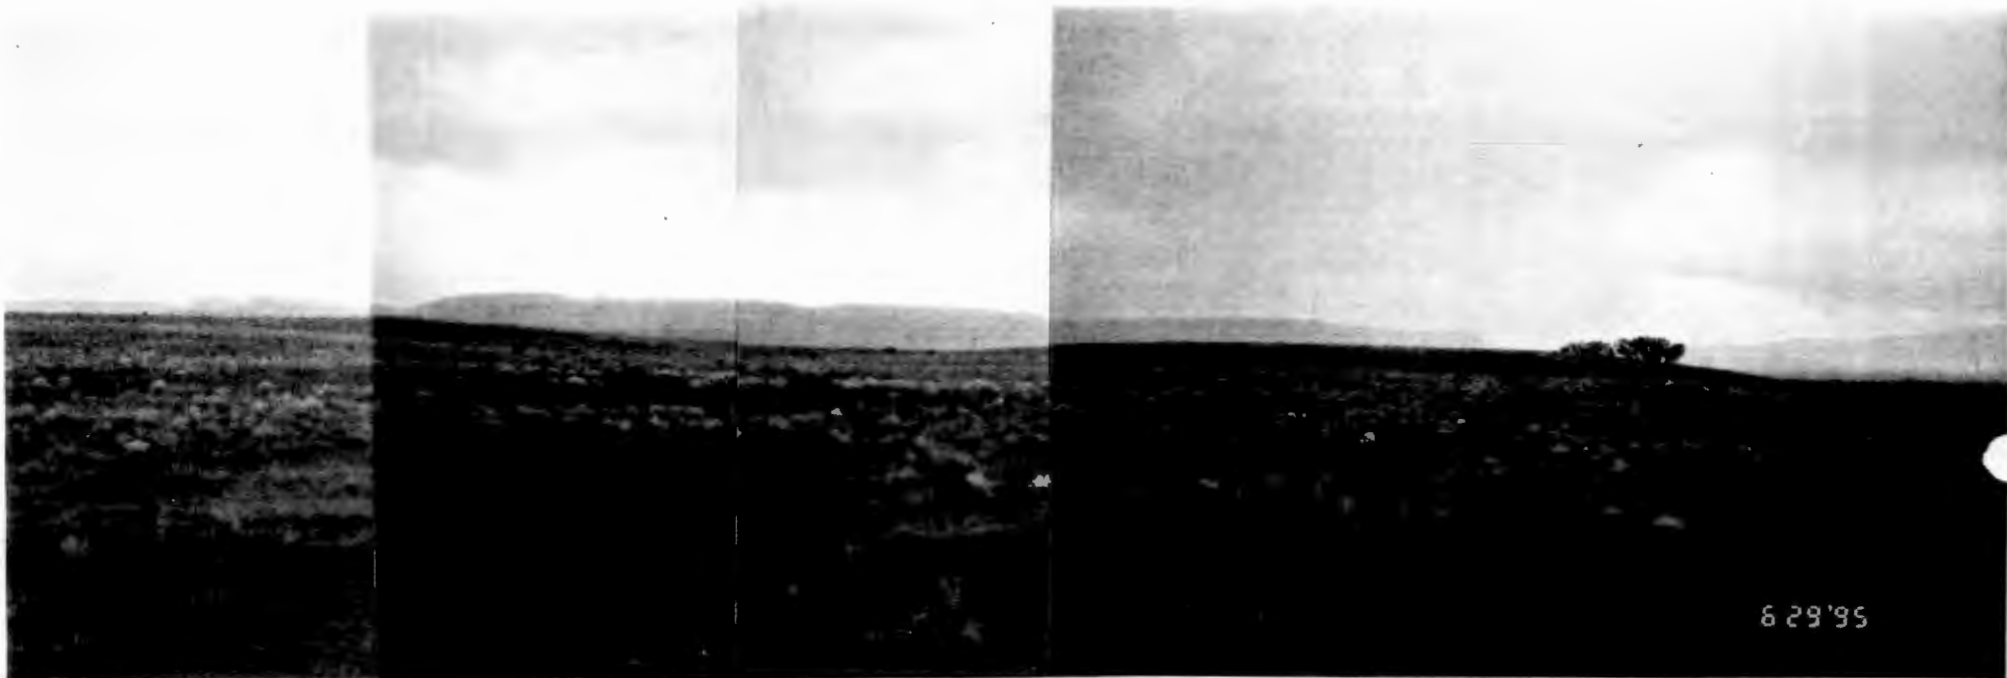
The following photographs were taken during the site inspection on June 28, 1995 to document conditions at the Section 23 Mine. These represent a panoramic view of the mine.

Based on the outcome of these inspections, staff does not recommend the release of the Section 23 site. The vegetation at this site was too sparse to provide adequate information needed in making the determination that the site has been reclaimed to a condition that allows for a self-sustaining ecosystem. Staff recommends waiting to make this determination until the plant community onsite has become better established.

Homestake's Section 23 Mine (T 14N, R 10W).
Panoramic view. June 28, 1995.
Joe DeAguero Photographer

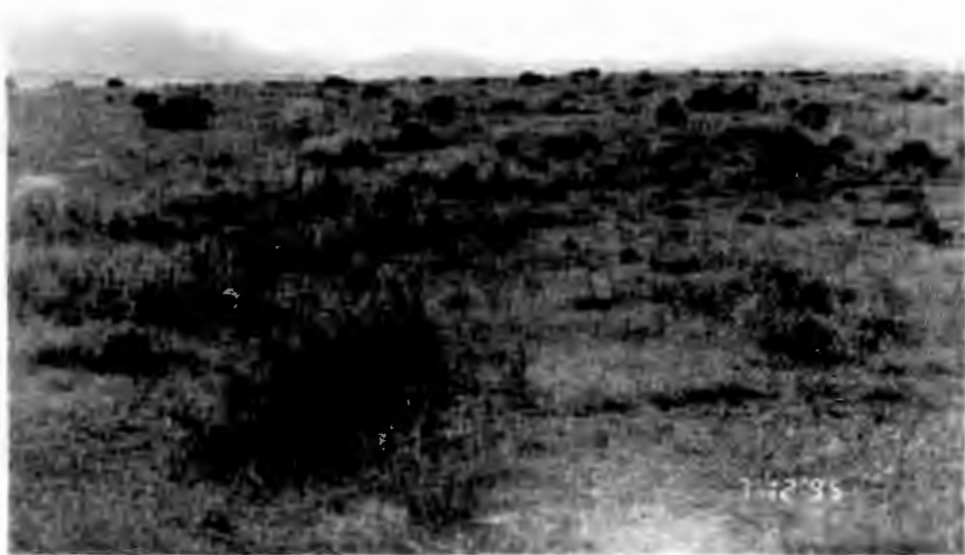
*Section 32, T14N, R10W
From middle of site facing southeast*

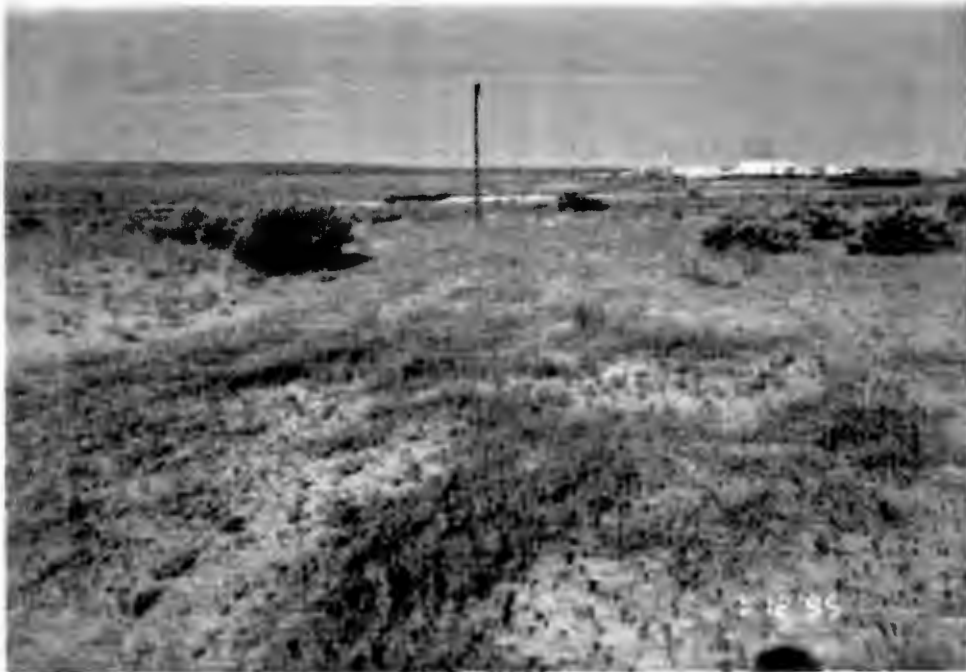
*Section 32, T14N, R10W
From east side of site facing west*

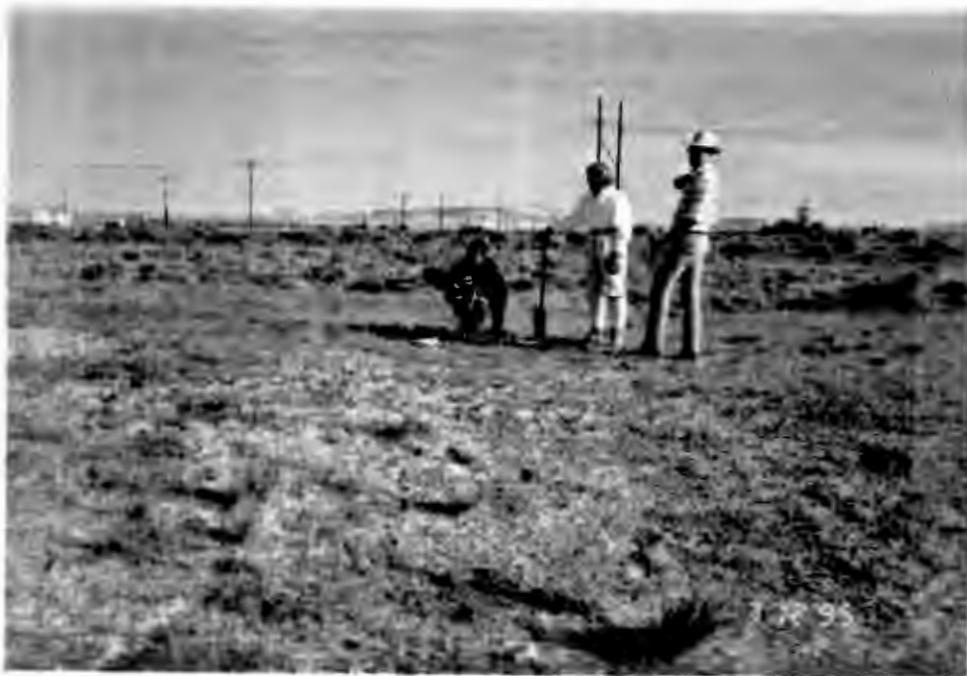
Section 32, T14N, R10W

From north side of site facing northwest

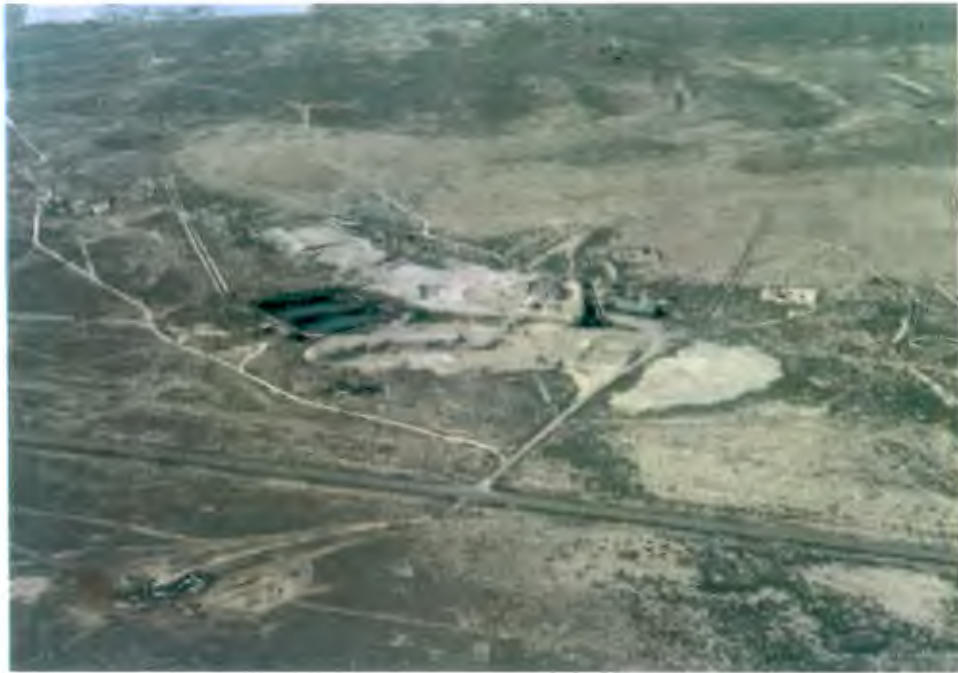
PHOTO 25A

- 25A: Aerial view of mine site before reclamation.
- 25B: Placement of soil cover over recontoured waste pile.
- 25C: Placement of soil over mine site prior to reseeding.
- 25D: Covered mine site prior to reseeding.
- 25E: View looking west at east side of recontoured low-grade ore pile.
- 25F: Borrow area in foreground, with reshaped low-grade ore pile in background, after recontouring and revegetation.
- 25G: View of east side of low grade ore pile showing area requiring additional regrading and revegetation.
- 25H: View from center of mine site looking toward Quivera mill showing natural vegetation patterns.
