**INTERIM REPORT FOR FINDINGS OF WATER  
QUALITY AND SEDIMENT CHEMISTRY ALONG THE  
RIO SAN JOSE**

**ROCA HONDA MINE DISCHARGE PERMIT APPLICATION (DP-1717)**

SEPTEMBER 2015

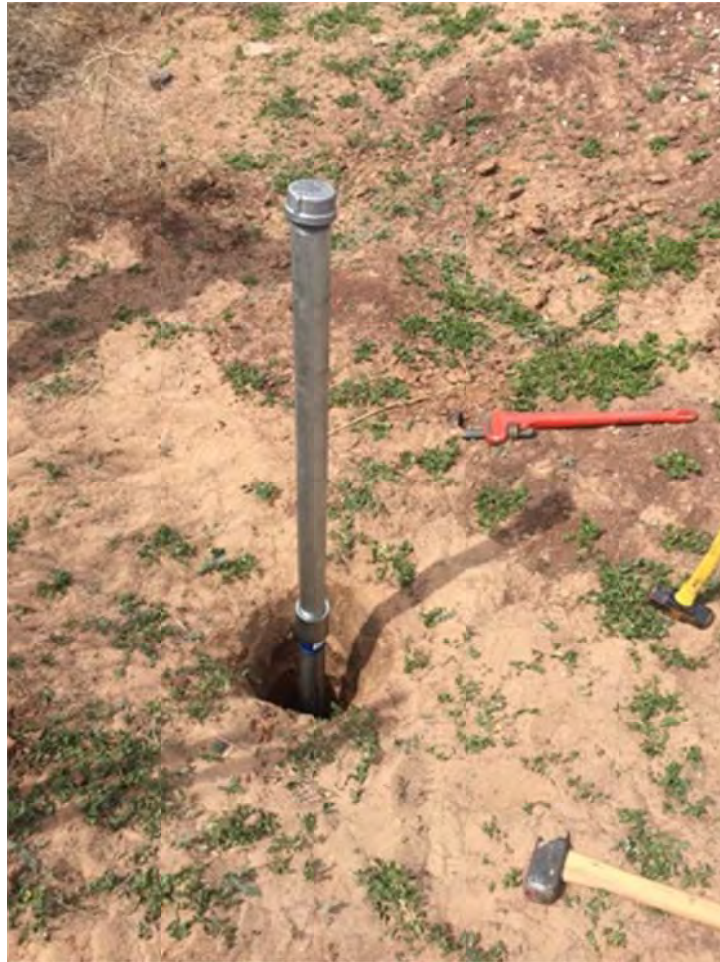
The April 2015 work plan recommended using well points to collect groundwater from the RSJ channel. On 5/21/2015, a well point was driven into the RSJ channel at the discharge point. To install the well point, a 2-3 ft. hole was dug, the well point was placed in the hole and was attempted to be driven to depth with a sledge hammer. The full length of the well point was in the ground and a joint of pipe was added (Figure 2-1). Continual pounding on the well point did little to drive the point deeper, damaged the cap used to protect the threads, and damaged the threads so that another joint of pipe could not be added. It was determined that in the areas of the RSJ that are ephemeral, there is too much clay and too little water to utilize well points.

*Figure 2-1. Attempt at Well Point Installation - Proposed Discharge Point*

Since installing well points by hand was determined to be impractical for this study, RHR is proposing to install three alluvial wells along the Rio San Jose to collect baseline water quality data as well as to use as future monitor wells. The three locations are shown on Figure 4-1, and correspond to three of the sites in the original work plan; the discharge location, Rio San Jose Park, and the East Grants location. Alluvial monitor wells would allow sampling to take place on an as needed basis, if water was present in the wells, and would provide sampling locations that could be monitored prior to, during, and after mining operations. RHR proposes installing these wells at least a year prior to the anticipated first discharge into the RSJ from the Roca Honda Mine. Construction of the pipeline to deliver the water will take a minimum of a year and wells would be installed when pipeline construction began. The wells would be permitted through the New Mexico Office of the State Engineer as monitor wells and would be constructed to meet their regulations.

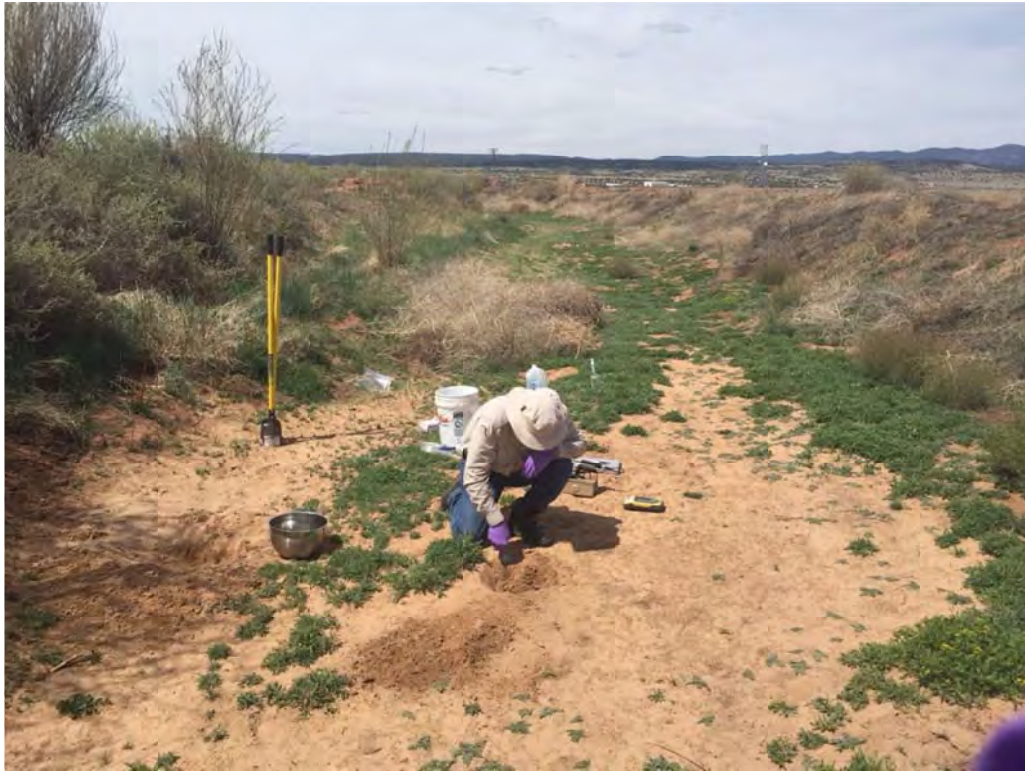
Sampling Location RSJ #1 is the furthest sampling location upstream in the RSJ channel and is approximately 1,000 ft upstream of the proposed discharge point. The site was visited and sampled on 5/27/2015. Figure 2-2 shows an upstream view, Figure 2-3 is looking downstream. The RSJ channel at this location was approximately 12 feet across with a sandy partially vegetated bottom. The channel has been engineered in this area and the levees have been built up for flood control. Digging into the channel revealed more clay material and consolidated sediment. There was no water present in the channel at or around the sample location

*Figure 2-2. Location RSJ #1 Facing Downstream (South)*

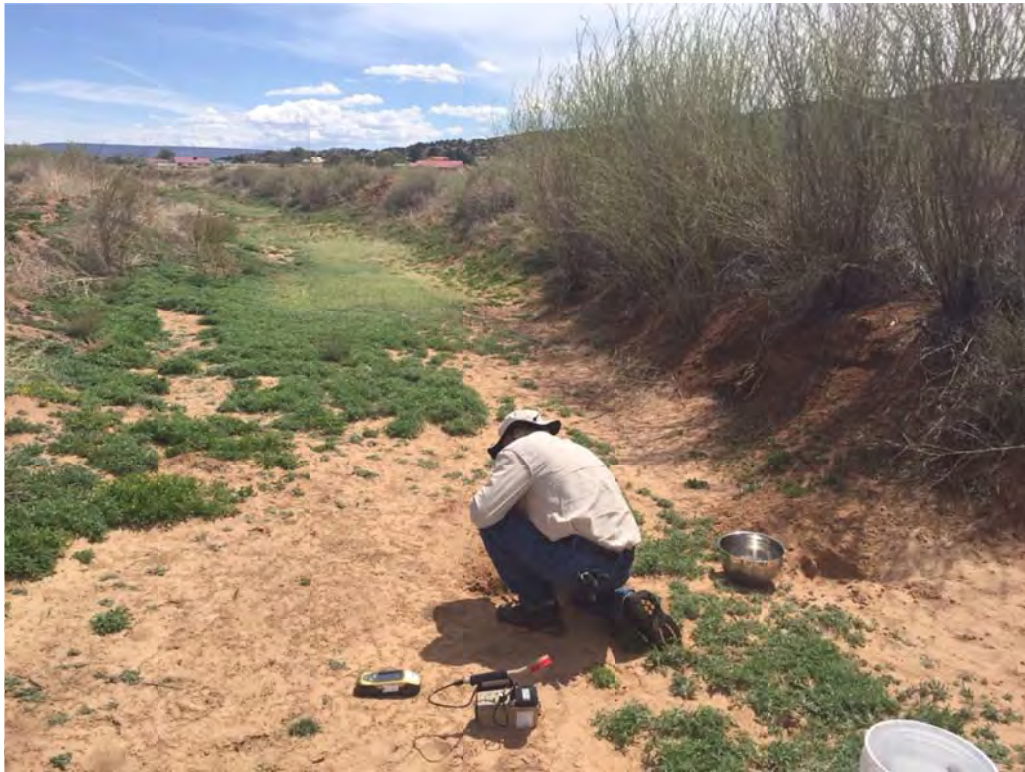
*Figure 2-3. Location RSJ #1 Facing Upstream (North)*

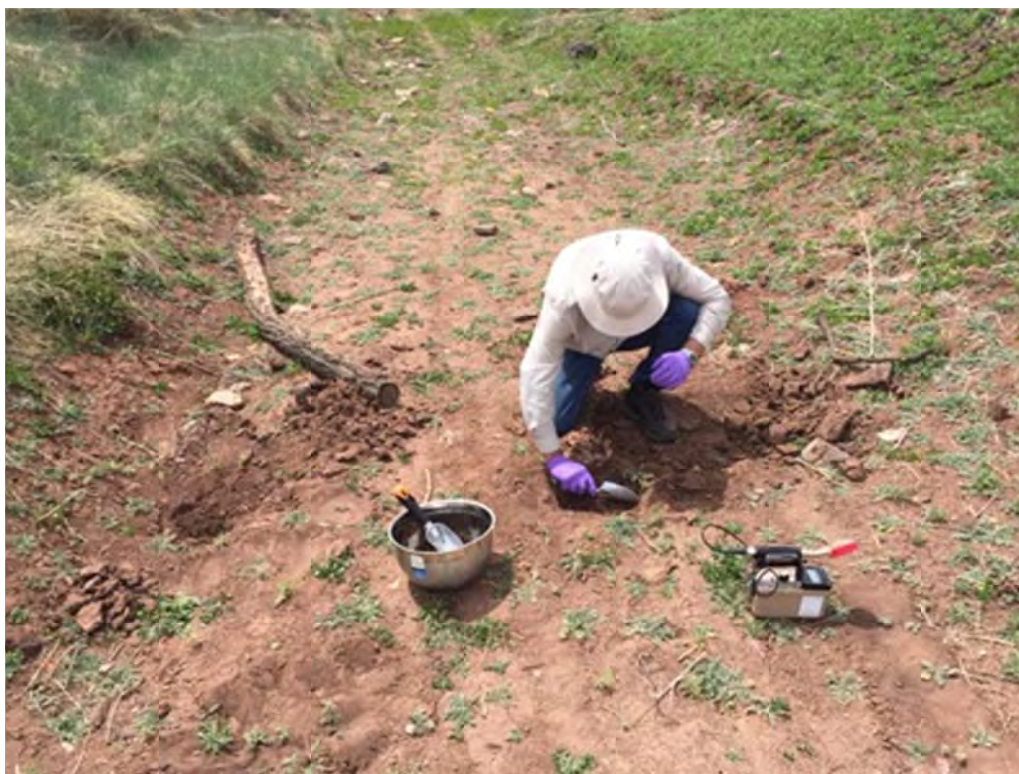
Sample location RSJ #3 is in a residential area in the Village of Milan where Cedar Rd. dead ends at the channel. This site was visited and sampled on 5/21/2015. Figure 2-4 shows the channel at location RSJ #3. The channel bottom at this location was harder, less sandy and slightly more vegetated than at the locations located further upstream. The channel was also slightly narrower at approximately 7 ft. across. There was no water present in the channel at or around the sample locations.

*Figure 2-4. Location RSJ #3 Facing Downstream*

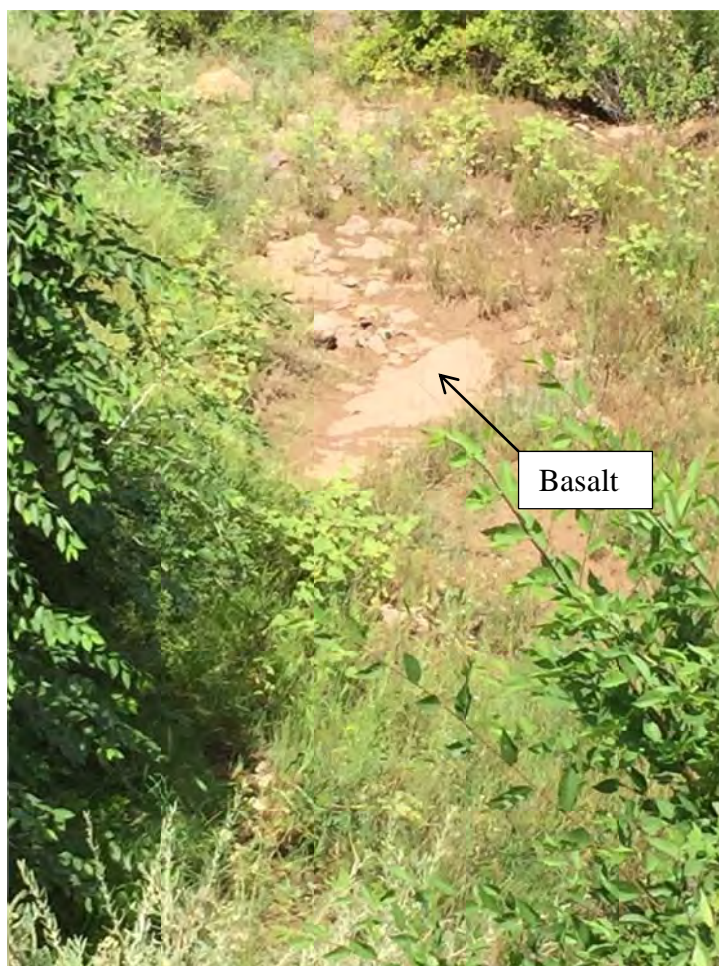
Sample location RSJ #4 is located on El Morro Rd behind the Diamond G hardware store. This location is also the same as an old USGS gaging station (08343000). This site was visited and sampled on 5/19/15. The channel at this location is very different from other locations, Figure 2-5 shows basalt outcropping in the channel with sand pack around the rocks. There is very little sediment overlying the bedrock, which is basalt. Where there is sand it appears windblown or is packed into cracks and voids in the basalt. The channel is steep sided and well incised. There was no water present in the channel at or around the sample locations.

Due to the lack of alluvium/sediment at this location only a single “grab” sample was collected from a depth of 0.5 ft. The basalt present at or very close to ground surface over much of the sampling location prohibited collection of a composite sample as well as a deeper 1.5 ft. sample.

*Figure 2-5. Rock Outcrop in Channel at RSJ#4*

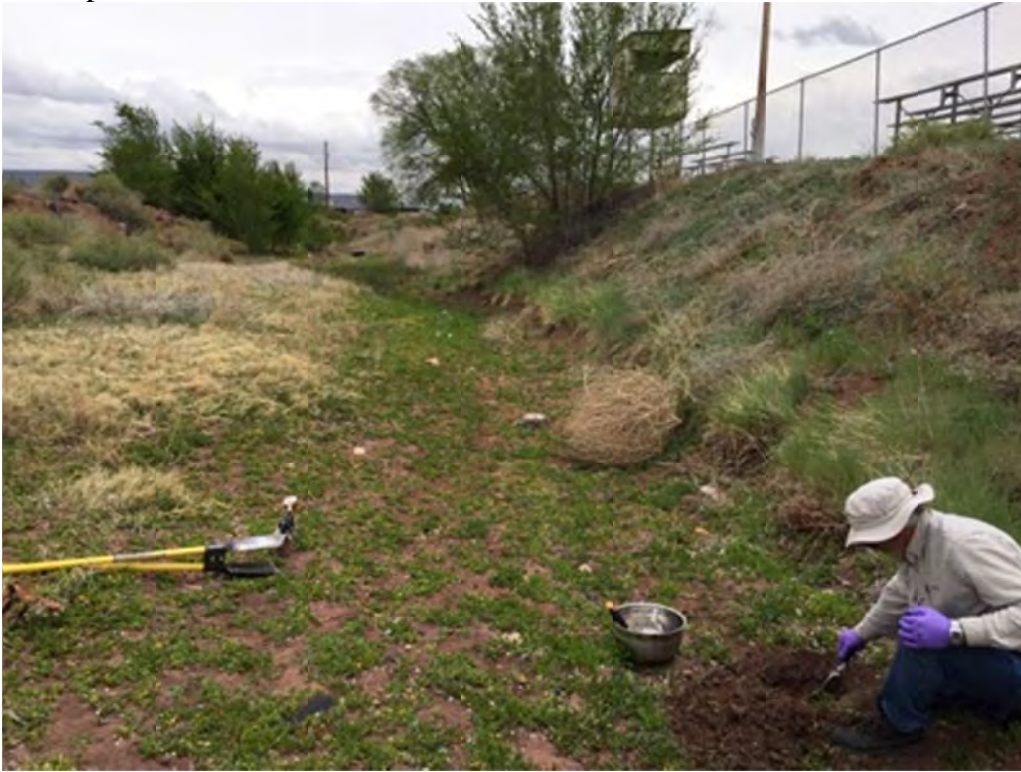
Sample location RSJ #5 is located in the RSJ channel behind San Jose Park in Grants. This location is more similar to RSJ #1-3 in that it has a sandy vegetated bottom. However the channel through this area is engineered to some degree, but does not have the heightened levees of other locations. The overall channel bottom is quite wide at this location (about 70 ft), but the

main channel is only approximately 8 ft. wide. There was no water present in the channel at or around the sample locations.

*Figure 2-6. Location RSJ #5 Facing Downstream*

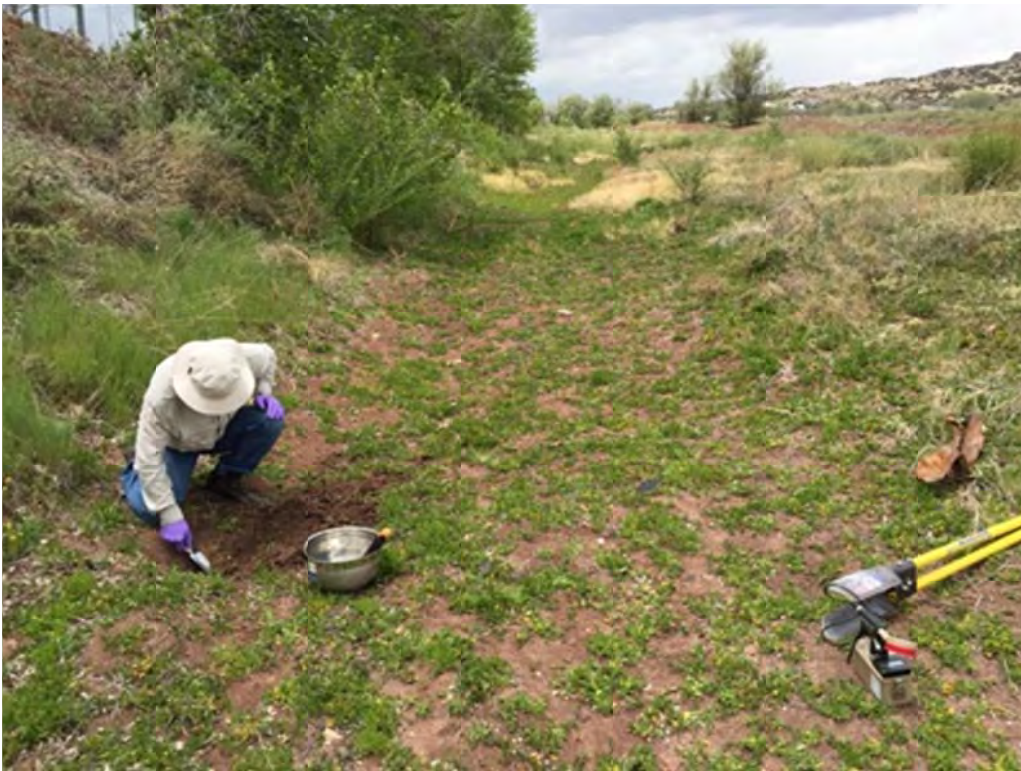
*Figure 2-7. Location RSJ #5 Facing Upstream*

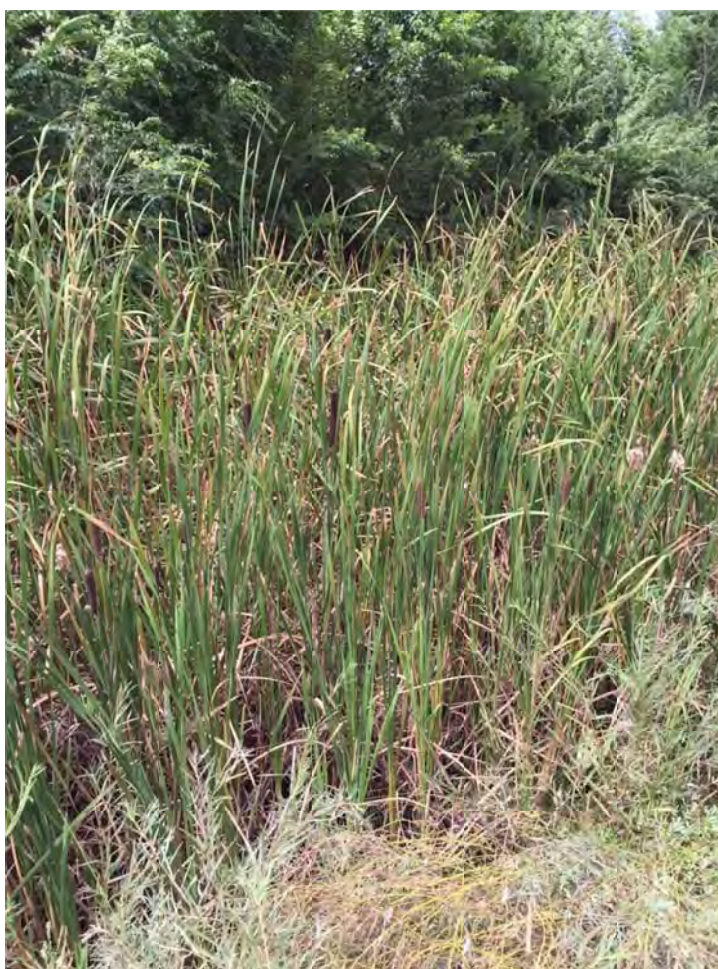
Sample location RSJ #6 is located near downtown Grants in a residential neighborhood at the end of Dixie St. This site was visited and sampled on 5/27/15. During this visit the site contained standing to slightly flowing water and was heavily vegetated with cattails (Figure 2-8). A walk up and down the channel from RSJ #6 revealed additional vegetation as well as frogs and fish (species undetermined) in the water. A previous visit to the site in December for seismic evaluation indicates that the channel is intermittent in the location as the channel was dry at that time. A second visit to the site in September revealed that the site holds water much of the year.

*Figure 2-8. Cattails at RSJ #6*

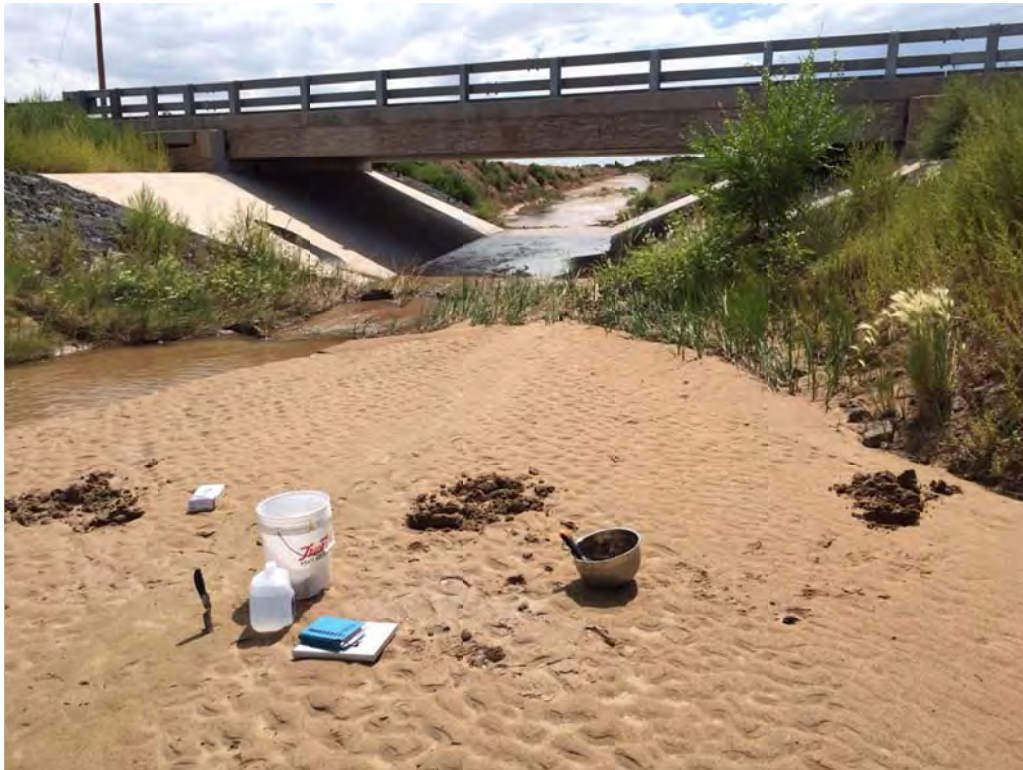
The channel at this location is highly engineered, and is often dredged/cleaned by the city using a backhoe. The channel bottom is approximately 21 ft wide at this location and is a sandy bottom with almost no vegetation in the channel. The sample site is about 50 ft upstream of the bridge on Nimitz Rd (Figure 2-9) and 200 ft downstream of the confluence with the drainage coming out of Lobo Canyon (Figure 2-10). There was flowing water occupying 6 ft of the channel on the day the samples were collected.

*Figure 2-9. Location RSJ #7 Looking Downstream towards Nimitz Rd. Bridge*

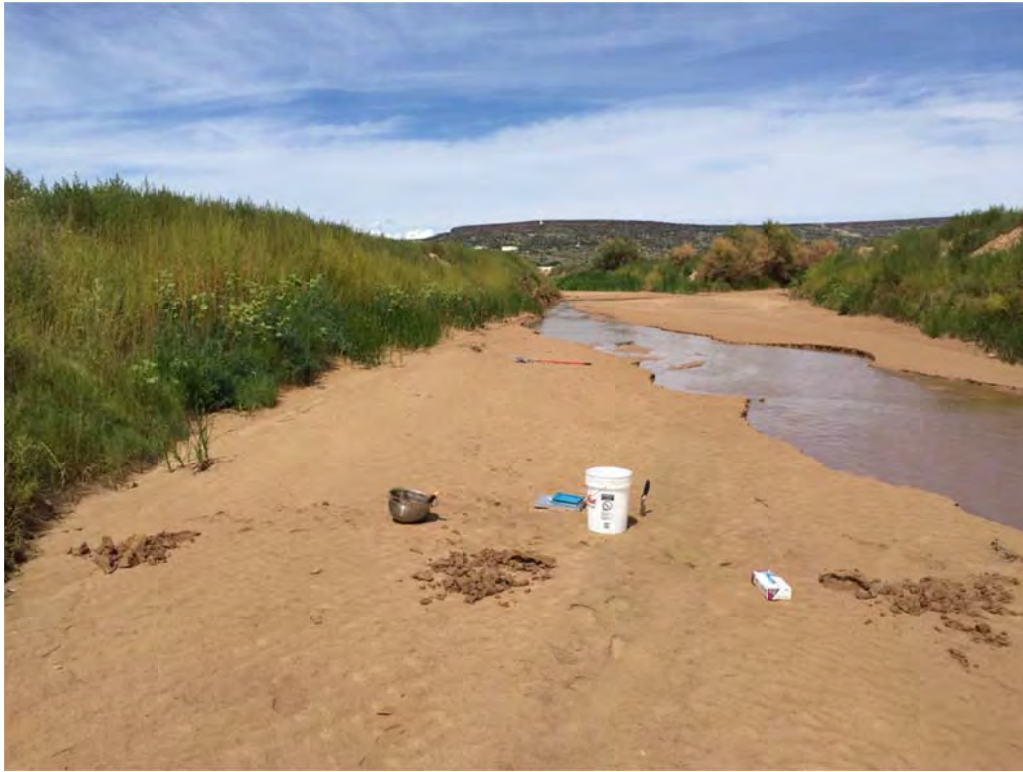
*Figure 2-10. Location RSJ #7 Looking Upstream towards the Confluence with Lobo Canyon Drainage*

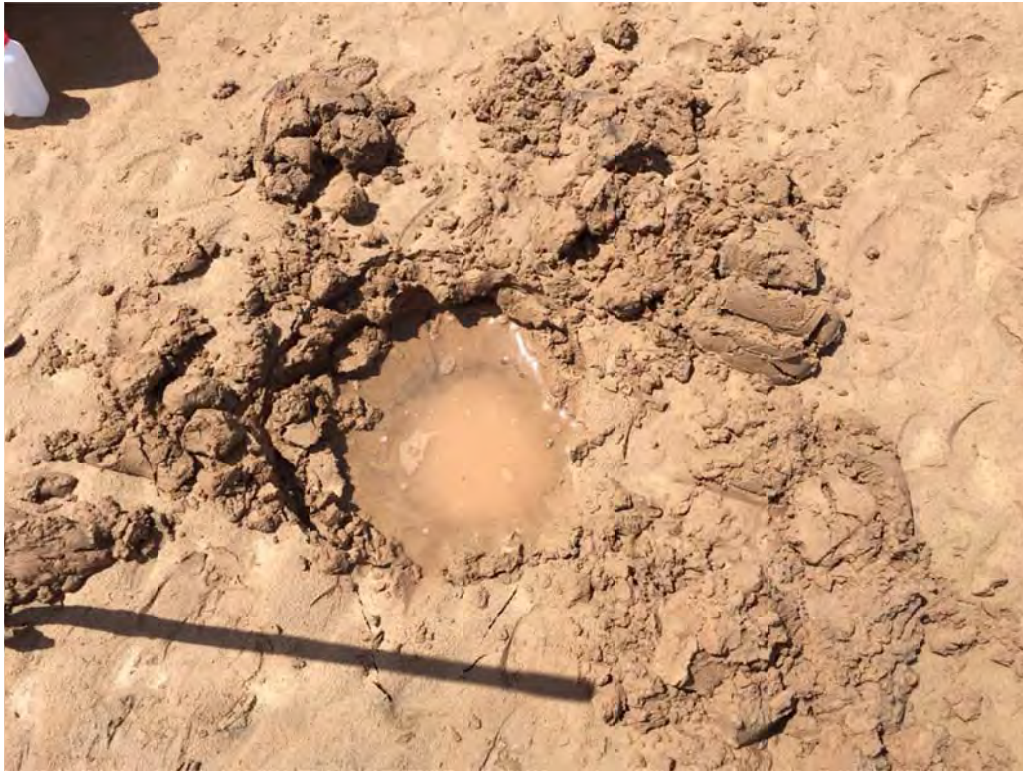
A “groundwater” sample was also collected from this site. The middle hole used for the sediment sample was deepened and widened to allow an adequate amount of water to seep in to gather a sample (Figure 2-11).

*Figure 2-11. Hole used at RSJ #7 to Collect Water Sample*

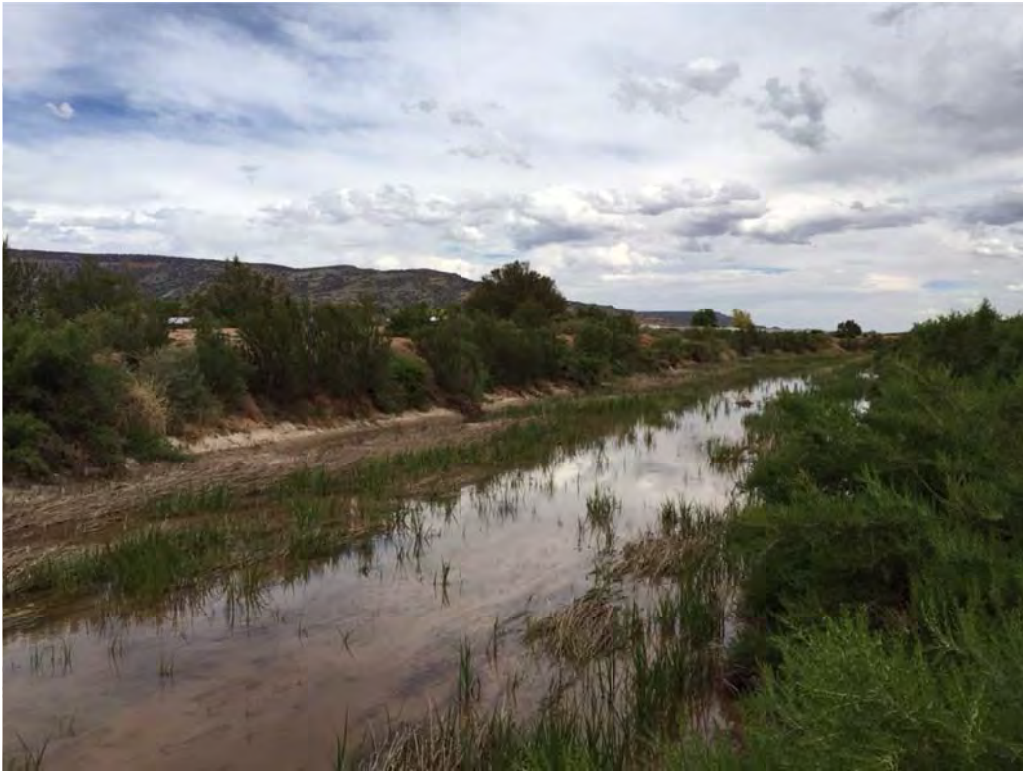
Sample location RSJ #8 is located near the former discharge point of the dismantled Grants Wastewater Treatment Plan. As with sample locations RSJ #6 & 7, this location also contained flowing water. The area was also highly vegetated with reeds and grasses. No aquatic life was observed at this location.

*Figure 2-12. Location RSJ #8 Facing Downstream*

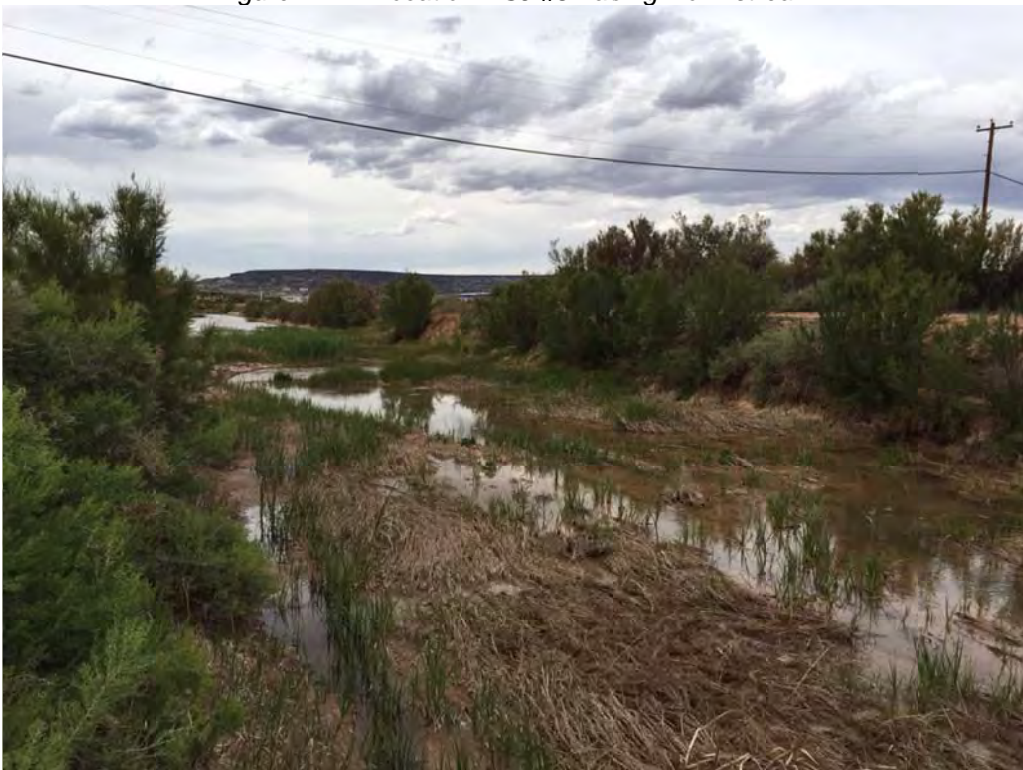
*Figure 2-13. Location RSJ #8 Facing Upstream*

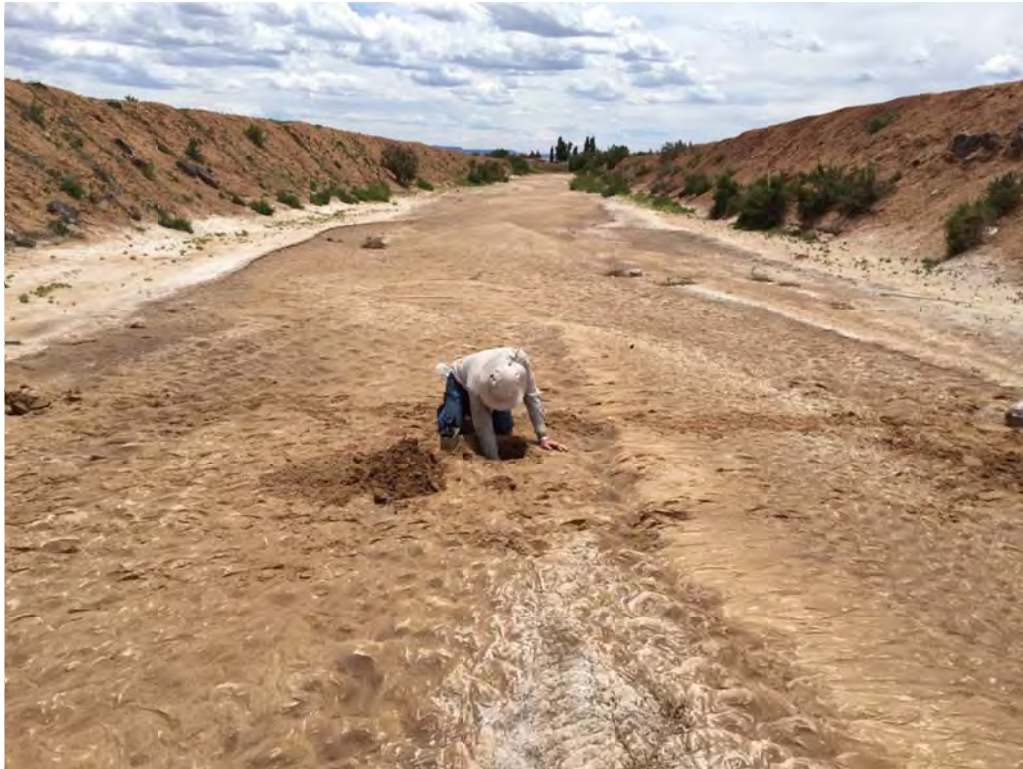
Sample location RSJ #9 is in Lobo Canyon drainage approximately 900 ft. north of the confluence with the Rio San Jose. This location was visited and sampled on 5/27/2015. The Lobo Canyon drainage has a very different morphology than the RSJ in that there is virtually no

vegetation in the channel and the channel itself has a much sandier bottom than the RSJ. The channel has been engineered at the sample location for flood control. The channel bottom is approximately 50 ft across with the main channel occupying approximately half that width. There was no water at the sample site, but there was ponded water just upstream of the sample location.

*Figure 2-14. Location RSJ #9 Facing Downstream (South)*

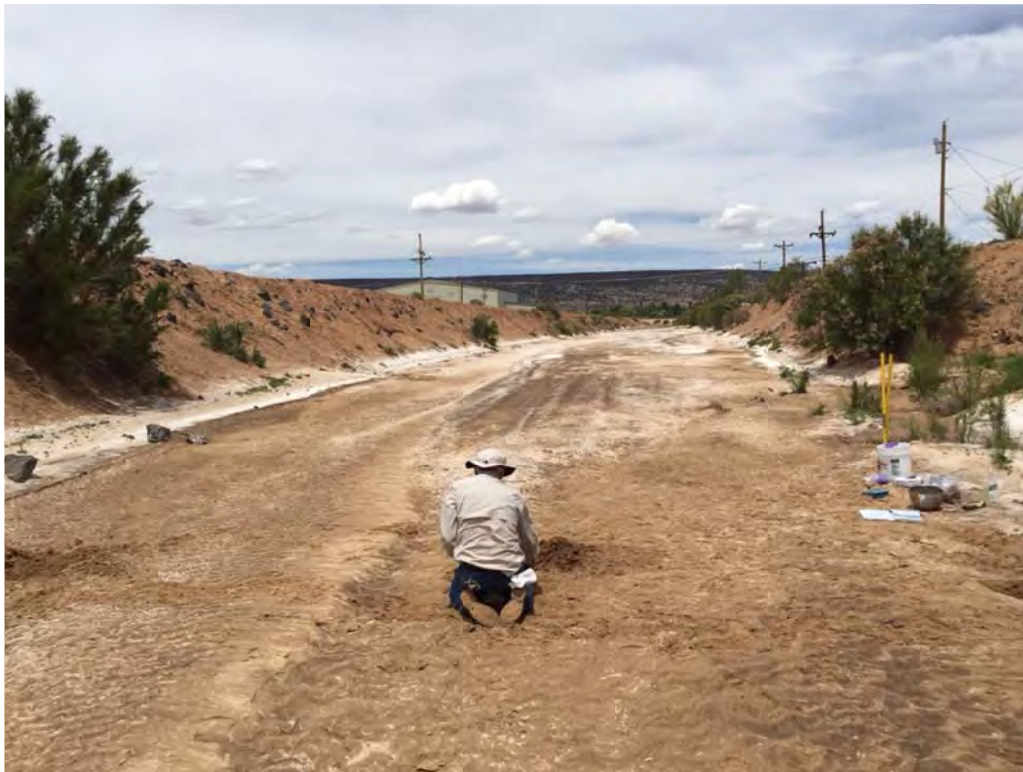
*Figure 2-15. Location RSJ #9 Facing Upstream (North)*
