**PRIOR RECLAMATION INSPECTION REPORT
AND
RECOMMENDATION FOR RELEASE OR PERMIT REQUIREMENT**

Quivira Mining Company

**Section 17 (T 14N, R 9W), Section 19 (T 14N, R 9W), Section 22 (T 14N, R 10W),
Section 24 (T 14N, R 10W), Section 30 (T 14N, R 9W), Section 30W (T 14N, R 9W),
Section 33 (T 14N, R 9W), and Section 36 (T 14N, R 9W) Mines**

**New Mexico Energy, Minerals and Natural Resources Department
Mining and Minerals Division
Mining Act Reclamation Bureau**

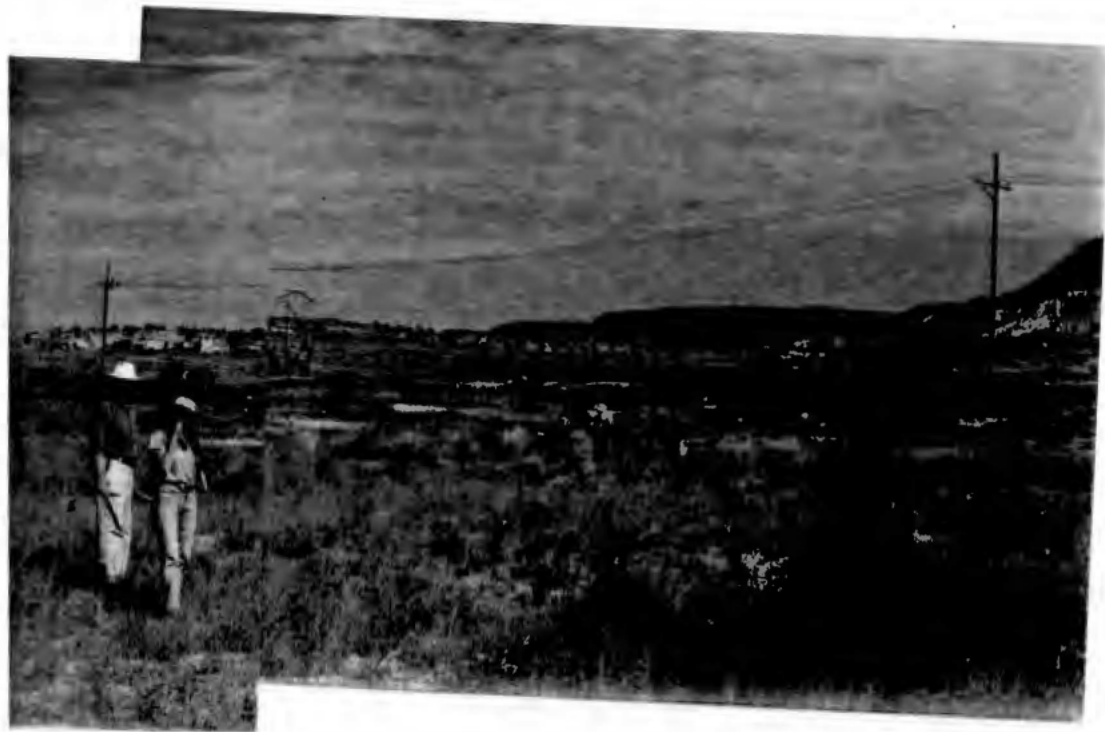
33 Mine
#3,485

#3, #4, #5: Photographs #3, #4, and #5 were taken from the same wasterock pad and span the west quadrant (#3 or right photograph), the west-southwest quadrant (#4 or middle photograph) to the south quadrant (#5 or left photograph).

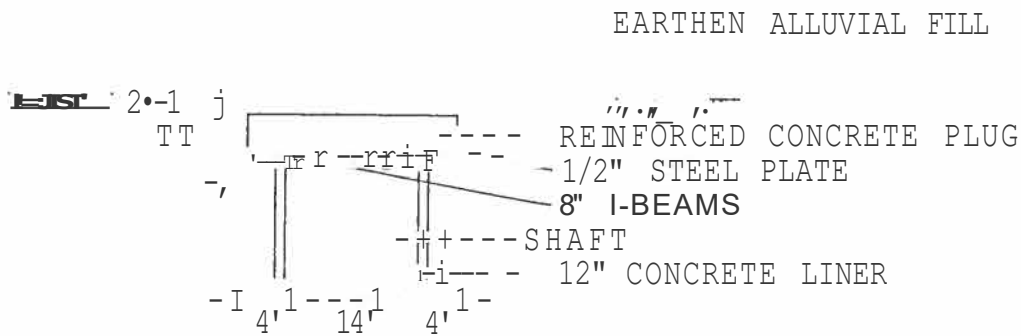
FIGURE 1
 SHAFT PLUG

The fourteen (14) foot circular, concrete lined, two (2) compartment shaft was reclaimed by first removing all concrete and steelwork to a depth of six (6) feet below grade. Quivira then poured a twenty four (24) foot diameter, steel and rebar re-enforced concrete plug four (4) feet thick over a half-inch steel plate on top of the shaft lining. The concrete plug was then covered with a minimum of two (2) feet of alluvial fill and re-contoured. A schematic of the shaft plug is presented in Figure 1.

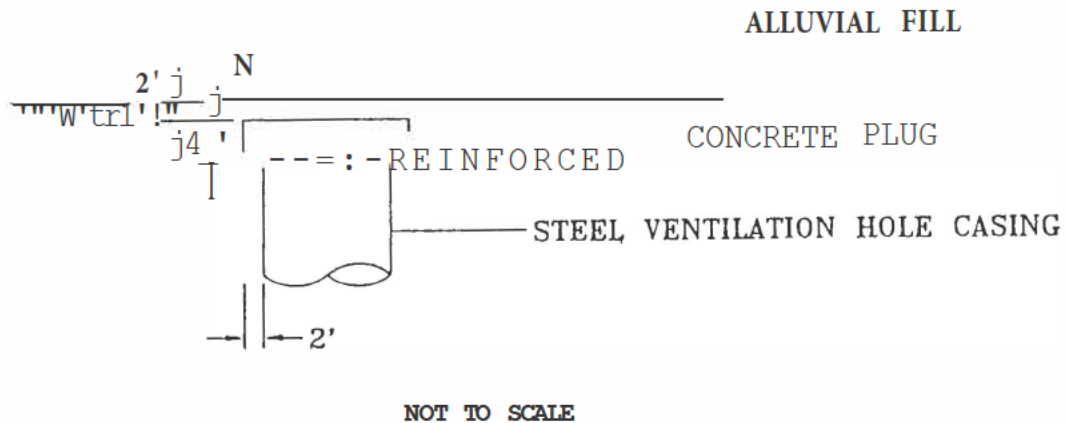
FIGURE 2
VENTHOLE PLUG

The ventilation holes were similarly plugged and sealed. The steel ventilation hole casings were cut six (6) feet below the surface grade. A four (4) foot thick, rebar and steel reinforced concrete plug was then poured at the ventilation hole site. The installed plug diameter exceeded the inside diameter of the ventilation hole by four (4) feet to ensure stability and completeness. The plug was sealed with the placement of a minimum of two (2) feet of alluvial fill over the concrete plug. Figure 2 displays a general schematic of the ventilation hole concrete plug.

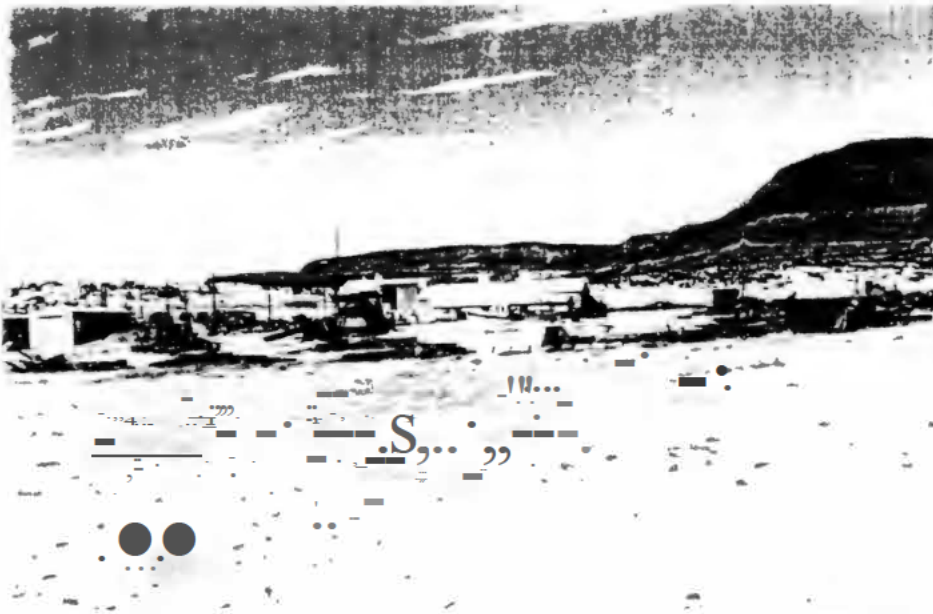
PICTO 1 - Section 36 Mine Site Prior to
Reclamation (except leadframe
which has already been taken
down).

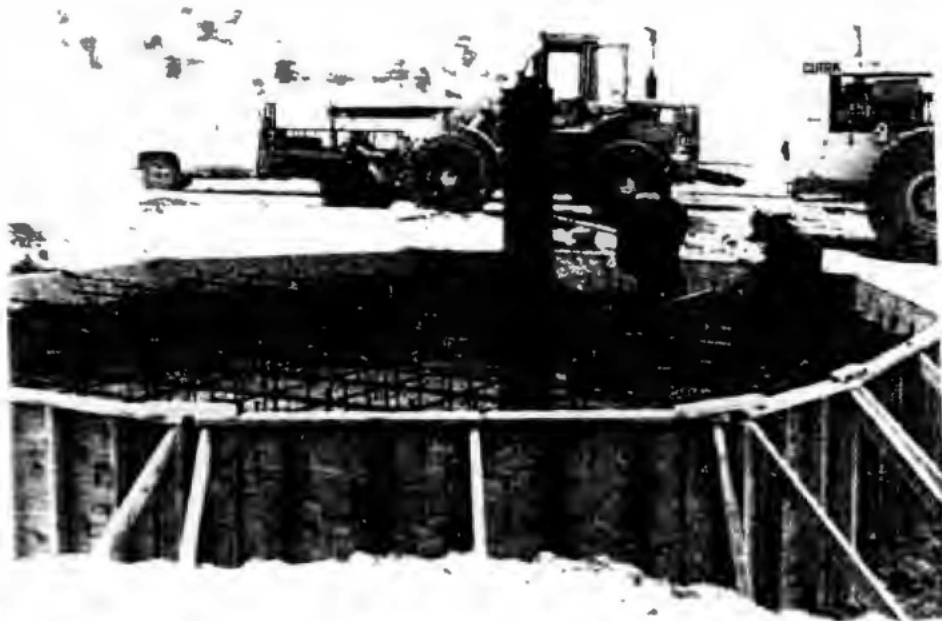
PICTO 2 - Concrete Shaft Plug Being Prepared.

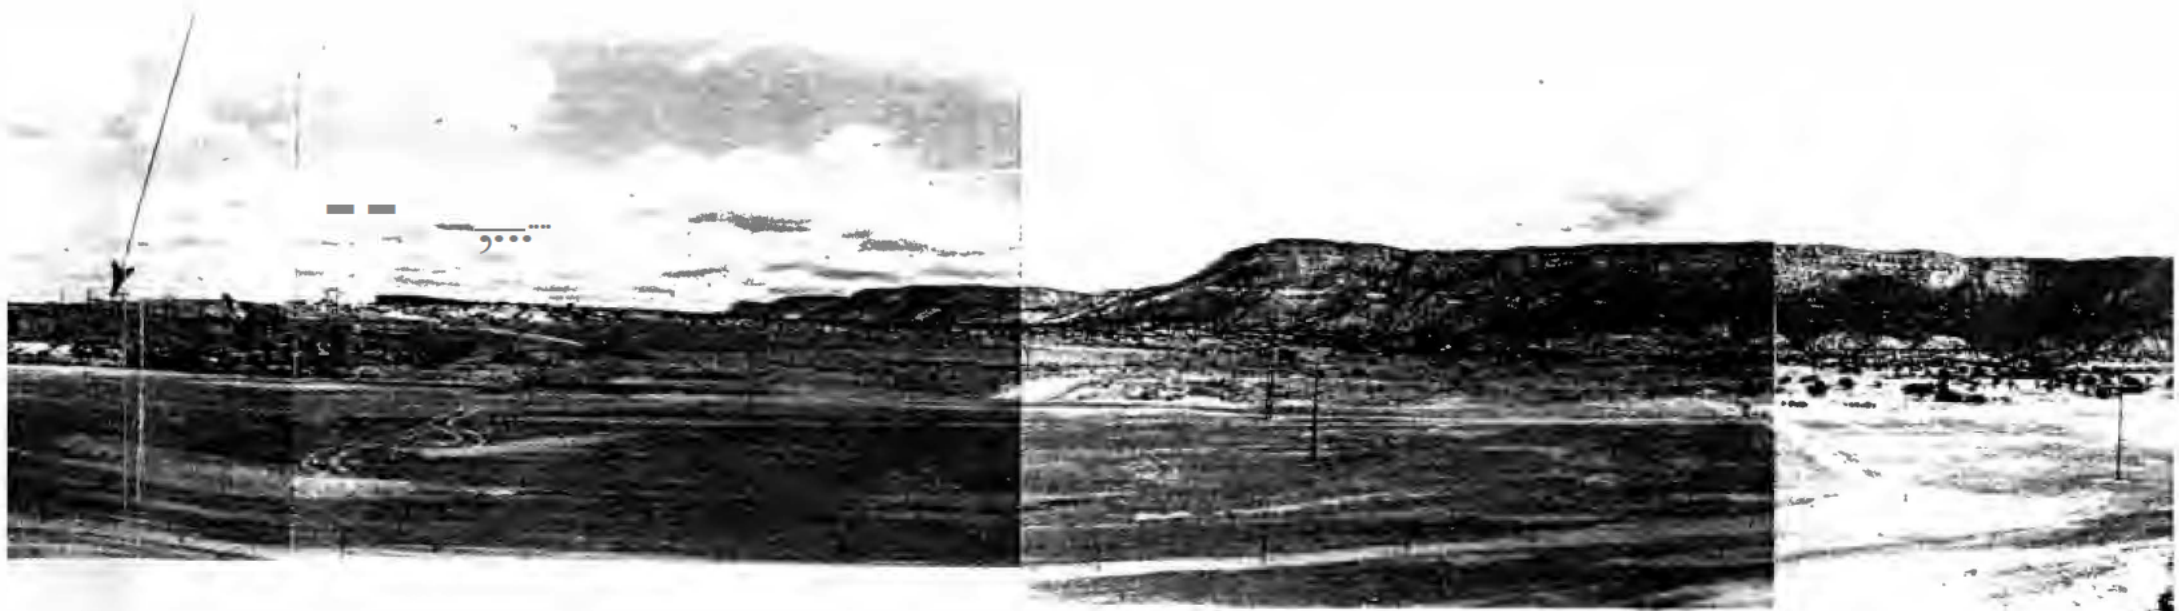
PICTO 7 - Panorama View of Section 36 ;line Site Reclaimed Prior
to Re-vegetating.
