**DEMING MILL AND TAILINGS
REISSUED PERMIT NO. LU009RE**

Updated: RECLAMATION AND UTILIZATION PLAN

**DEMING MILL & MILL TAILINGS
DEMING, NEW MEXICO**

**Updated: Reclamation for Tailings
Identified by Test Pitting**

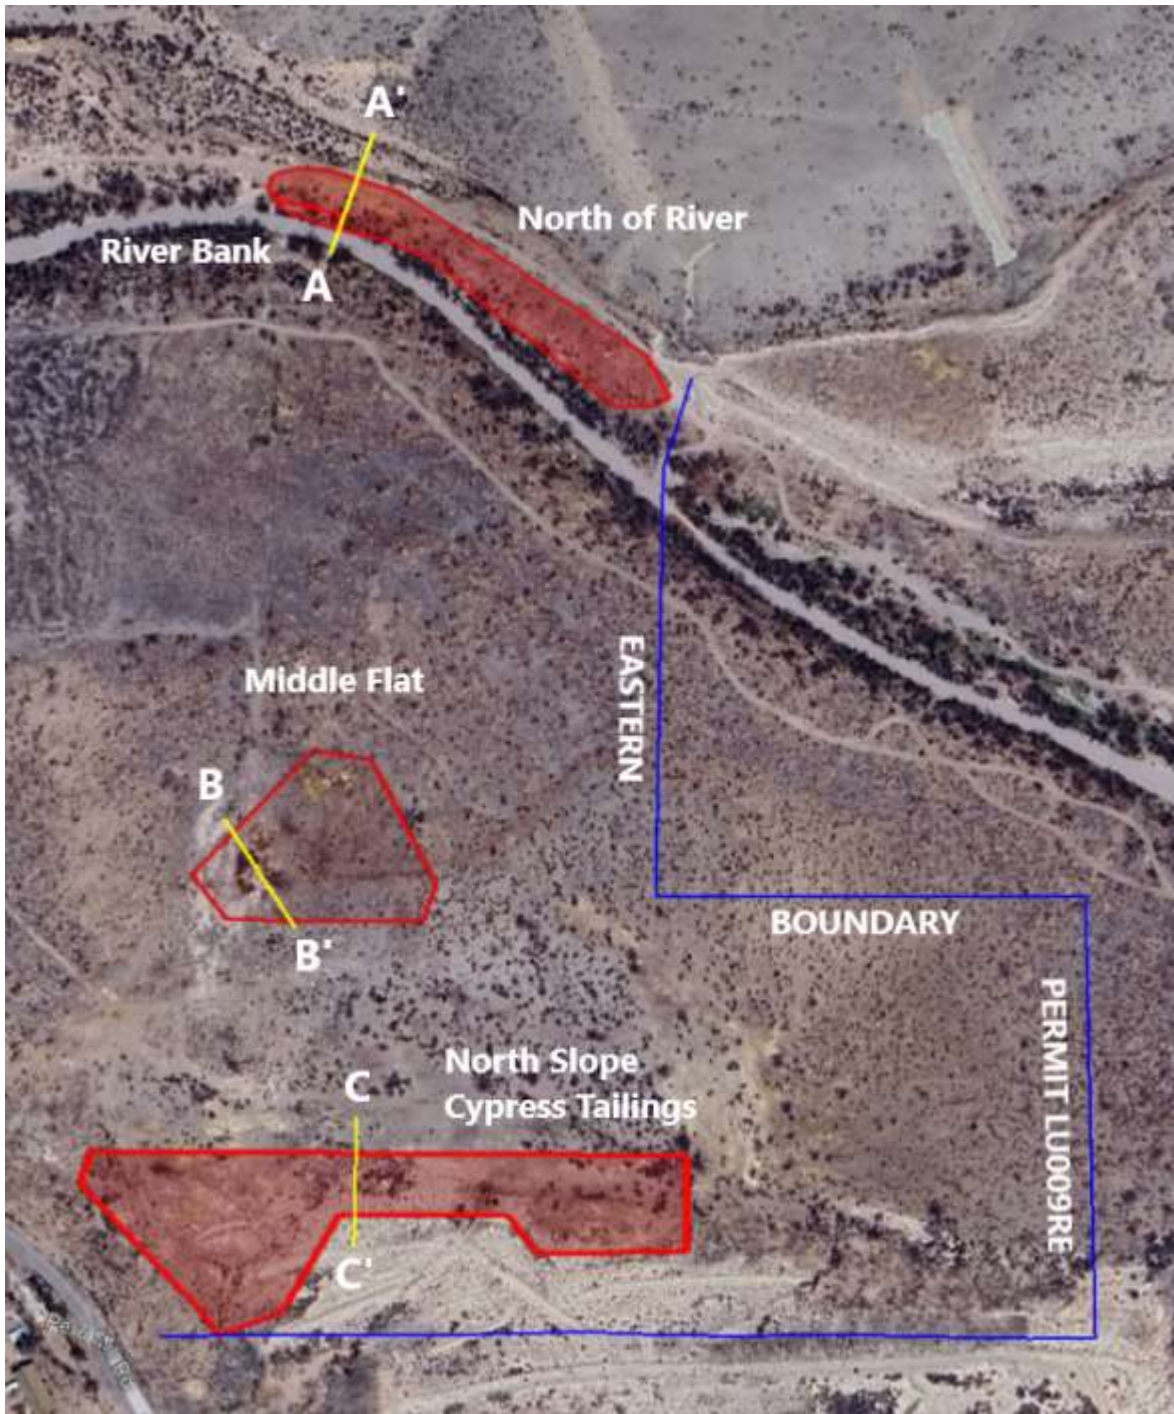
Figure 1. Areas of concern with the trace of cross sections.

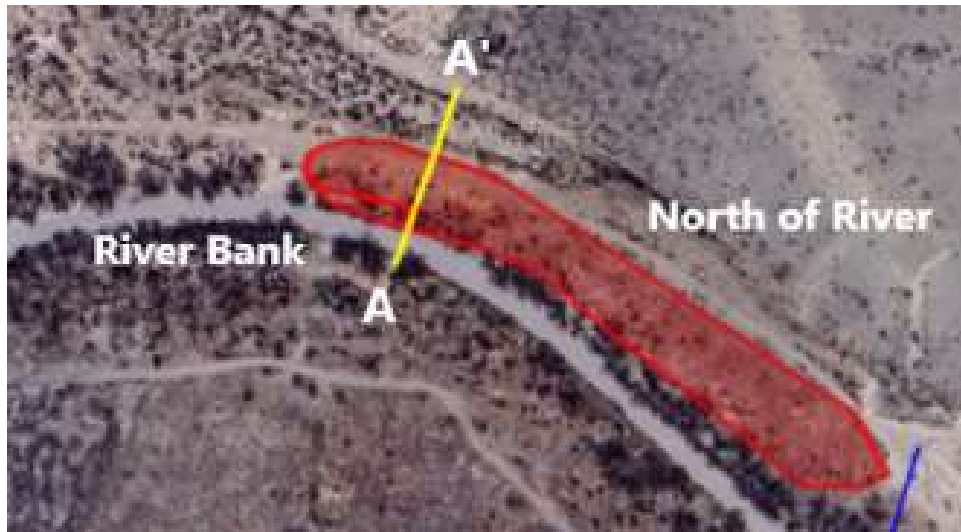
Figure 2. A – A' Tailings Area and Trace of Longitudinal Section

“The tailings found north of the Mimbres River are typically well sorted dark yellowish orange/brown weakly cemented gypsum bearing fine sand. Some areas show evidence of remobilized tailings mixed with sand and gravel. pH values range from 2.94 to 5.44 with a median value of 3.52 and average of 3.64 with a median thickness of 6 inches and average of 5.57 inches. Tailings are erratic with little lateral continuity and in places are covered with a thin veneer of natural sediments (slope wash or aeolian sand). Tailings are estimated to be present in 1.16 acres at this site.”

5. The areas where tailings are removed (extent unknown at this time but will not exceed 1.16 acres, See Figure 2) will be covered with 1 foot of gravel material from the borrow pit. Fine material will not be needed because underlying soil remaining after the removal of the mill tailings is similar to fine material from the borrow pit, and the tailings will have been removed. Figure 6.

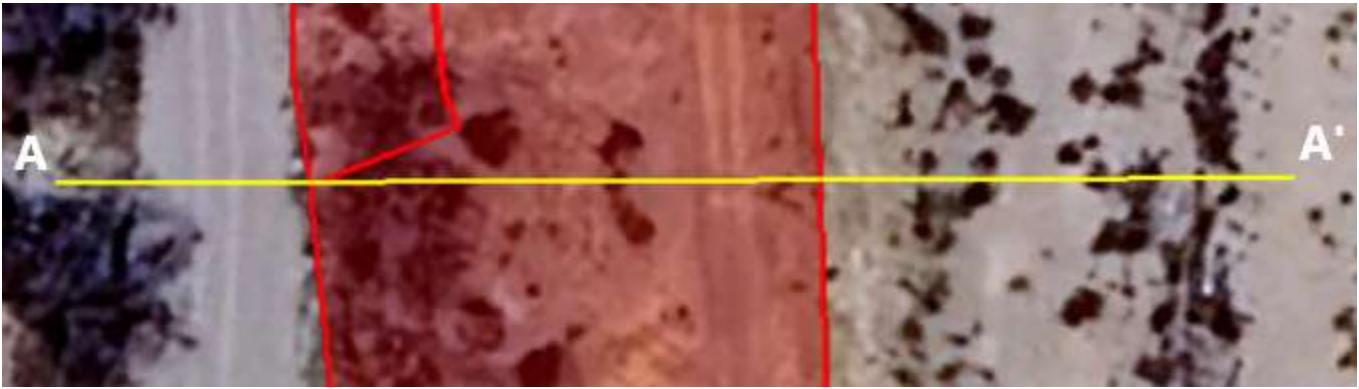
“Limited testing in this area immediately adjacent to the river channel revealed only one site where the tailings are present. Here 15 inches of weakly cemented interbedded fine grained sand tailings mixed with medium to coarse alluvial sand was encountered at the surface, in the bank but not in the river channel. There is little evidence to indicate that the tailings are being transported downstream in the river channel but rather are related to slope wash. It is estimated that only 1,837 square feet of this material is present here.” See Figure 3.

Figure 3. A – A' Section trace on surface near Mimbres River

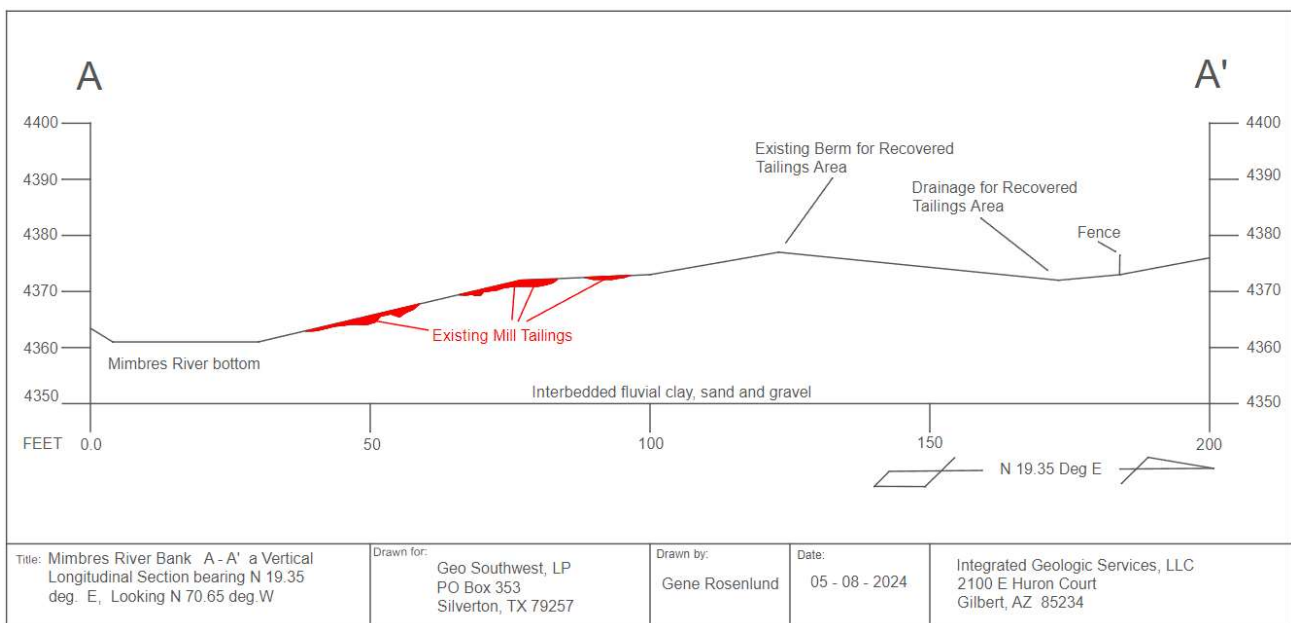
Figure 5. Current topography and Mill Tailings along Mimbres River (Riverbank & North of River)

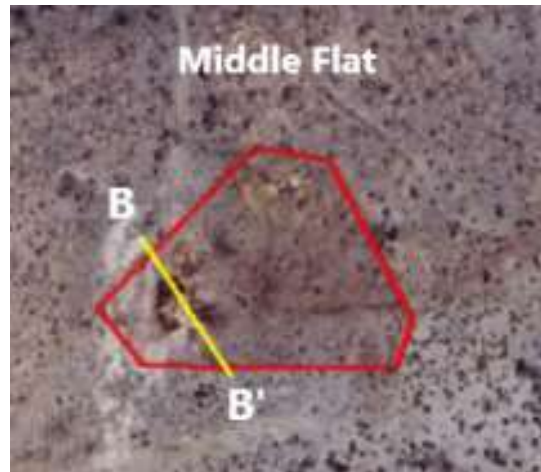
Figure 7. B – B' Tailings Area and Trace of Longitudinal Section

Only three pits in this area intersected tailings. The most notable occurrence was in pit GEOSW3 where very well cemented tailings prevented excavation beyond 19 inches. The tailings consisted of 10 inches of well cemented sandstone comprised of tailings overlain by 5 inches of Interbedded loosely cemented light gray and black medium grained sand with root fragments. Further study revealed that the cementing agent here is gypsum. In an adjacent pit, GEOSW5, the tailings covered soil containing root material. Leaching from the tailings above was sufficient to produce 4 inches of soil with a pH of 3.78. This area is estimated to contain 1.51 acres of tailings.

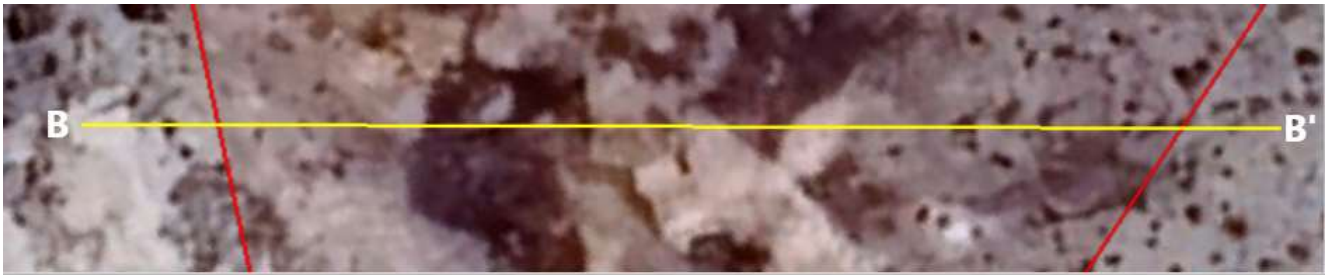
Figure 9. B – B' Section trace on surface in Middle Flat Area

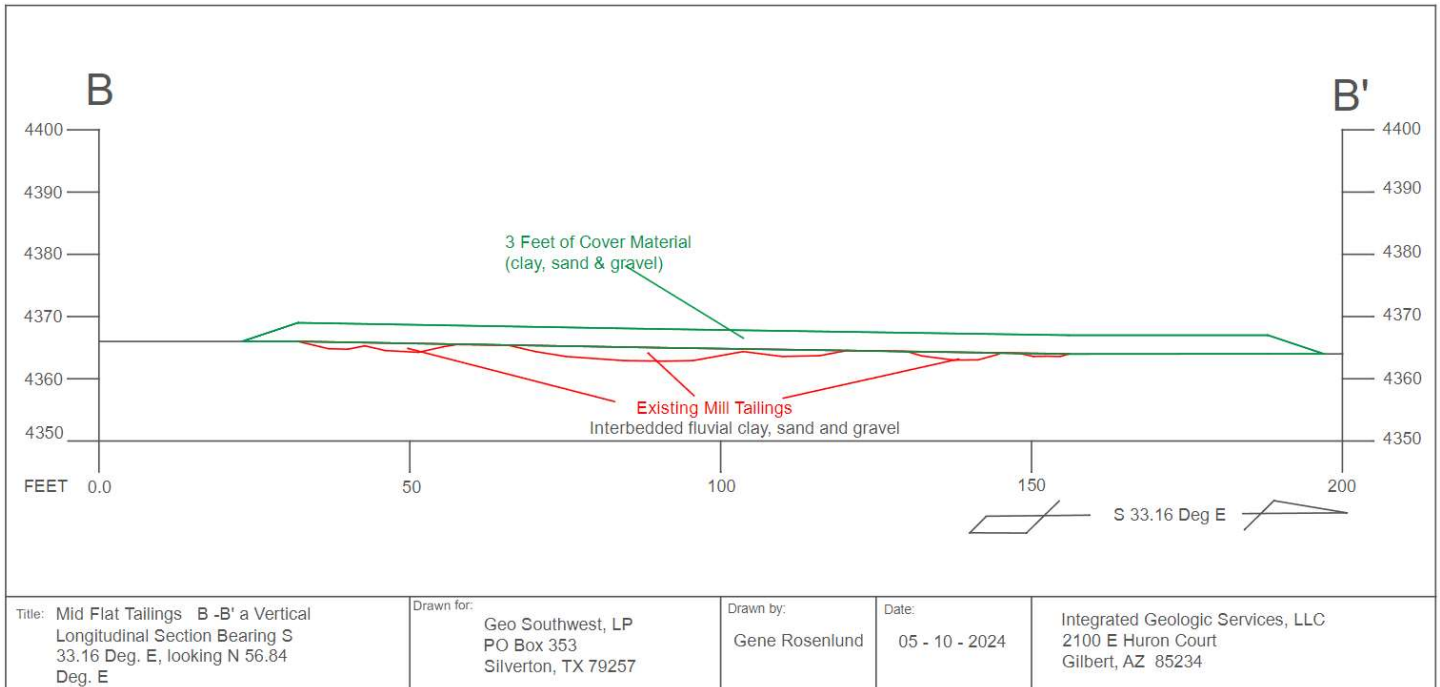
Figure 10. Proposed reclamation of Mill Tailings in the Middle Flat Area

1. Much of the area outlined for Middle Flat is underlain by mill tailings. They will not be moved or disturbed.
2. Tailings from the Mimbres River and Thickener Tank South areas will be hauled to the Middle Flat area, dumped, leveled, and contoured prior to adding cover material. The actual volume of the tailing material coming from other areas is not known.

3. The entire area, which varies only 2 feet in elevation, and tailings from other areas, will be covered with 3 feet of clay, sand, and gravel from the borrow pit. This coverage will extend beyond areas underlain by visible mill tailings to ensure coverage. Figure 1.

4. Finished slopes at the edges of the cover material will be (flatter than) less than 3 to 1 horizontal to vertical ratio.
5. Areas disturbed or covered with pit material during this reclamation effort will be revegetated according to requirements cited in Section 9.F Reissued Permit No LU009RE – Permit Revision 14-1.

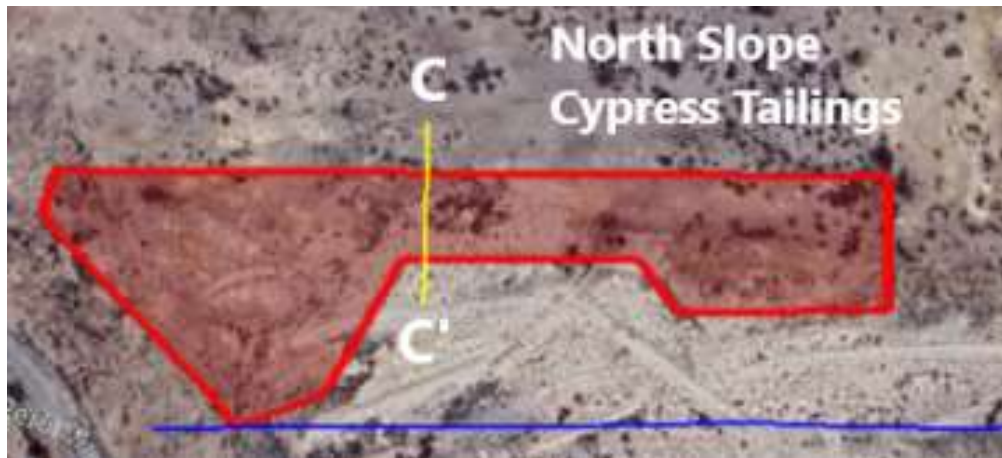
Figure 11. C – C' Tailings Area and Trace of Longitudinal Section

The goal of pitting in this area was to define the northern extension of tailing which have eroded from the north slope of the Cypress tailings and spread out over the soil to the north. Three pits were excavated which established the northern limit by encountering only natural sediments. One pit, GEOSW27, did encounter sandy soil with abundant roots containing occasional reddish sandy clusters suggesting that trace amounts of limited tailings may be present. The pH was measured at 5.11. It was estimated during the pitting study that 4.53 acres of tailing may be associated with this area.

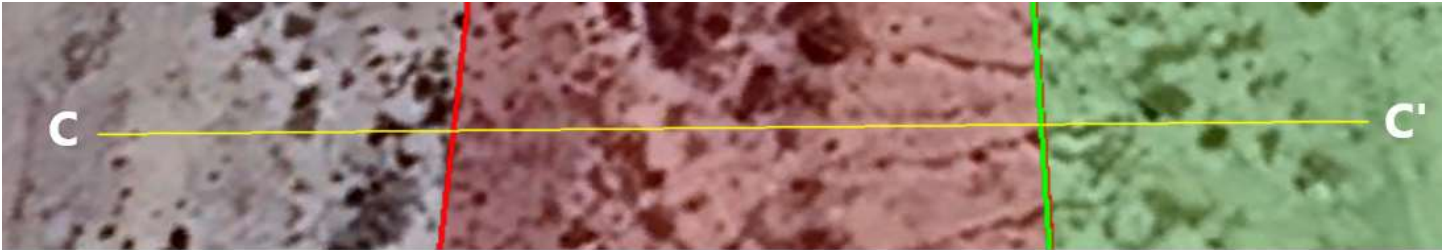
Figure 14. C – C' Section trace on surface in Cypress North Slope Area

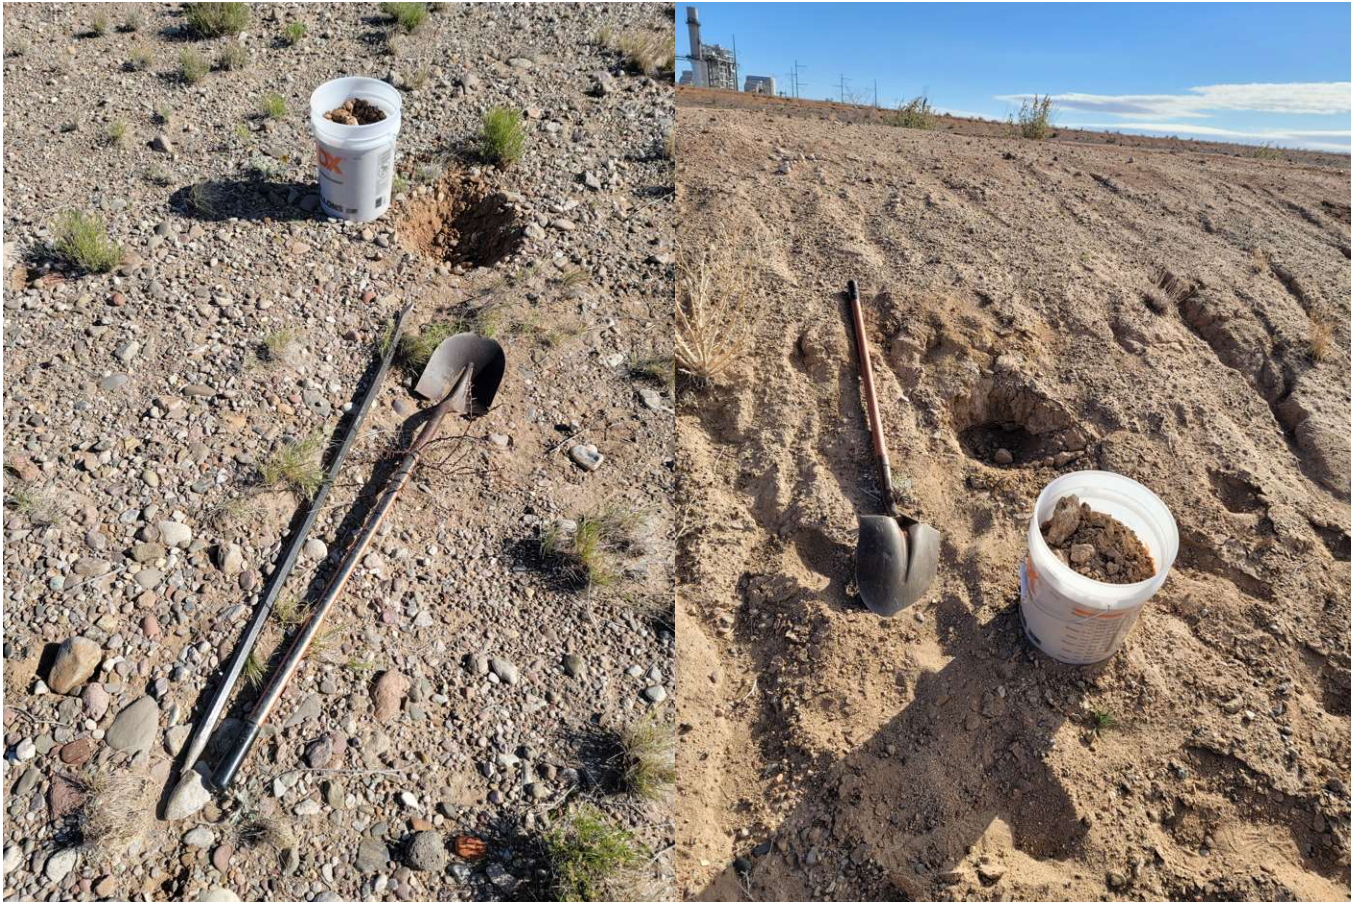
Figure 17. In-bank Gravel Cover and Fine Cover Material in borrow pit.
