# Post Mine Land Use Building Inspections

**Freeport-McMoRan Inc.  
Chino Mines Company  
99 Santa Rita Mine Road  
Vanadium, New Mexico 88043**

**Telesto Solutions Inc.  
750 14<sup>th</sup> Street SW  
Loveland, Colorado 80537**

**March 2024**

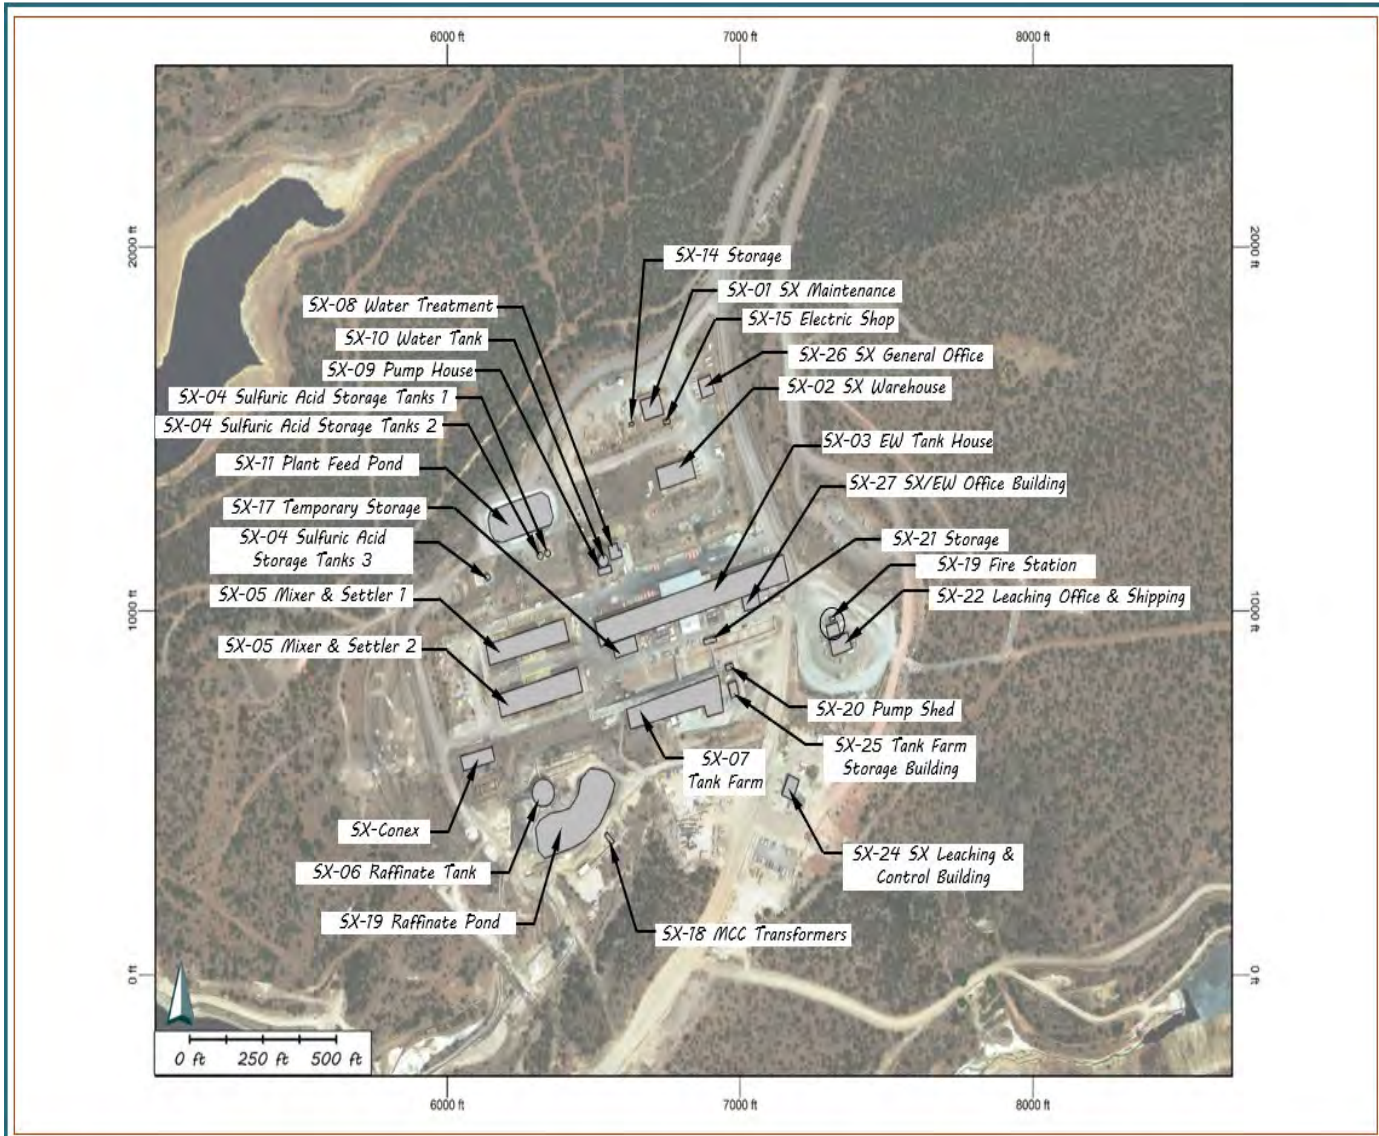
**Figure 2 SX/EW Area Buildings**

Figure 2 displays the 23 buildings inspected in the SX/EW Area.. Table 2 provides a list of the buildings in this area, and a general description of their current use. Attachment B provides the original inspection field sheets and building photographs.

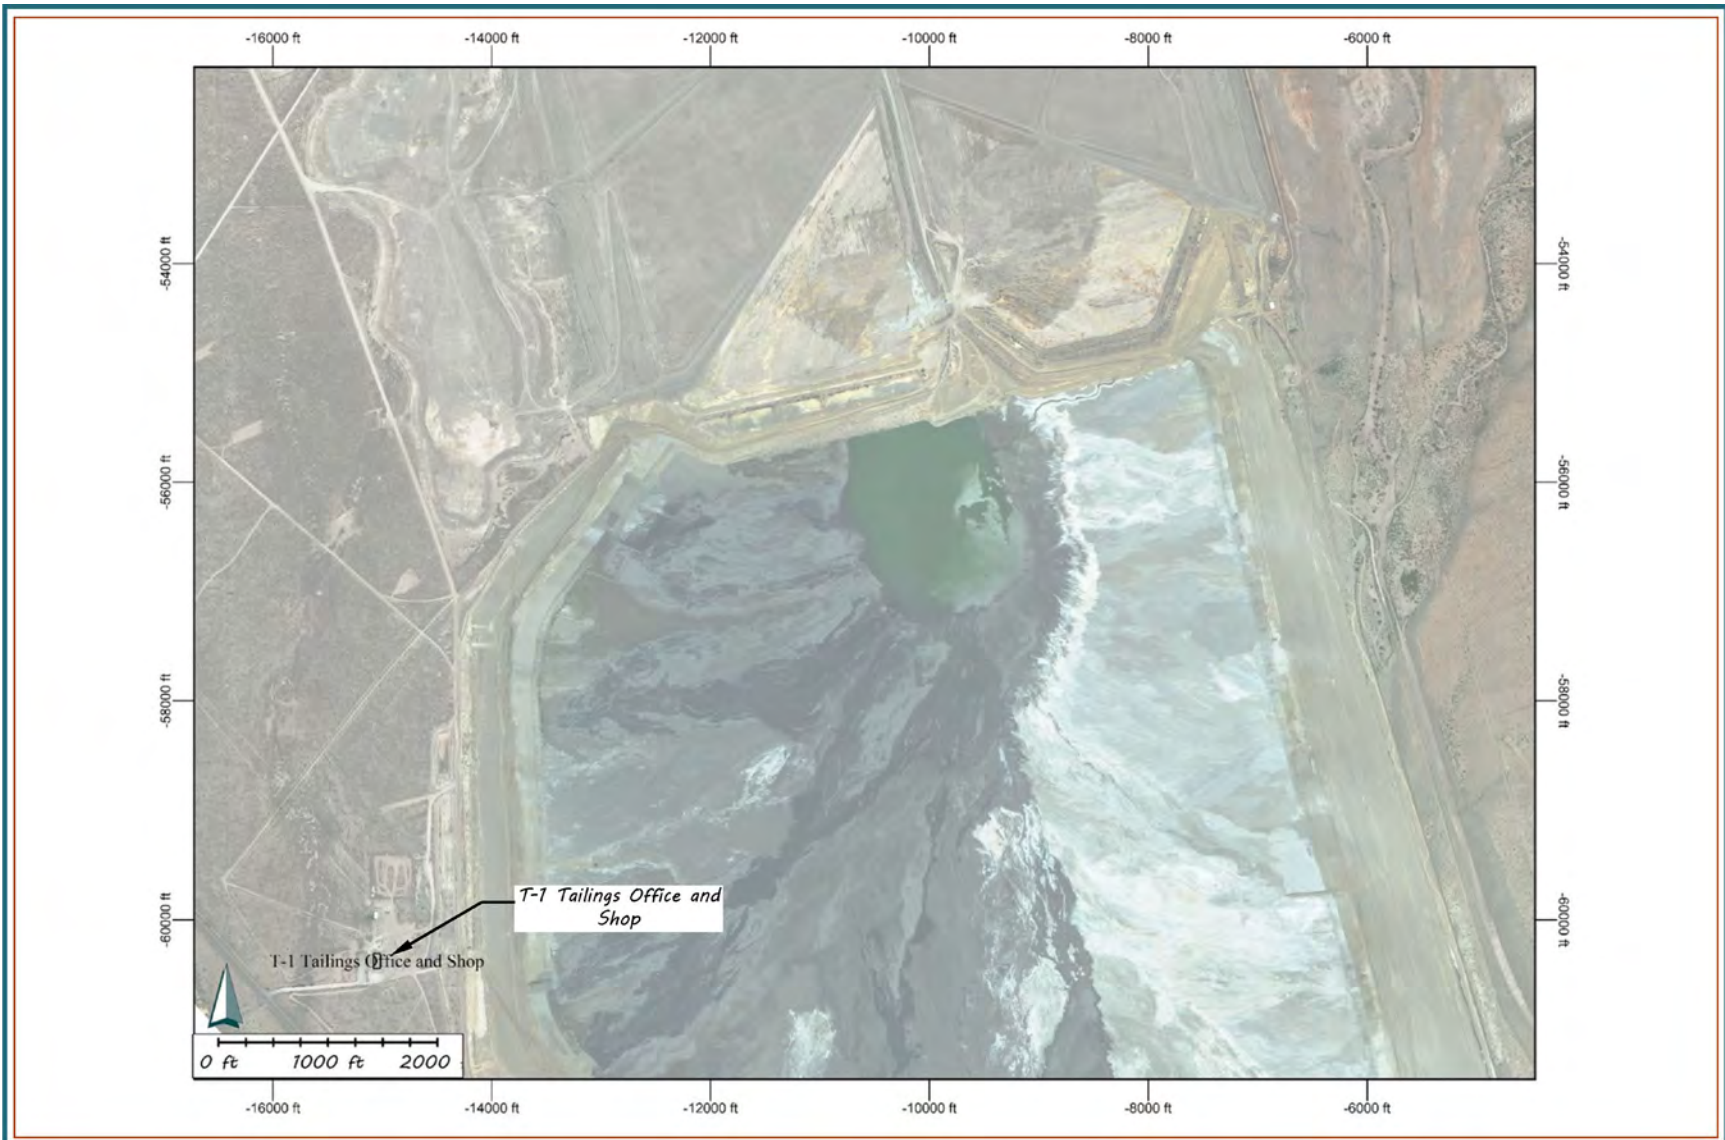
**Figure 5 Miscellaneous Area Buildings–Tailings**

Figures 4 and 5 displays the buildings inspected in the Reservoir 8 and Tailings Areas. In all the team inspected 23 buildings. Table 4 provides a list of the buildings in the MF area, and a general description of their current use. Attachment D provides the original inspection field sheets and building photographs.
