PROJECT: 200450-001	TASK 03
PREPARED BY:

PMLU BUILDING INSPECTION FORM

Freeport-McMoran Chino Mine

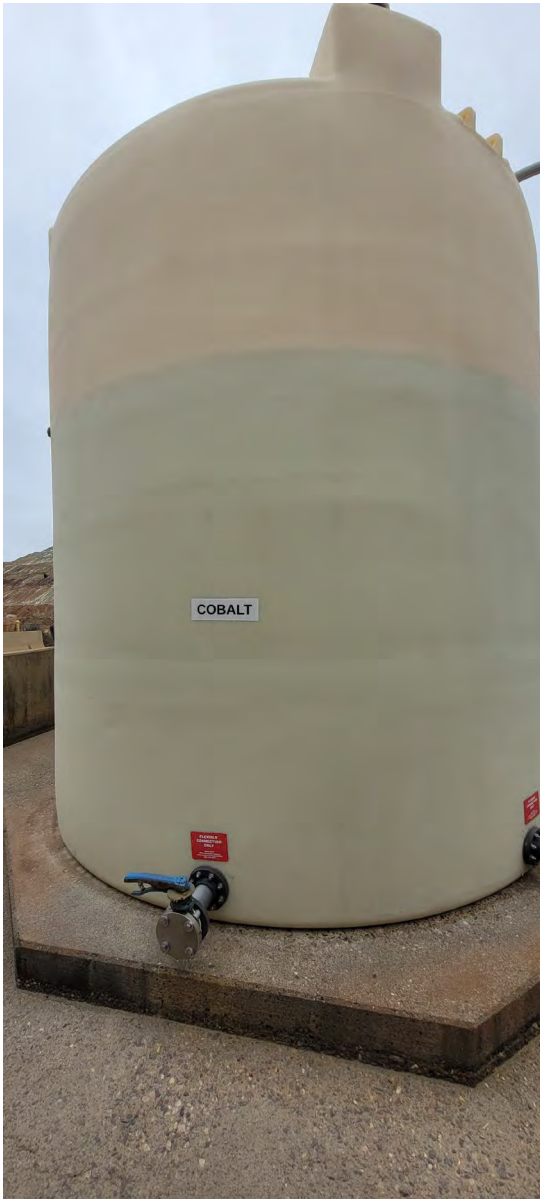
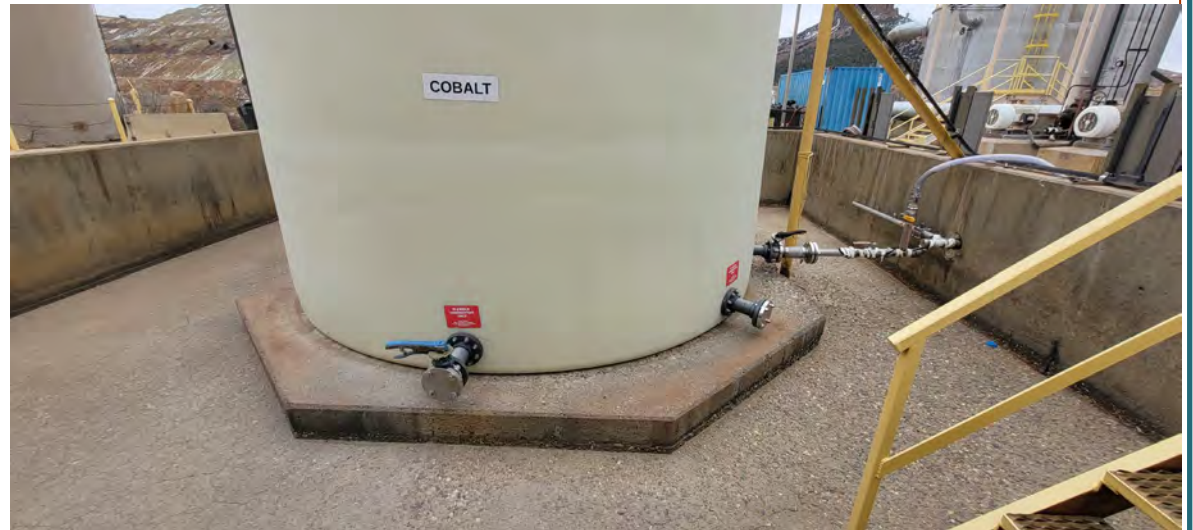
SX-20
Cobalt Tank

Category	Condition			Comments
	Good	Fair	Poor	
Civil				
Condition of Site	X			Cobalt Storage + Tank to south in good condition
Drainage Around Facility	X			
Access to Facility	X			
Building Parking			X	
Fencing or Security			X	
Foundation				
Foundation	X			
Floor Slabs	X			
If process Facility: Cond of equip fnds				
Structure				
Framing: Walls	X			
Framing: Roofs	X			
Framing: Internal	X			
If Concrete structure				
Mechanical				
HVAC if present				↓
Water Supply if present				
Waste water if present				
Other utilities if present				
Fire protection if present				
Piping				
if facility is not building				
if facility is process	X			
Electrical				
Power supply	X			↓
Power distribution	X			
Lighting				
Other utilities if present				
Architectural				
Condition of Flooring				↓
Wall systems				
roofing				
ceilings				
doors				
windows				
points of egress

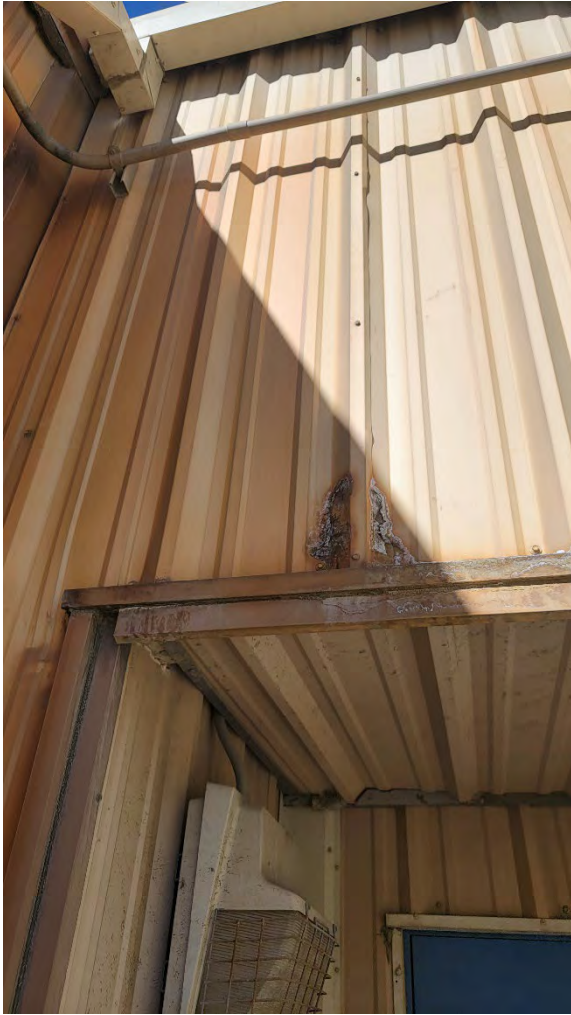
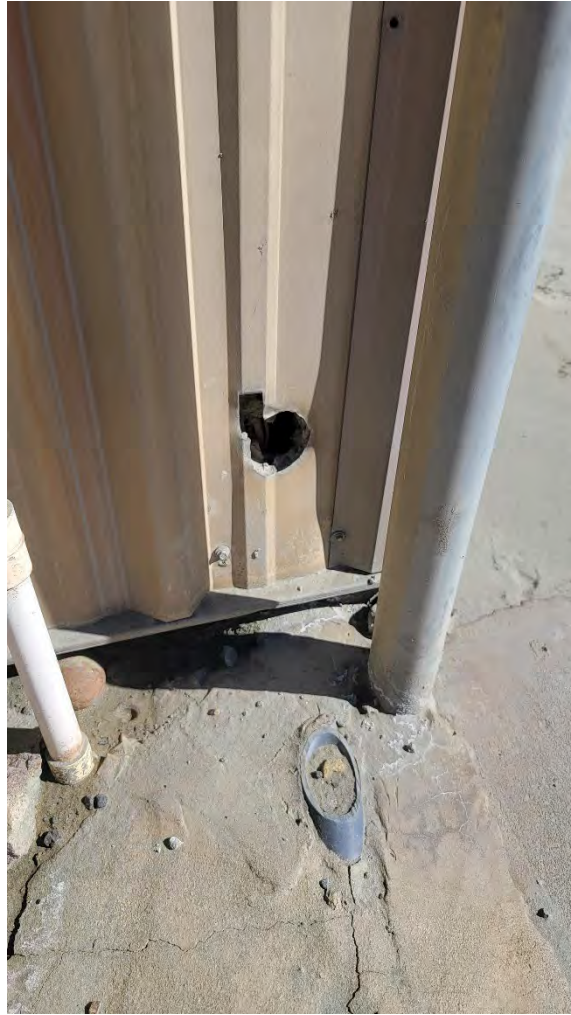
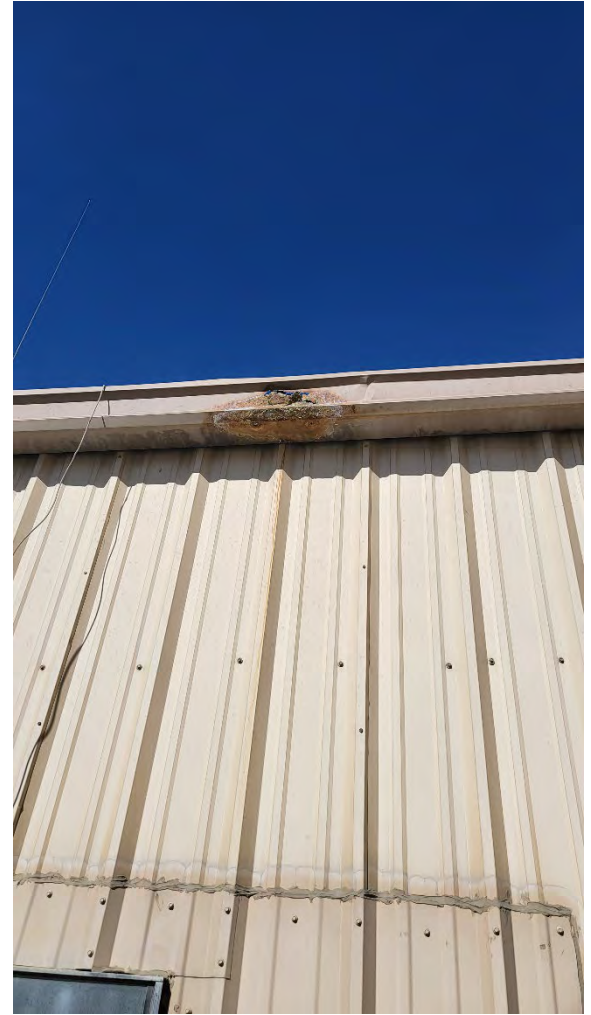
CP-01
External Damage

Category	Condition			Comments
	Good	Fair	Poor	
Civil				
Condition of Site	X			
Drainage Around Facility		X		rusty gutters, water ponding
Access to Facility	X			
Building Parking				nn
Fencing or Security				
Foundation				
Foundation	X			
Floor Slabs	X			
If process Facility: Cond of equip fnds				
Structure				
Framing: Walls		X		Dented walls, hole in wall
Framing: Roofs	X			
Framing: Internal	X			
If Concrete structure				
Mechanical				
HVAC if present	X			
Water Supply if present	X			
Waste water if present	X			
Other utilities if present				
Fire protection if present				nn
Piping				
if facility is not building				
if facility is process				
Electrical				
Power supply	X			
Power distribution	X			
Lighting	X			
Other utilities if present				
Architectural				
Condition of Flooring	X			
Wall systems	X			
roofing	X			
ceilings	X			
doors	X			
windows	X			
points of egress	X

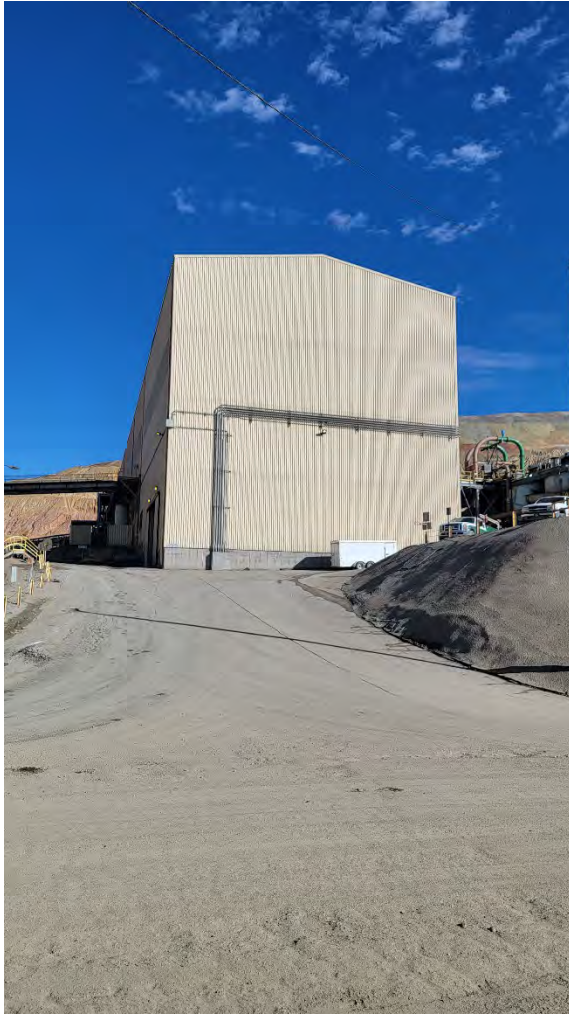
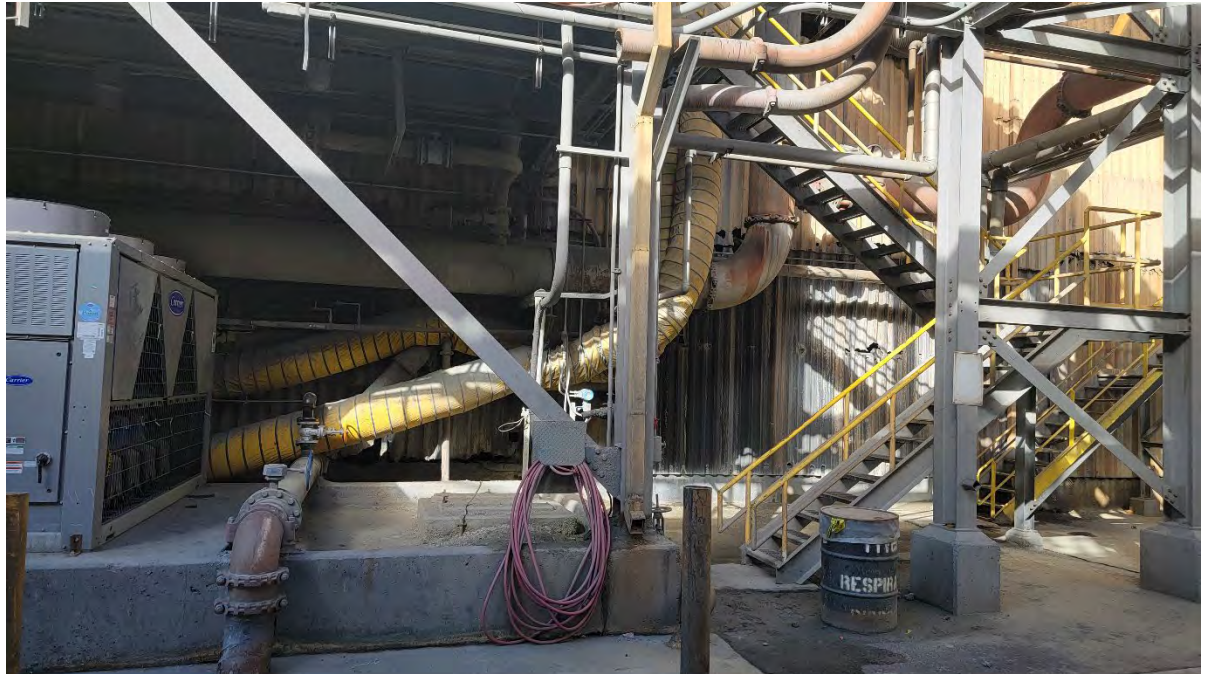
CP-02
External & Internal View

Category	Condition			Comments
	Good	Fair	Poor	
Civil				
Condition of Site	X			
Drainage Around Facility		X		
Access to Facility	X			
Building Parking		X		
Fencing or Security				
Foundation				
Foundation	X			
Floor Slabs	X	X		cracked floor slabs
If process Facility: Cond of equip fnds				
Structure				
Framing: Walls		X		
Framing: Roofs	X			
Framing: Internal	X			
If Concrete structure				
Mechanical				
HVAC if present				nn
Water Supply if present	X			
Waste water if present	X			
Other utilities if present				
Fire protection if present				nn
Piping				
if facility is not building				
if facility is process	X			
Electrical				
Power supply	X			
Power distribution	X			
Lighting	X			
Other utilities if present				
Architectural				
Condition of Flooring	X			
Wall systems	X			
roofing	X			
ceilings	X			
doors	X			
windows	X			
points of egress	X

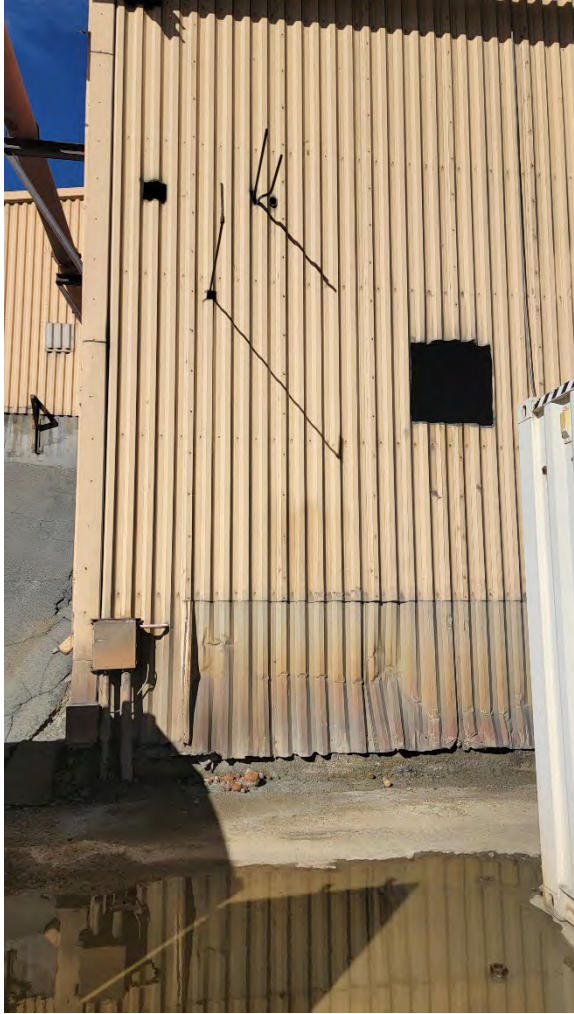
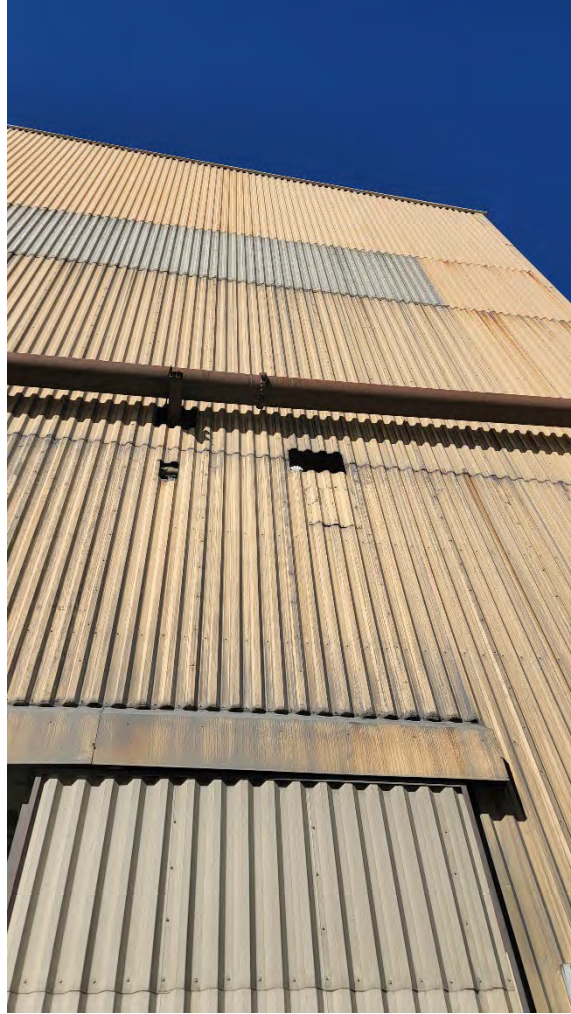
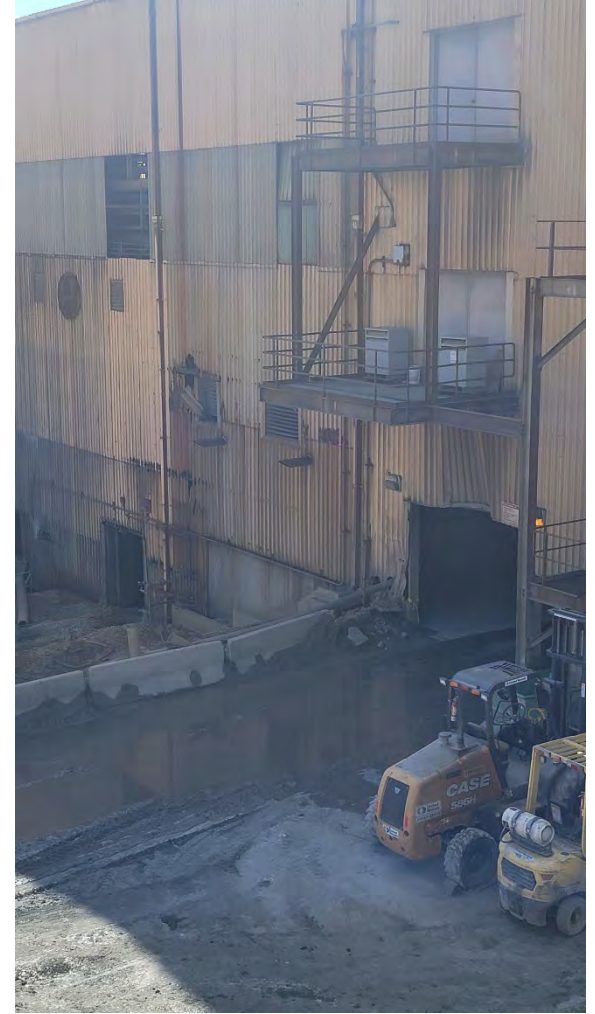
CP-02
External Damage

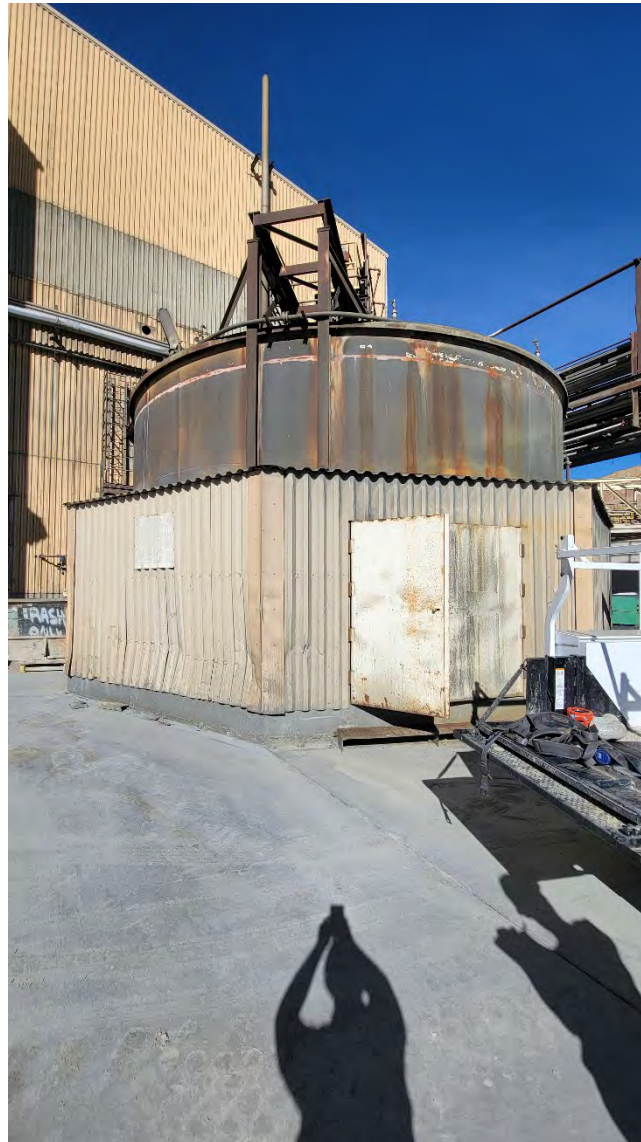
CP-05
Molly Tank - External View

Category	Condition			Comments
	Good	Fair	Poor	
Civil				
Condition of Site	X			Pooling along eastern edge
Drainage Around Facility		X		
Access to Facility	X			
Building Parking		X		
Fencing or Security	X			
Foundation				
Foundation	X			
Floor Slabs	X			
If process Facility: Cond of equip fnds				
Structure				
Framing: Walls	X			
Framing: Roofs	X			
Framing: Internal	X			
If Concrete structure				
Mechanical				
HVAC if present				↑ ↓
Water Supply if present				
Waste water if present				
Other utilities if present				
Fire protection if present				
Piping				
if facility is not building				
if facility is process				
Electrical				
Power supply	X			
Power distribution	X			
Lighting	X			
Other utilities if present				
Architectural				
Condition of Flooring				
Wall systems				
roofing				
ceilings				
doors				
windows				
points of egress

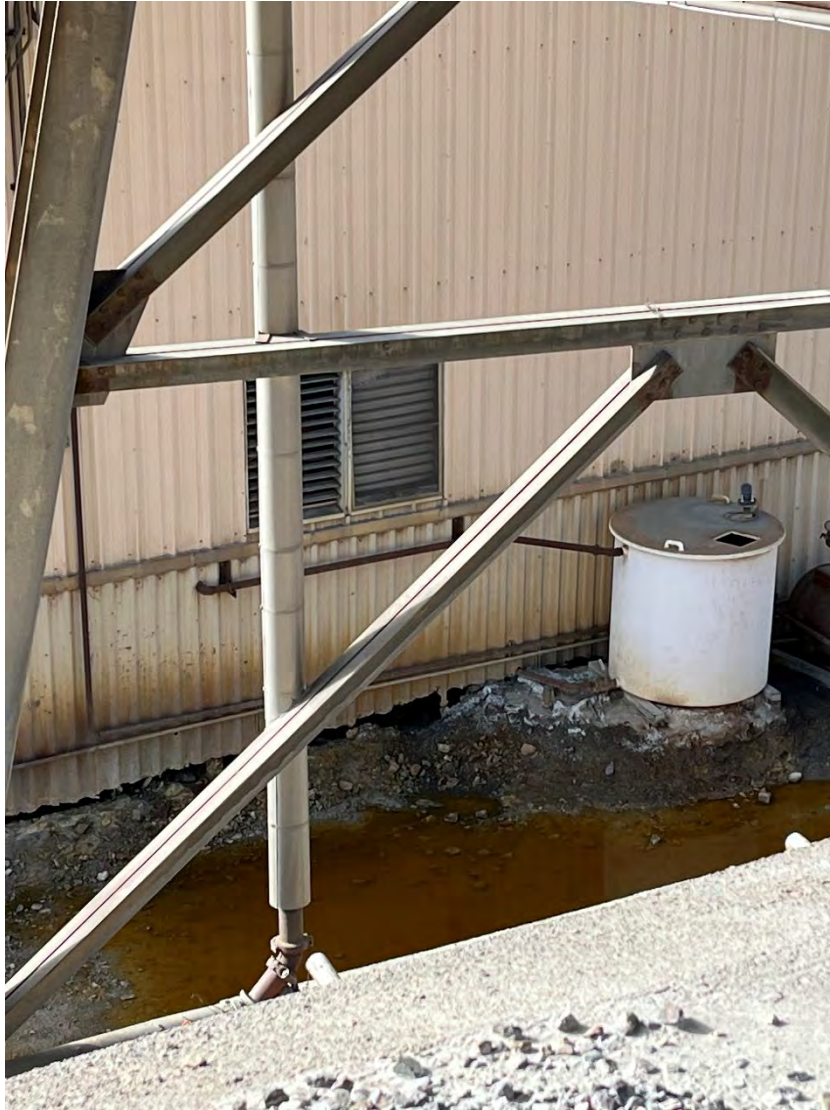
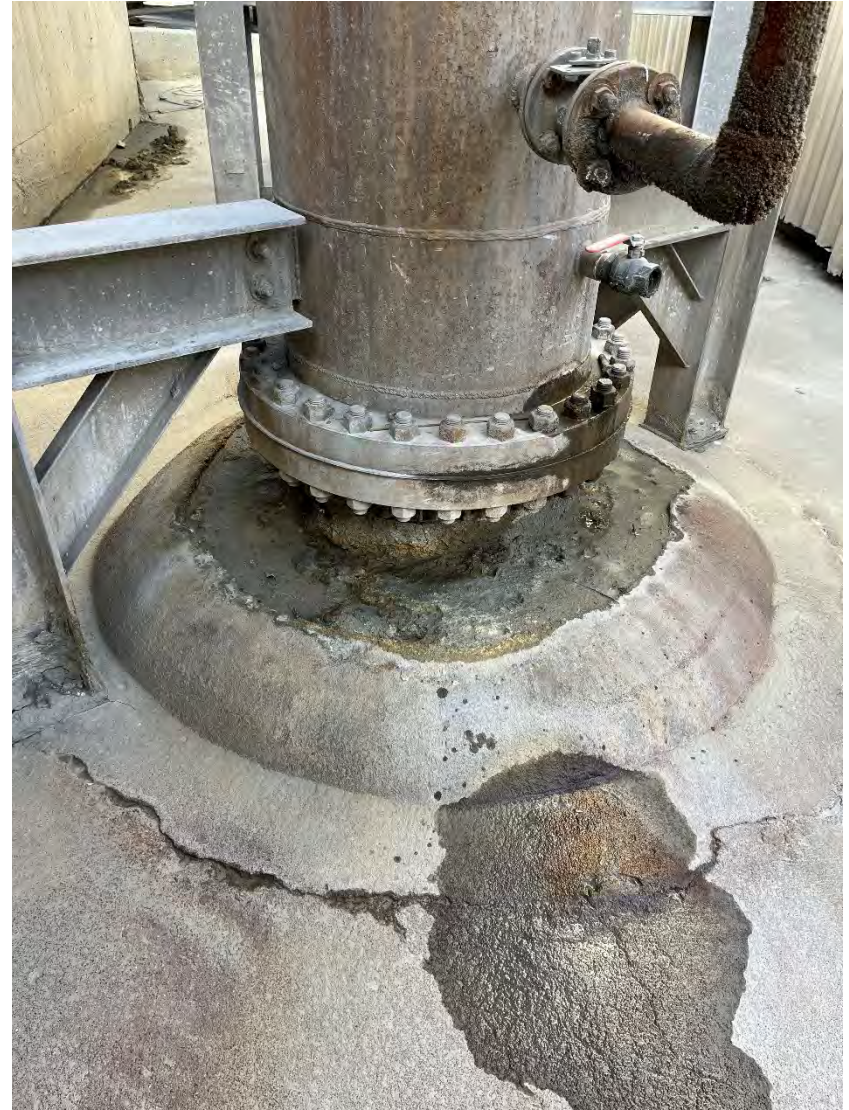
CP-05
External Damage

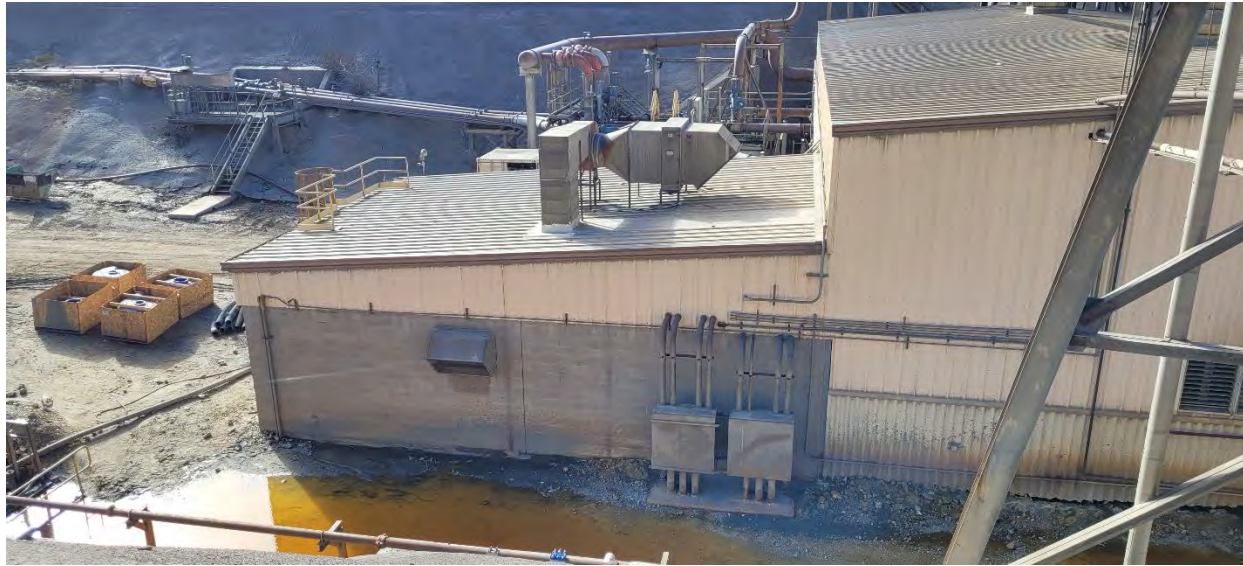
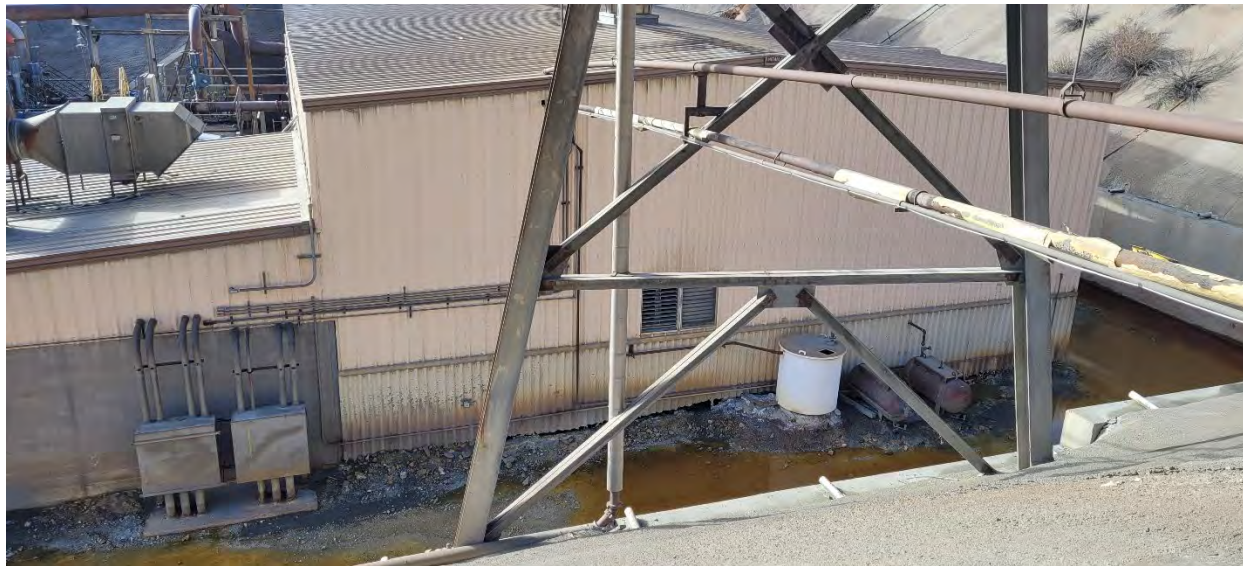
Category	Condition			Comments
	Good	Fair	Poor	
Civil				
Condition of Site				
Drainage Around Facility			X	
Access to Facility		X		steep
Building Parking				N/A
Fencing or Security				N/A
Foundation				
Foundation		X		
Floor Slabs	X			outside pipe stand foundations OK
If process Facility: Cond of equip fnds	X			cut side upper decking rusty
Structure				
Framing: Walls			X	
Framing: Roofs		X		-Bldg skel is poor @ base
Framing: Internal			X	-mmmm holes
If Concrete structure				-North side wall pillar rusted mid bldg - north, several others have web missing @ bottom
Mechanical				
HVAC if present	N/A			
Water Supply if present				
Waste water if present				
Other utilities if present				
Fire protection if present				
Piping				
if facility is not building				
if facility is process	X			
Electrical				
Power supply	X			
Power distribution	X			
Lighting	X			
Other utilities if present				
Architectural				
Condition of Flooring

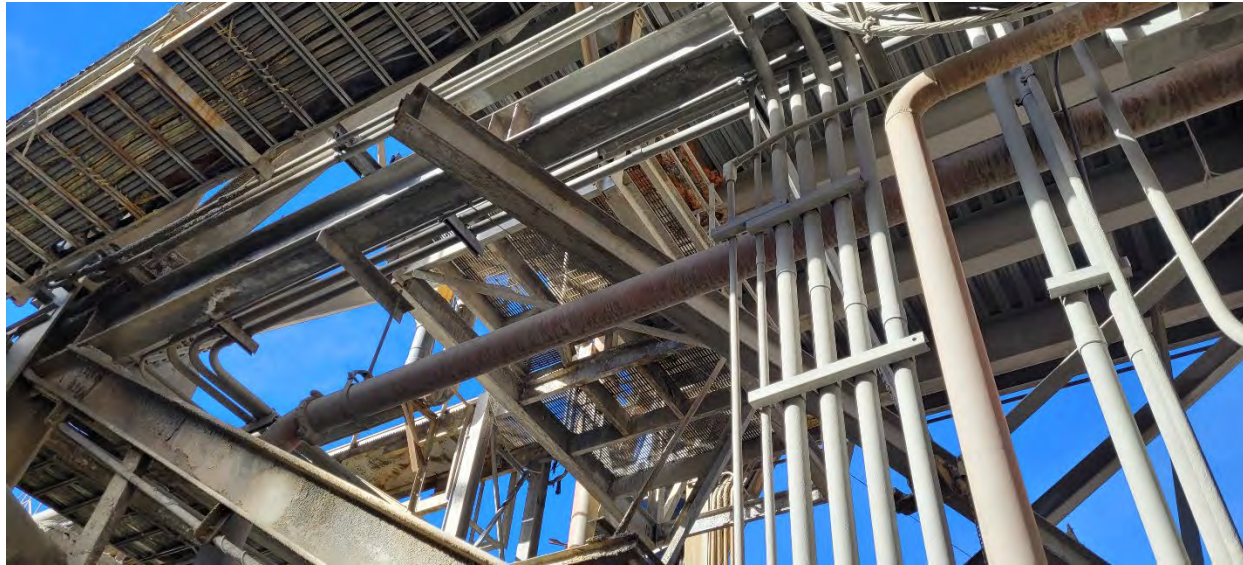
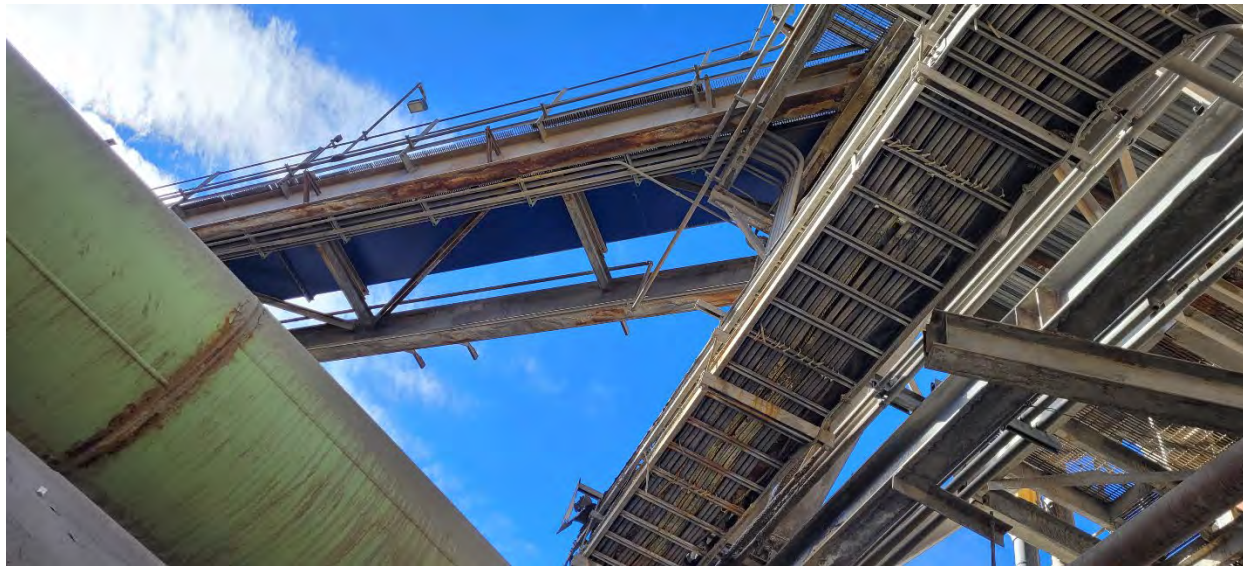
CP-06
External Damage

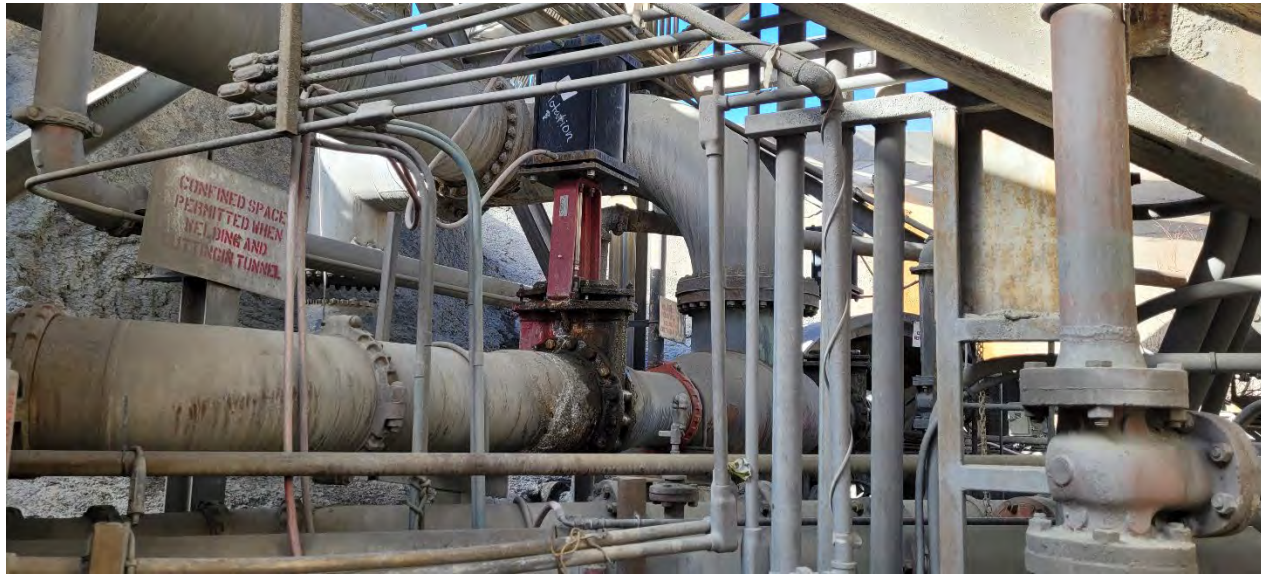
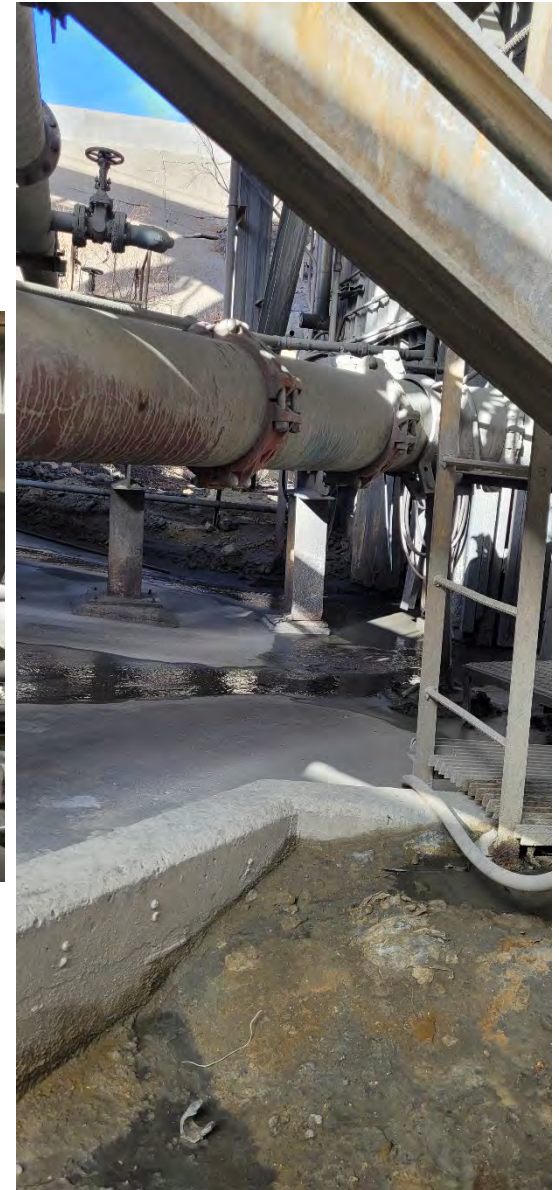
CP-06
External Damage

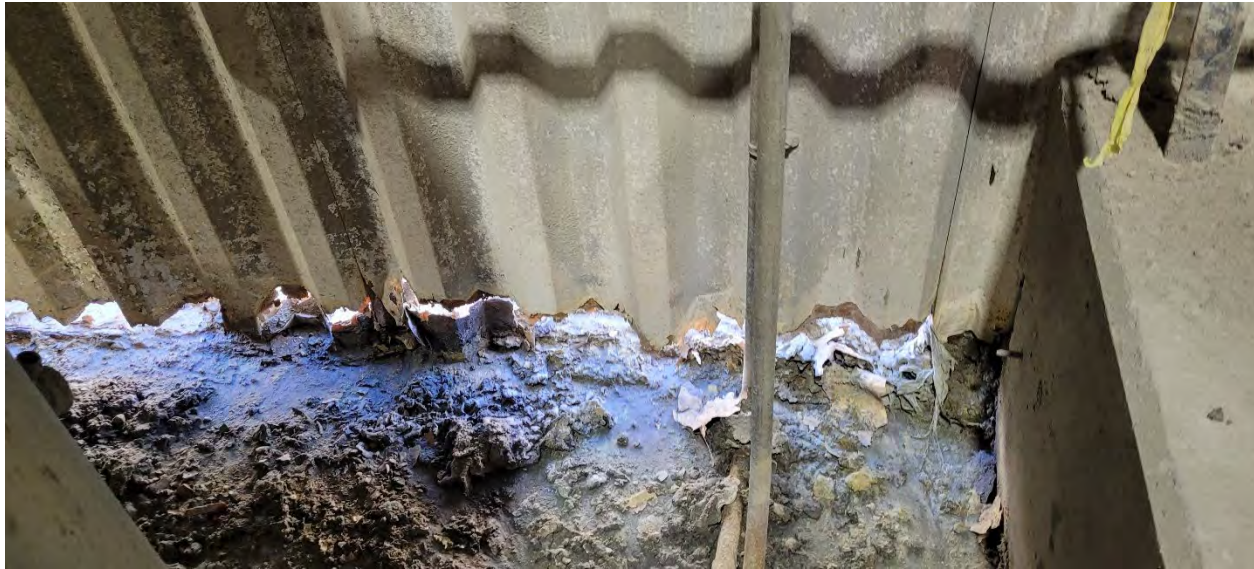
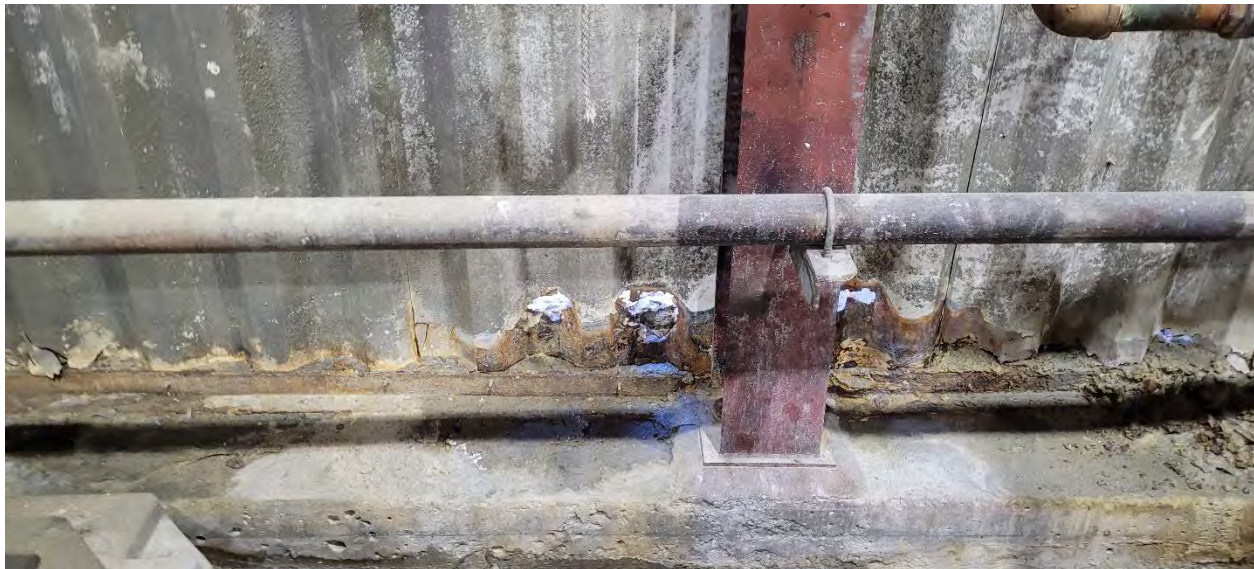
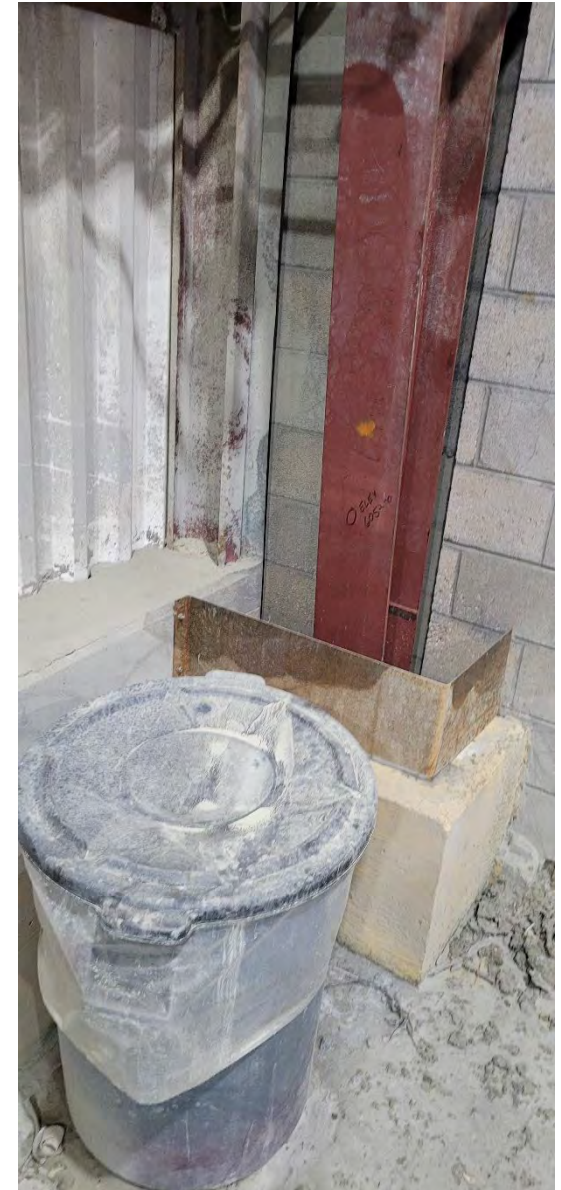
CP-06
Internal Damage

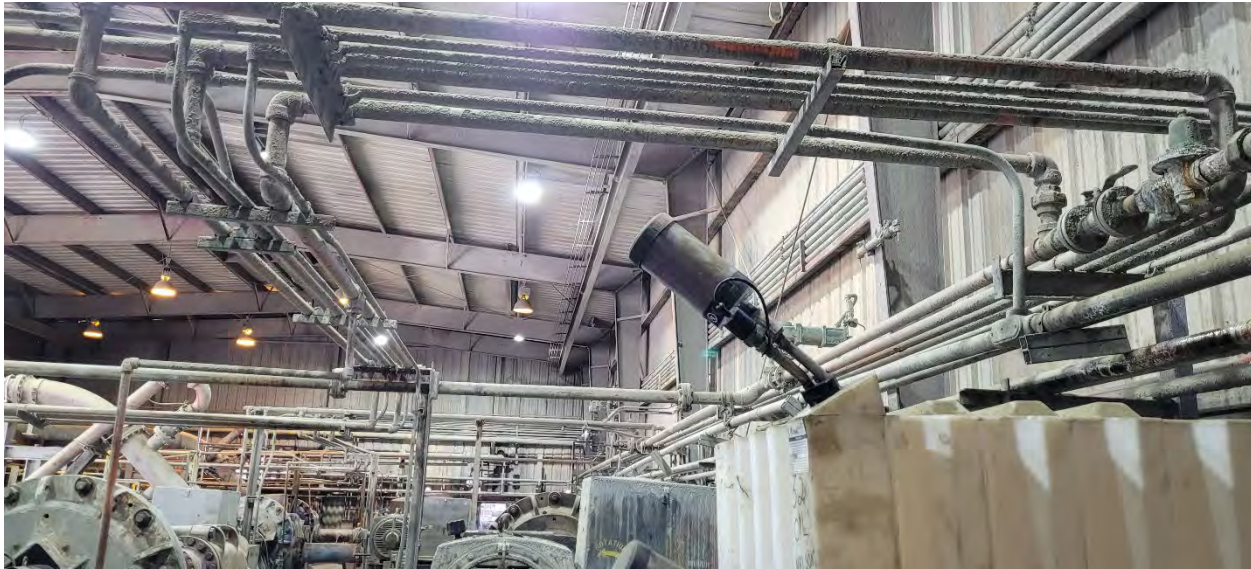
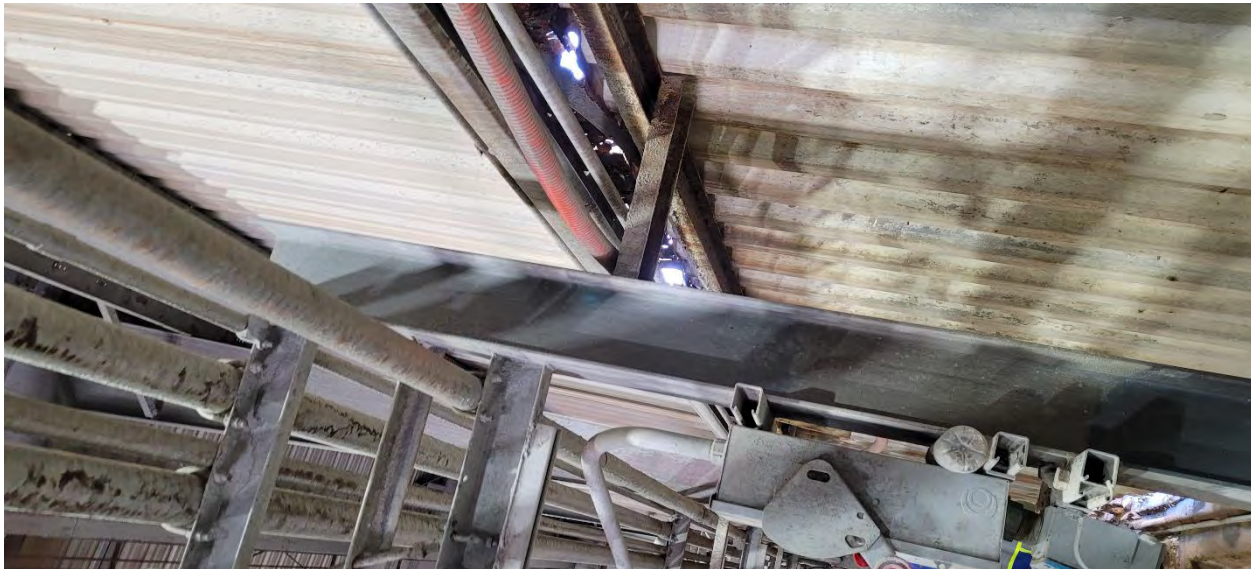
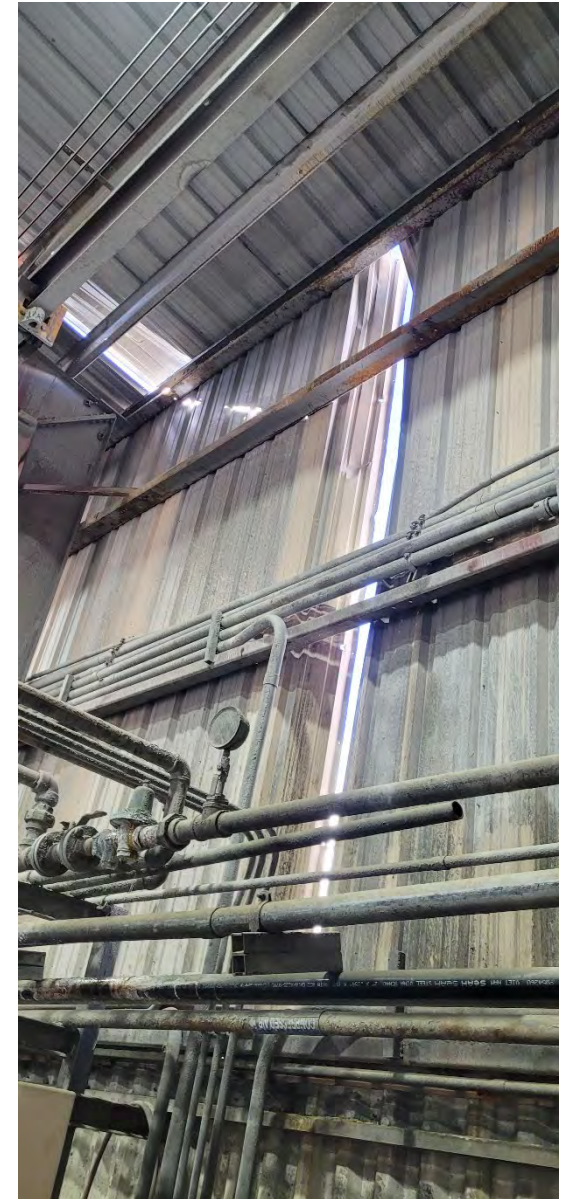
CP-06
Internal Damage

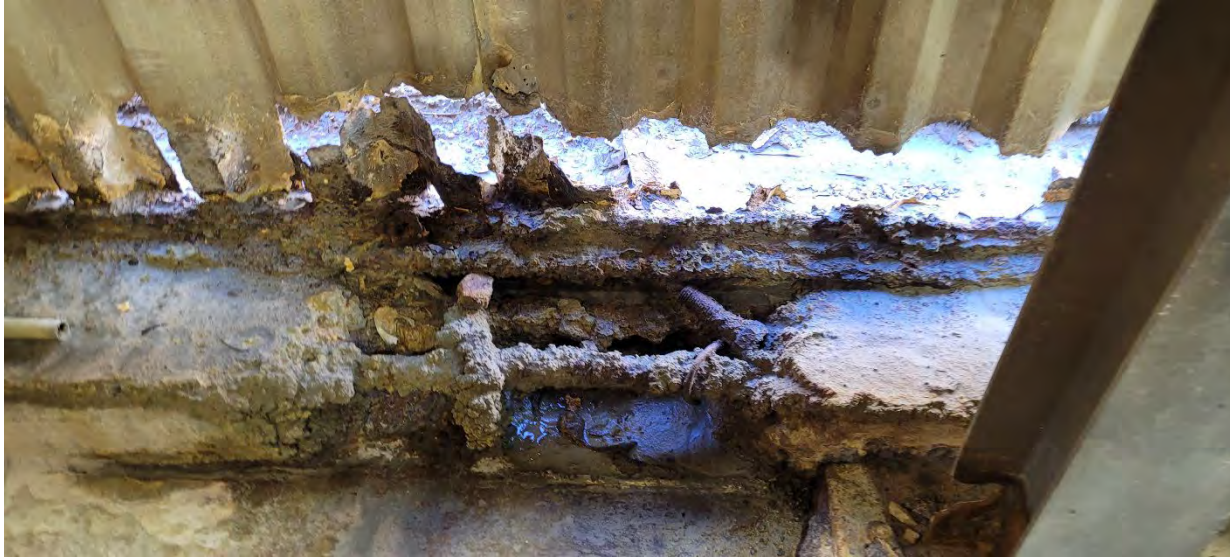
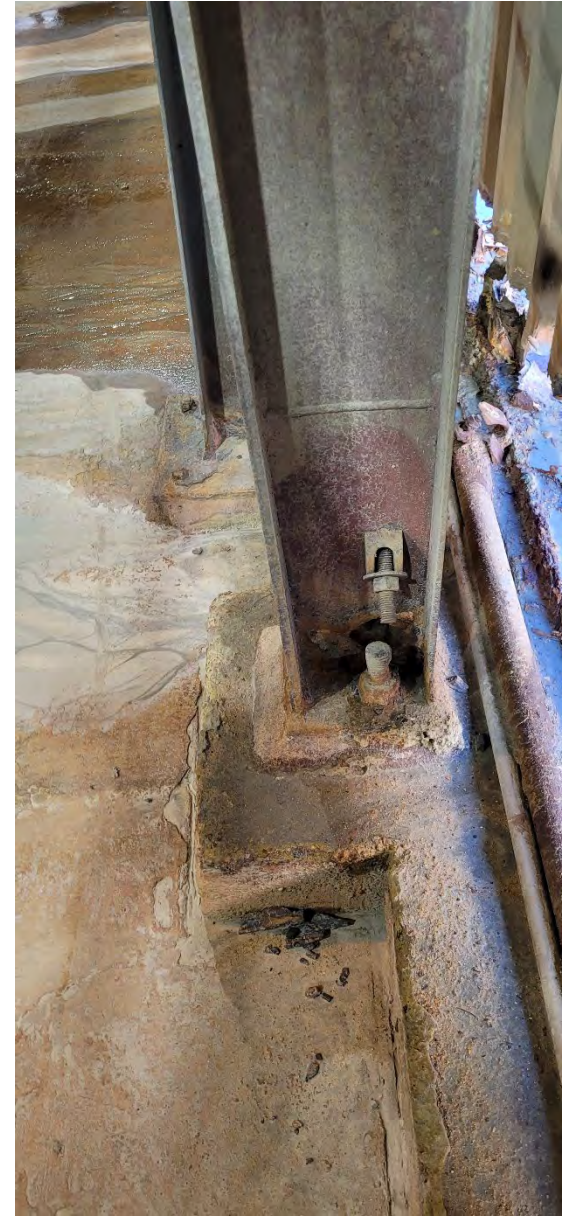
CP-06
Internal Damage

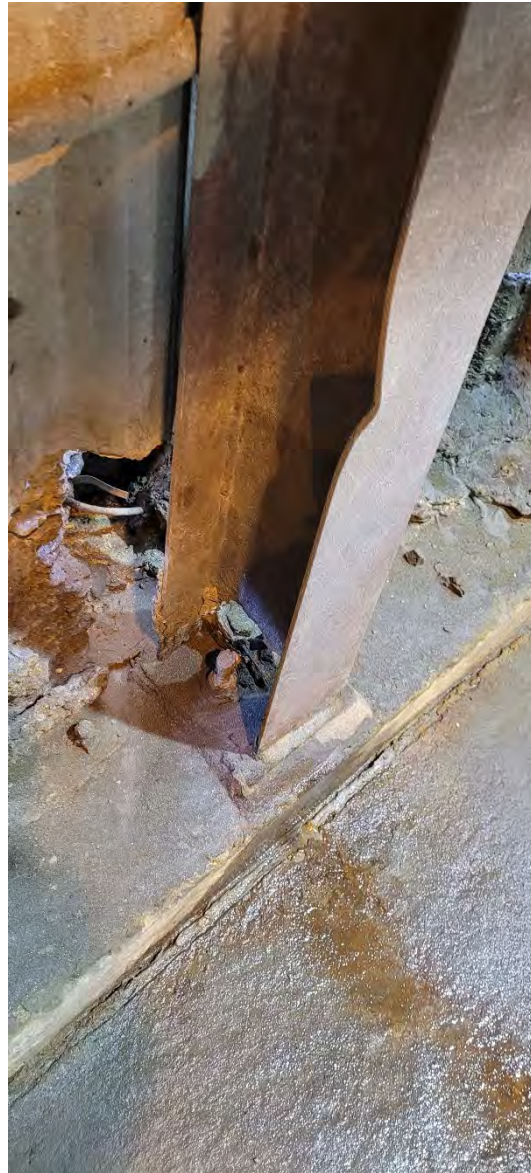
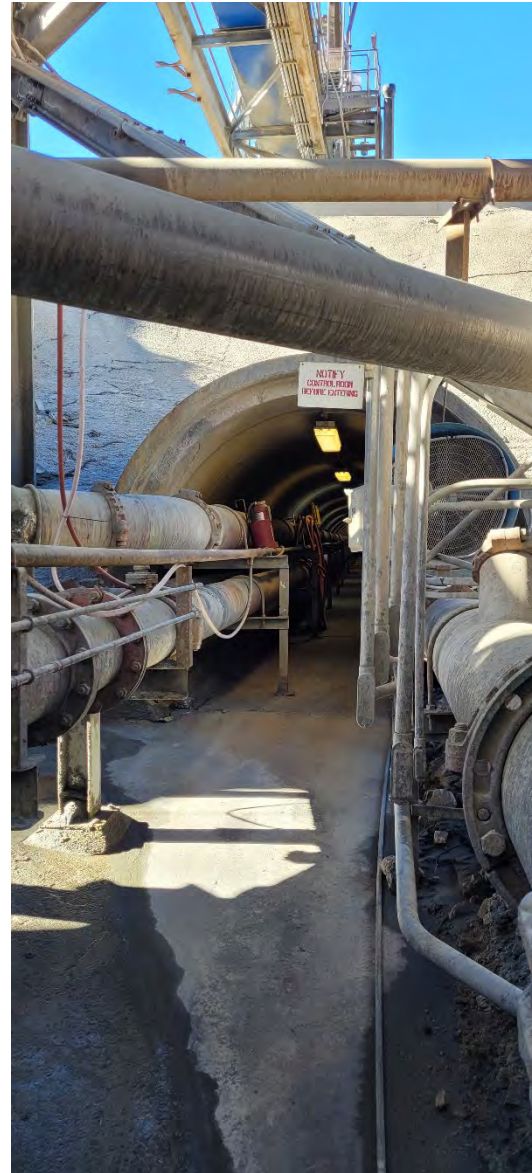
CP-06
External Damage

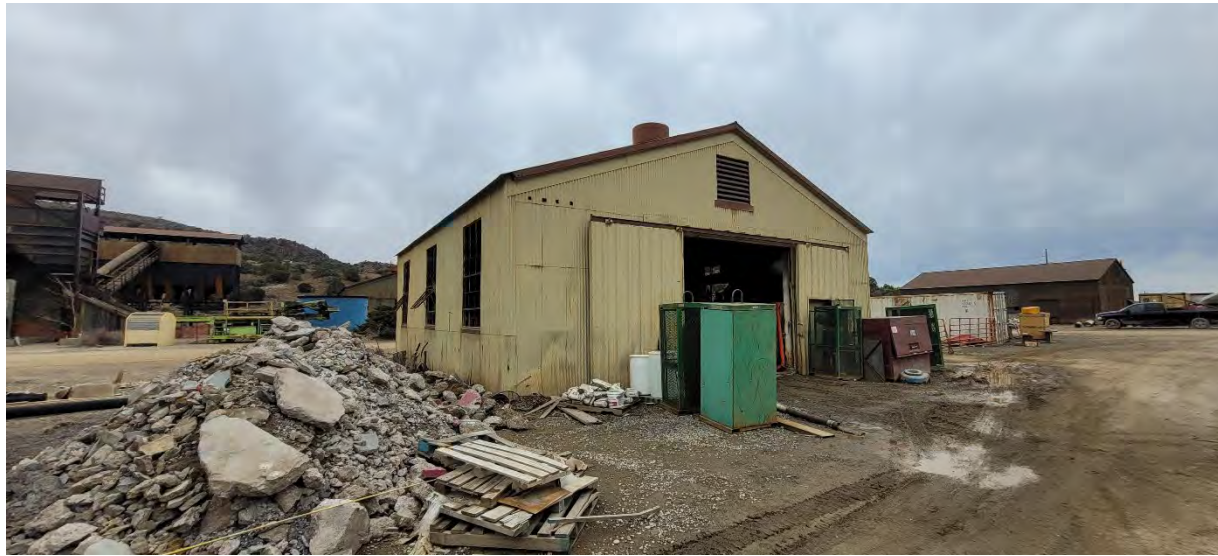
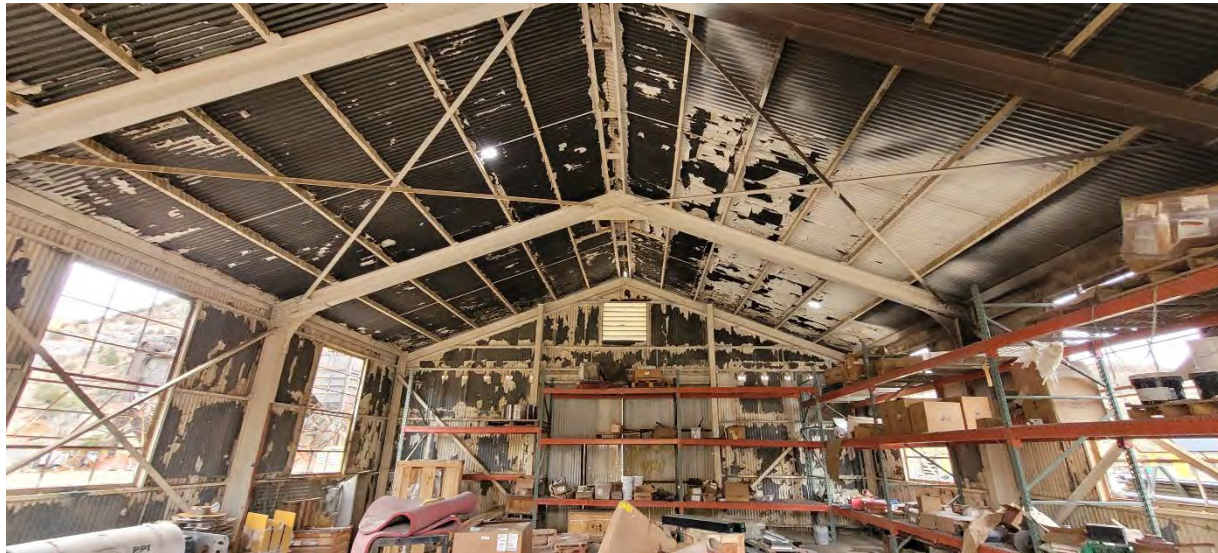
CP-08
External View & Damage
