PROJECT: 200450-001	TASK 03
PREPARED BY:

PMLU BUILDING INSPECTION FORM

Freeport-McMoran Chino Mine

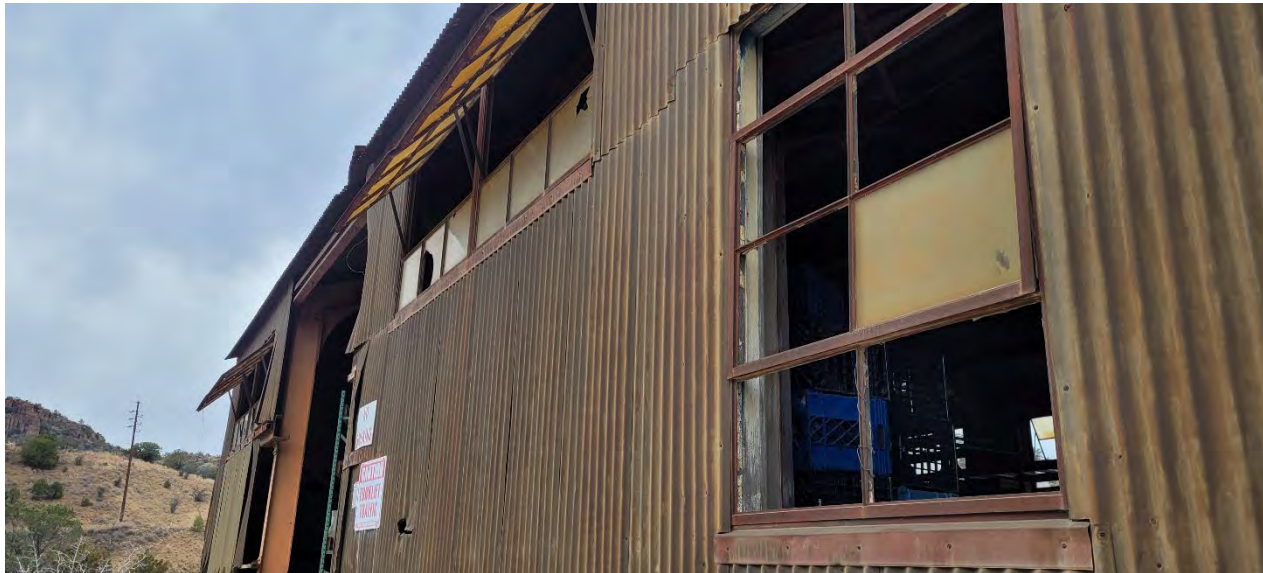
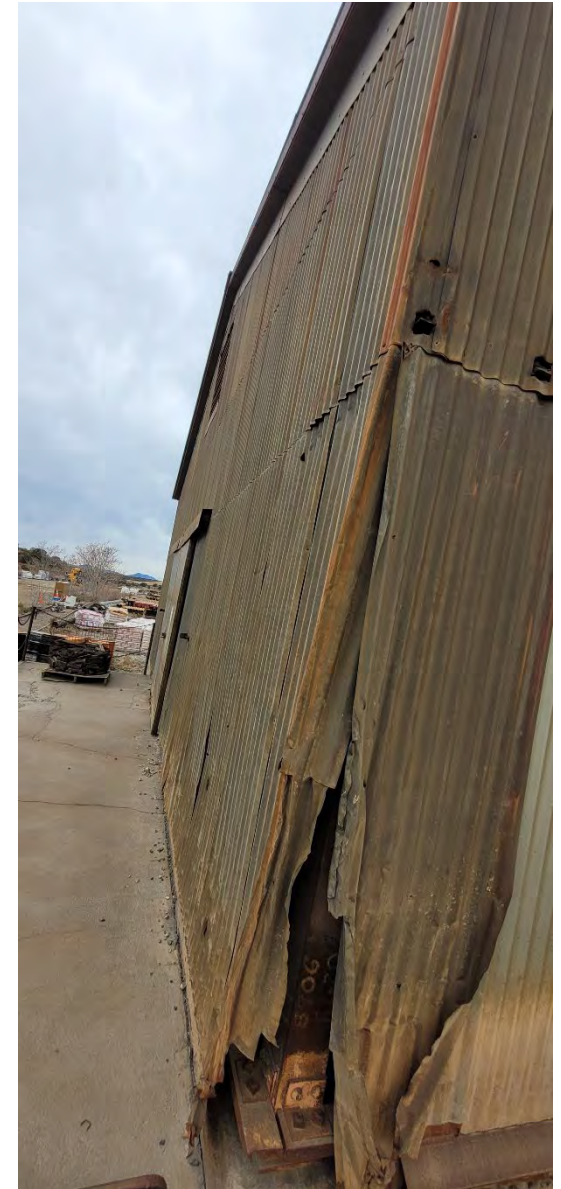
CP-08
External Damage

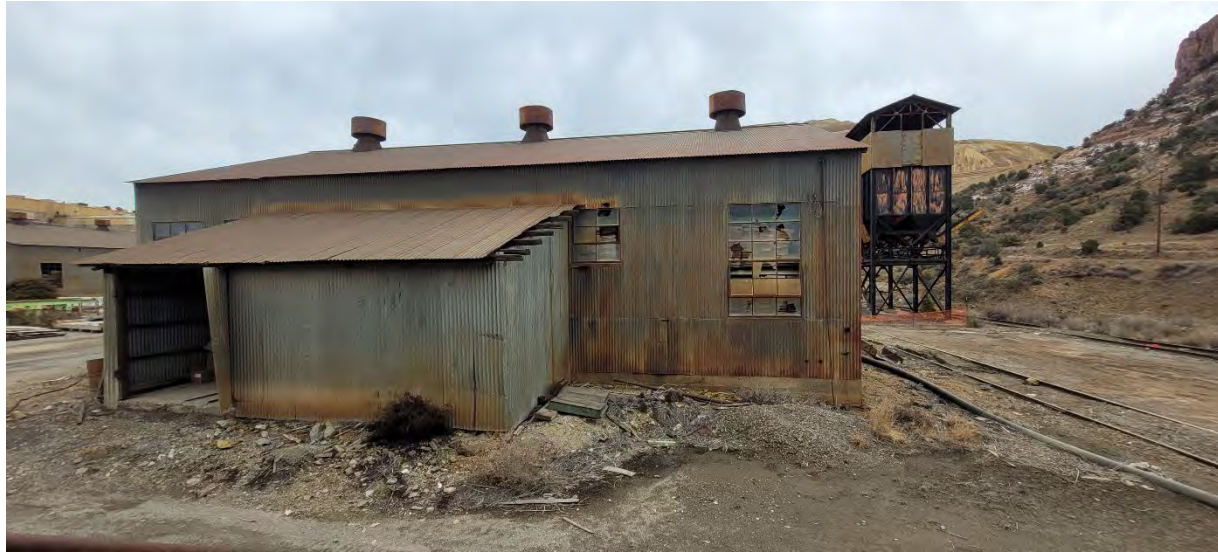
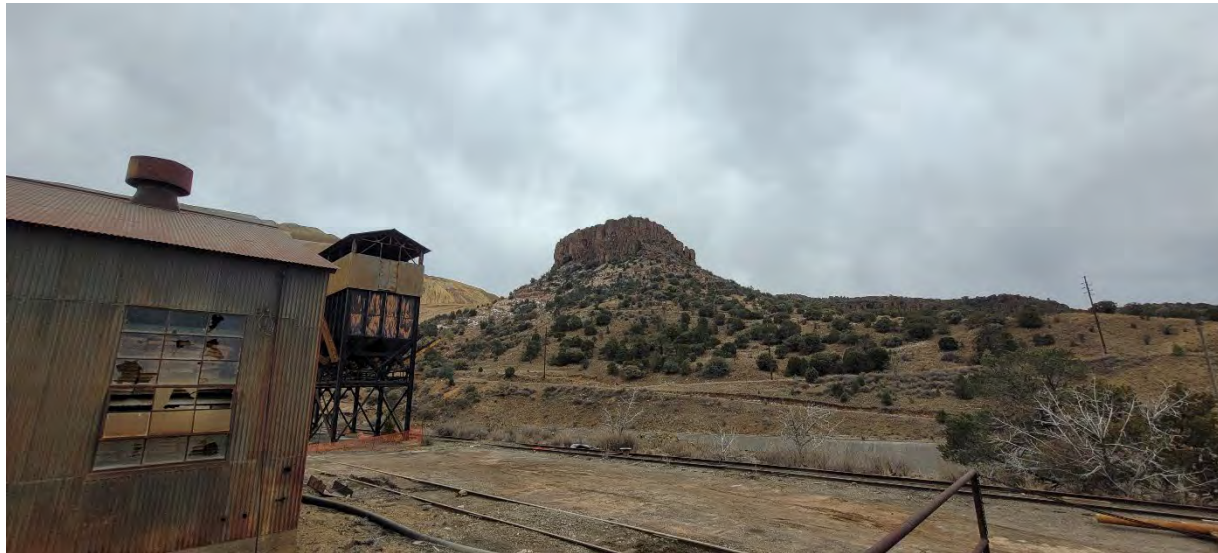
CP-08
External View & Damage

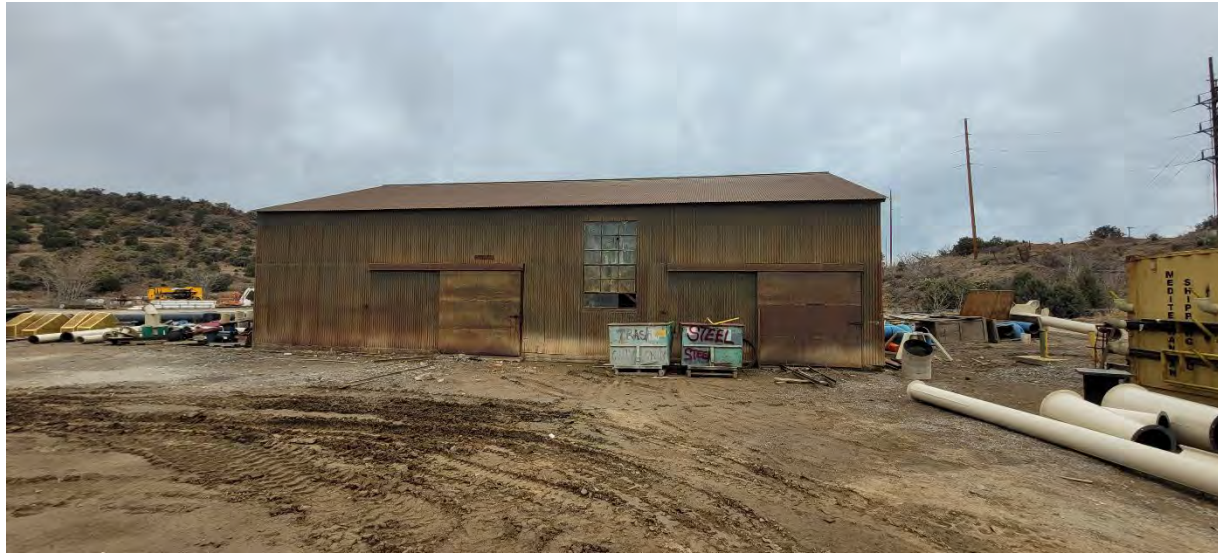
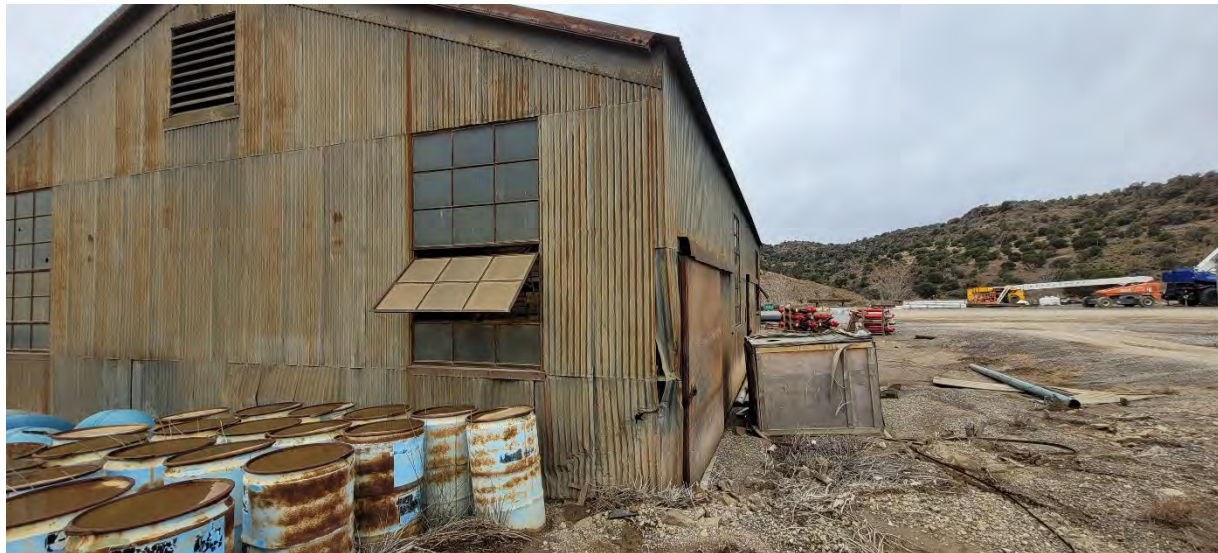
CP-08
External View & Damage

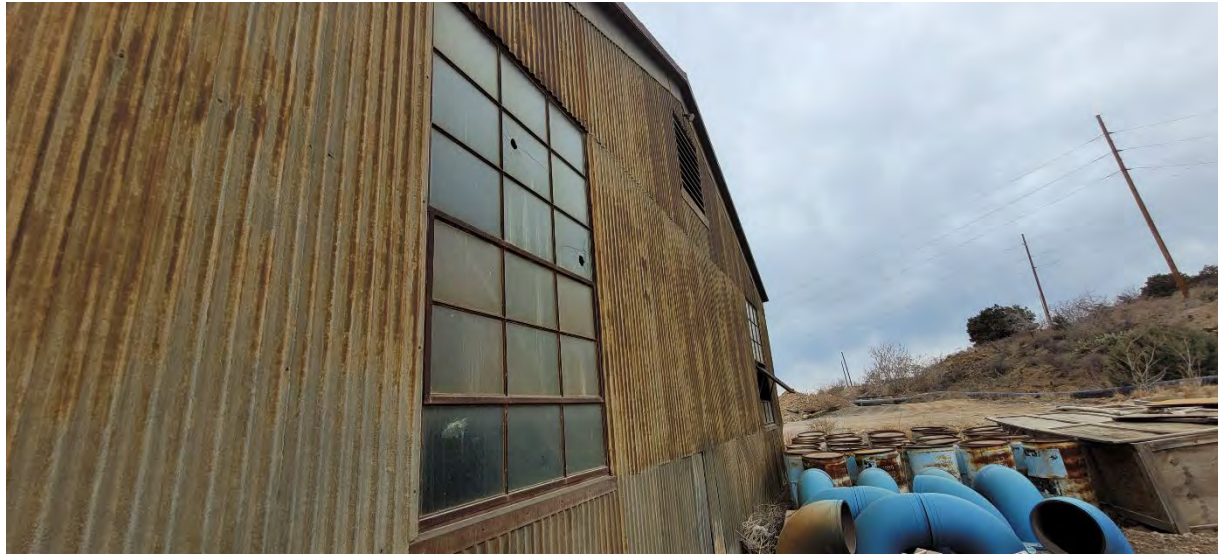
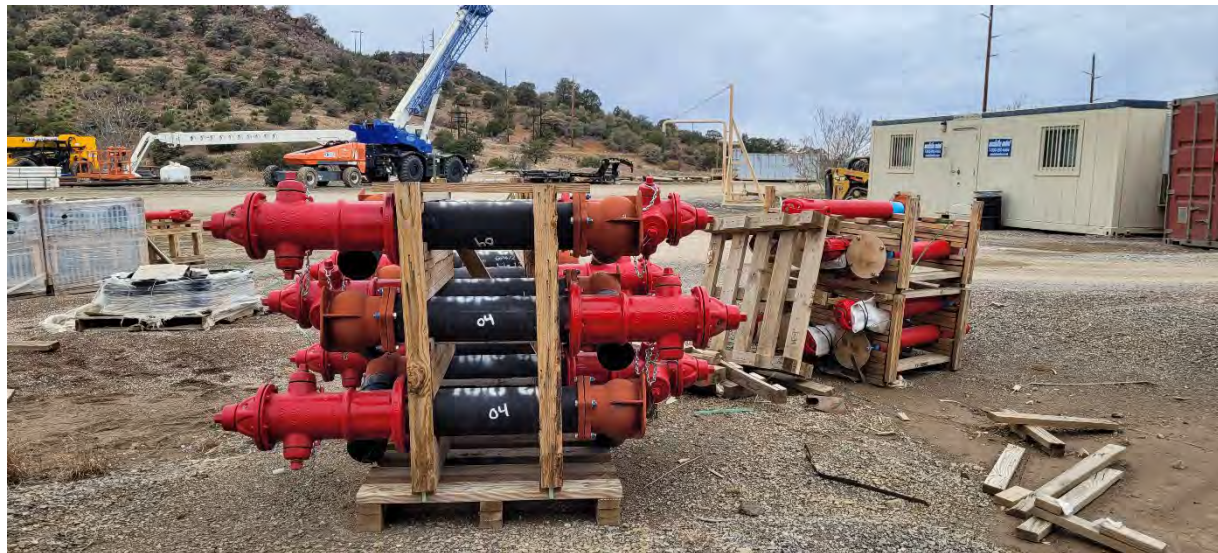
Category	Condition			Comments
	Good	Fair	Poor	
Civil				N/A
Condition of Site	X			See map notes & photos 4 Bldgs historical SW Bldg (gen shab Dn old maps)
Drainage Around Facility	X			
Access to Facility	X			
Building Parking			X	
Fencing or Security			X	
Foundation				
Foundation	X			
Floor Slabs	X			
If process Facility: Cond of equip frnds				
Structure				
Framing: Walls	X			sheds have damage
Framing: Roofs				
Framing: Internal				
If Concrete structure				
Mechanical				
HVAC if present				↓
Water Supply if present				
Waste water if present				
Other utilities if present				
Fire protection if present				
Piping				
if facility is not building				↓
if facility is process				
Electrical				
Power supply				↓
Power distribution				
Lighting				
Other utilities if present				
Architectural				
Condition of Flooring				↓
Wall systems				
roofing				
ceilings				
doors			X	
windows			X	
points of egress

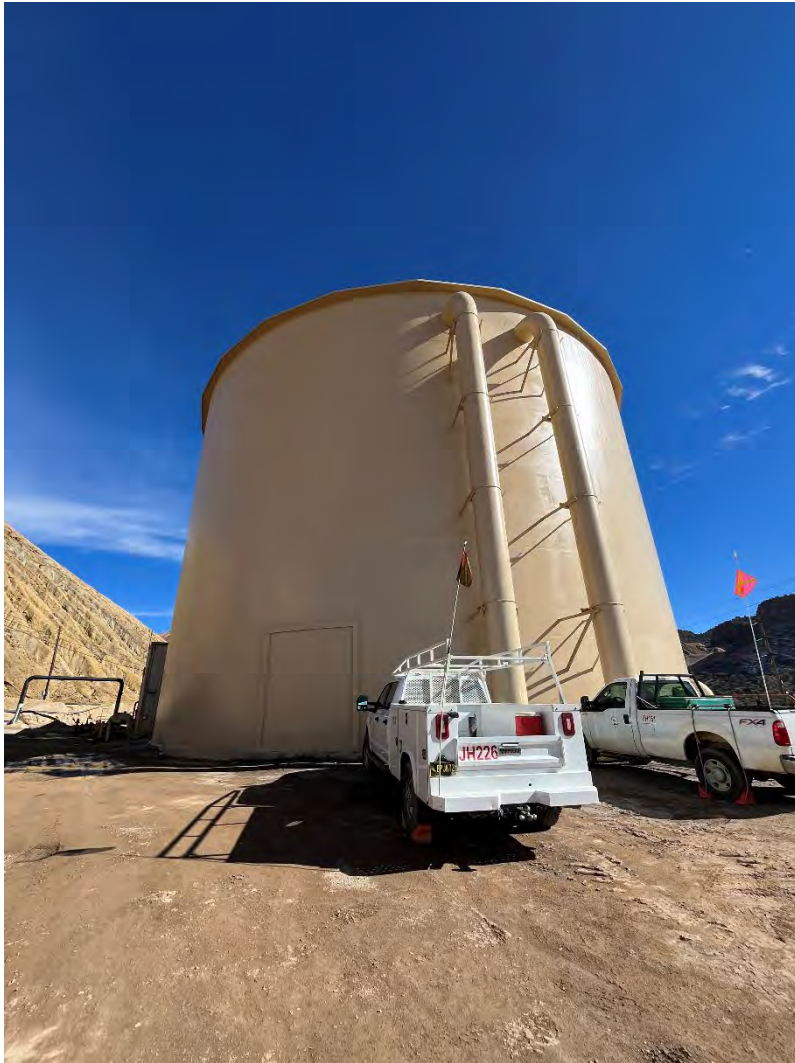
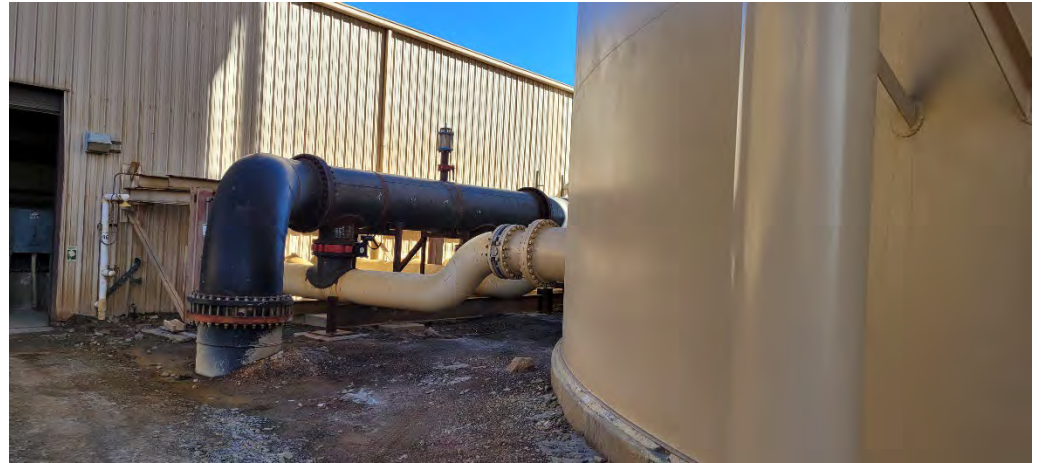
CP-09
External View

Category	Condition			Comments
	Good	Fair	Poor	
Civil				
Condition of Site				All Good, recently constructed
Drainage Around Facility				
Access to Facility				
Building Parking				
Fencing or Security				
Foundation				
Foundation	X			- Minor surface spalling
Floor Slabs				
If process Facility: Cond of equip fnds				
Structure				
Framing: Walls				- Great
Framing: Roofs				
Framing: Internal				
If Concrete structure				
Mechanical				
HVAC if present				
Water Supply if present				
Waste water if present				
Other utilities if present				
Fire protection if present				
Piping				
if facility is not building	X			
if facility is process	X			
Electrical				
Power supply	X			
Power distribution				
Lighting				
Other utilities if present				
Architectural				
Condition of Flooring				N/A ↓
Wall systems				
roofing				
ceilings				
doors				
windows				
points of egress

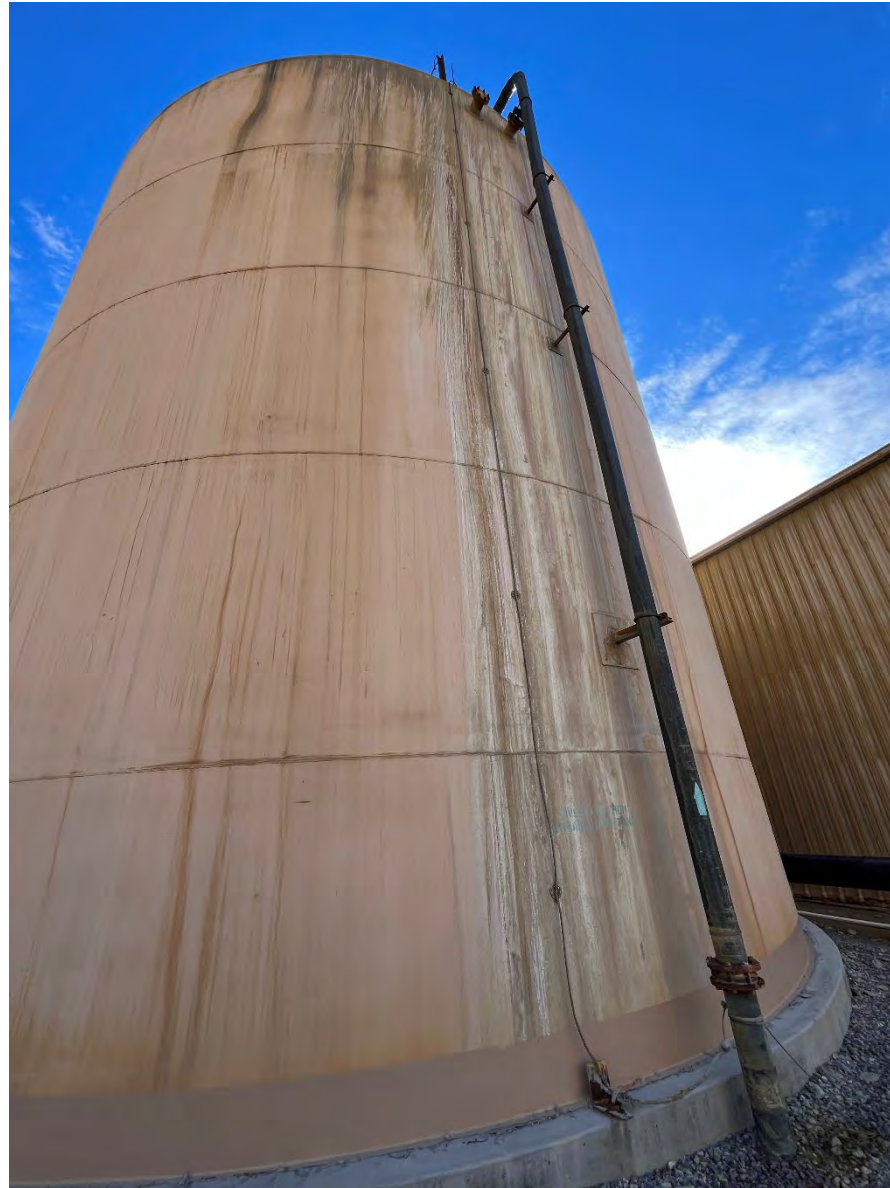
CP-10
External View

Category	Condition			Comments
	Good	Fair	Poor	
Civil				
Condition of Site	✓			
Drainage Around Facility		✓		
Access to Facility	✓			
Building Parking N/A				
Fencing or Security				
Foundation				
Foundation	✓			
Floor Slabs				
If process Facility: Cond of equip fnds	✓			
Structure				
Framing: Walls		✓		Historic leak present IM
Framing: Roofs N/A				
Framing: Internal				
If Concrete structure				
Mechanical				
HVAC if present N/A				
Water Supply if present				
Waste water if present				
Other utilities if present				
Fire protection if present				
Piping				
if facility is not building				This is a tank
if facility is process	✓			
Electrical				
Power supply				
Power distribution				
Lighting				
Other utilities if present				
Architectural				
Condition of Flooring				
Wall systems				
roofing				
ceilings				
doors				
windows				
points of egress

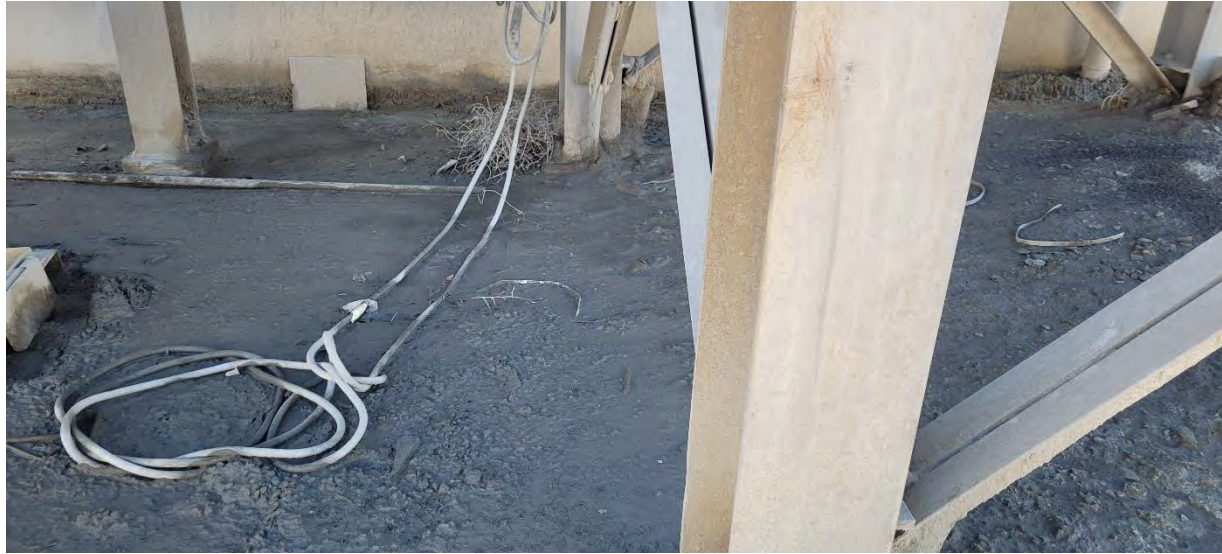
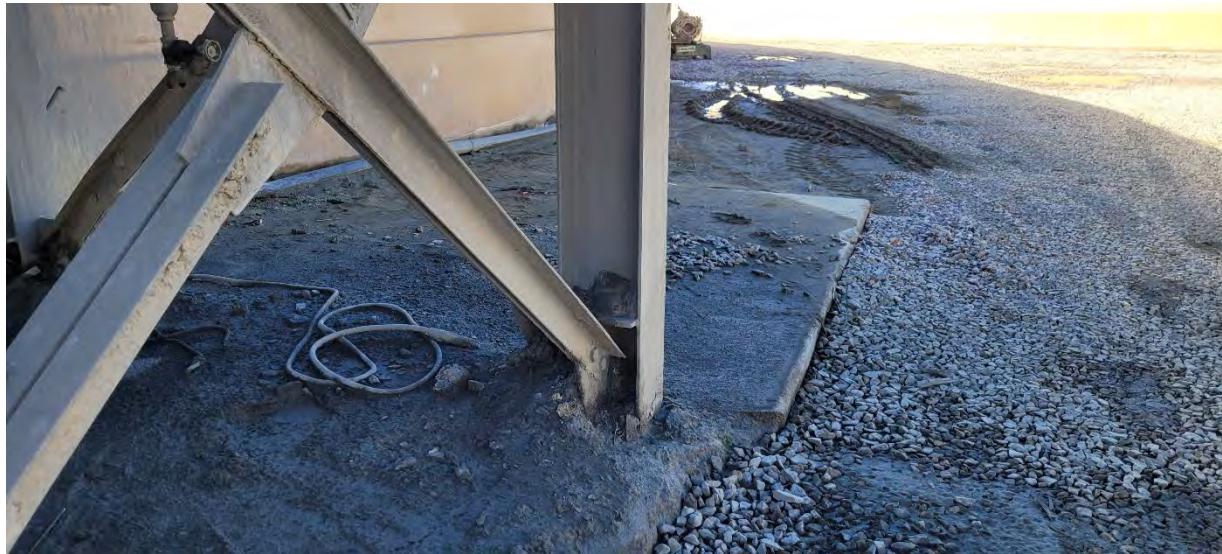
CP-11
External Damage

Category	Condition			Comments
	Good	Fair	Poor	
Civil				
Condition of Site	X			North side pooling badly N/A
Drainage Around Facility		X		
Access to Facility	X			
Building Parking				
Fencing or Security	X			
Foundation				
Foundation	X			
Floor Slabs	X			
If process Facility: Cond of equip fnds				
Structure				
Framing: Walls	X			Minor surface rust @ base N/A ↓
Framing: Roofs				
Framing: Internal				
If Concrete structure				
Mechanical				
HVAC if present				N/A ↓
Water Supply if present				
Waste water if present				
Other utilities if present				
Fire protection if present				
Piping				
if facility is not building if facility is process	X			
Electrical				
Power supply	X			N/A ↓
Power distribution				
Lighting				
Other utilities if present				
Architectural				
Condition of Flooring				N/A ↓
Wall systems				
roofing				
ceilings				
doors				
windows				
points of egress

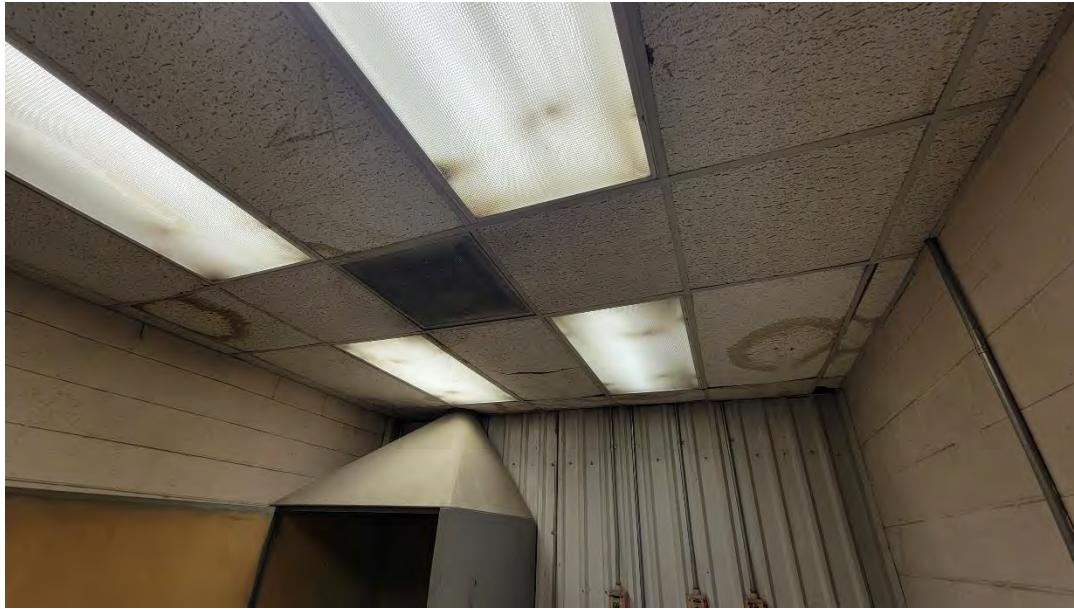
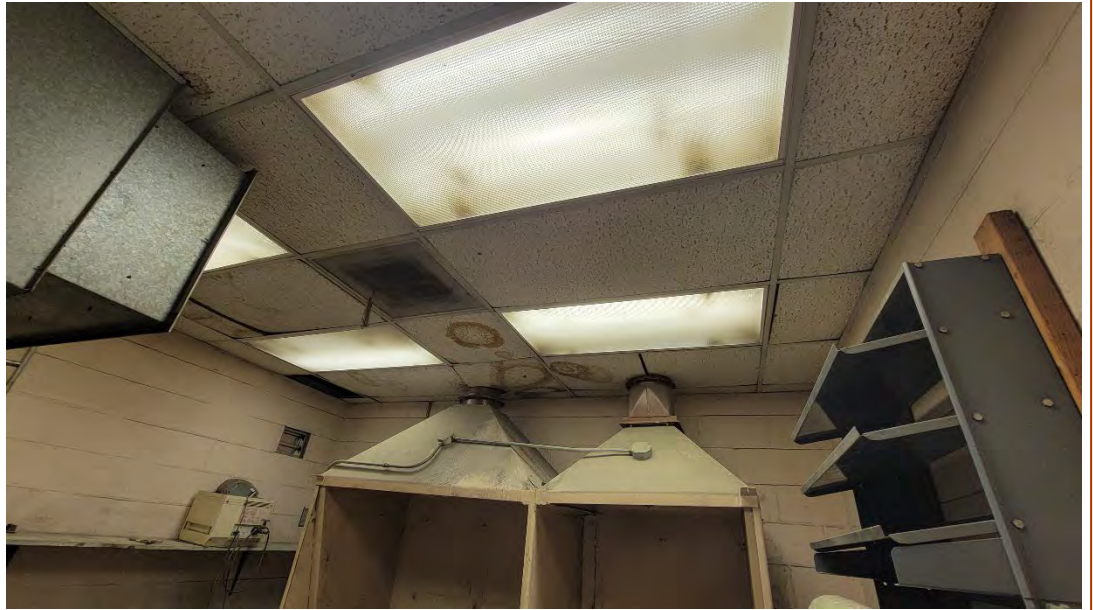
CP-12
Internal Damage

Category	Condition			Comments
	Good	Fair	Poor	
Civil				
Condition of Site	X			Improper Drainage inside
Drainage Around Facility		X		
Access to Facility	X			
Building Parking	X			
Fencing or Security				
Foundation				
Foundation	X			
Floor Slabs	X			
If process Facility: Cond of equip fnds				
Structure				
Framing: Walls	X			
Framing: Roofs		X		
Framing: Internal	X			
If Concrete structure				
Mechanical				
HVAC if present	X			Eye wash stations
Water Supply if present	X			
Waste water if present	X			
Other utilities if present	X			
Fire protection if present	X			
Piping				
if facility is not building				
if facility is process				
Electrical				
Power supply	X			Fume hood vacuum fair + overs
Power distribution	X			
Lighting	X			
Other utilities if present	X			
Architectural				
Condition of Flooring	X			water Damage
Wall systems	X			
roofing		X		
ceilings	X	X		
doors	X			
windows	X			
points of egress	X

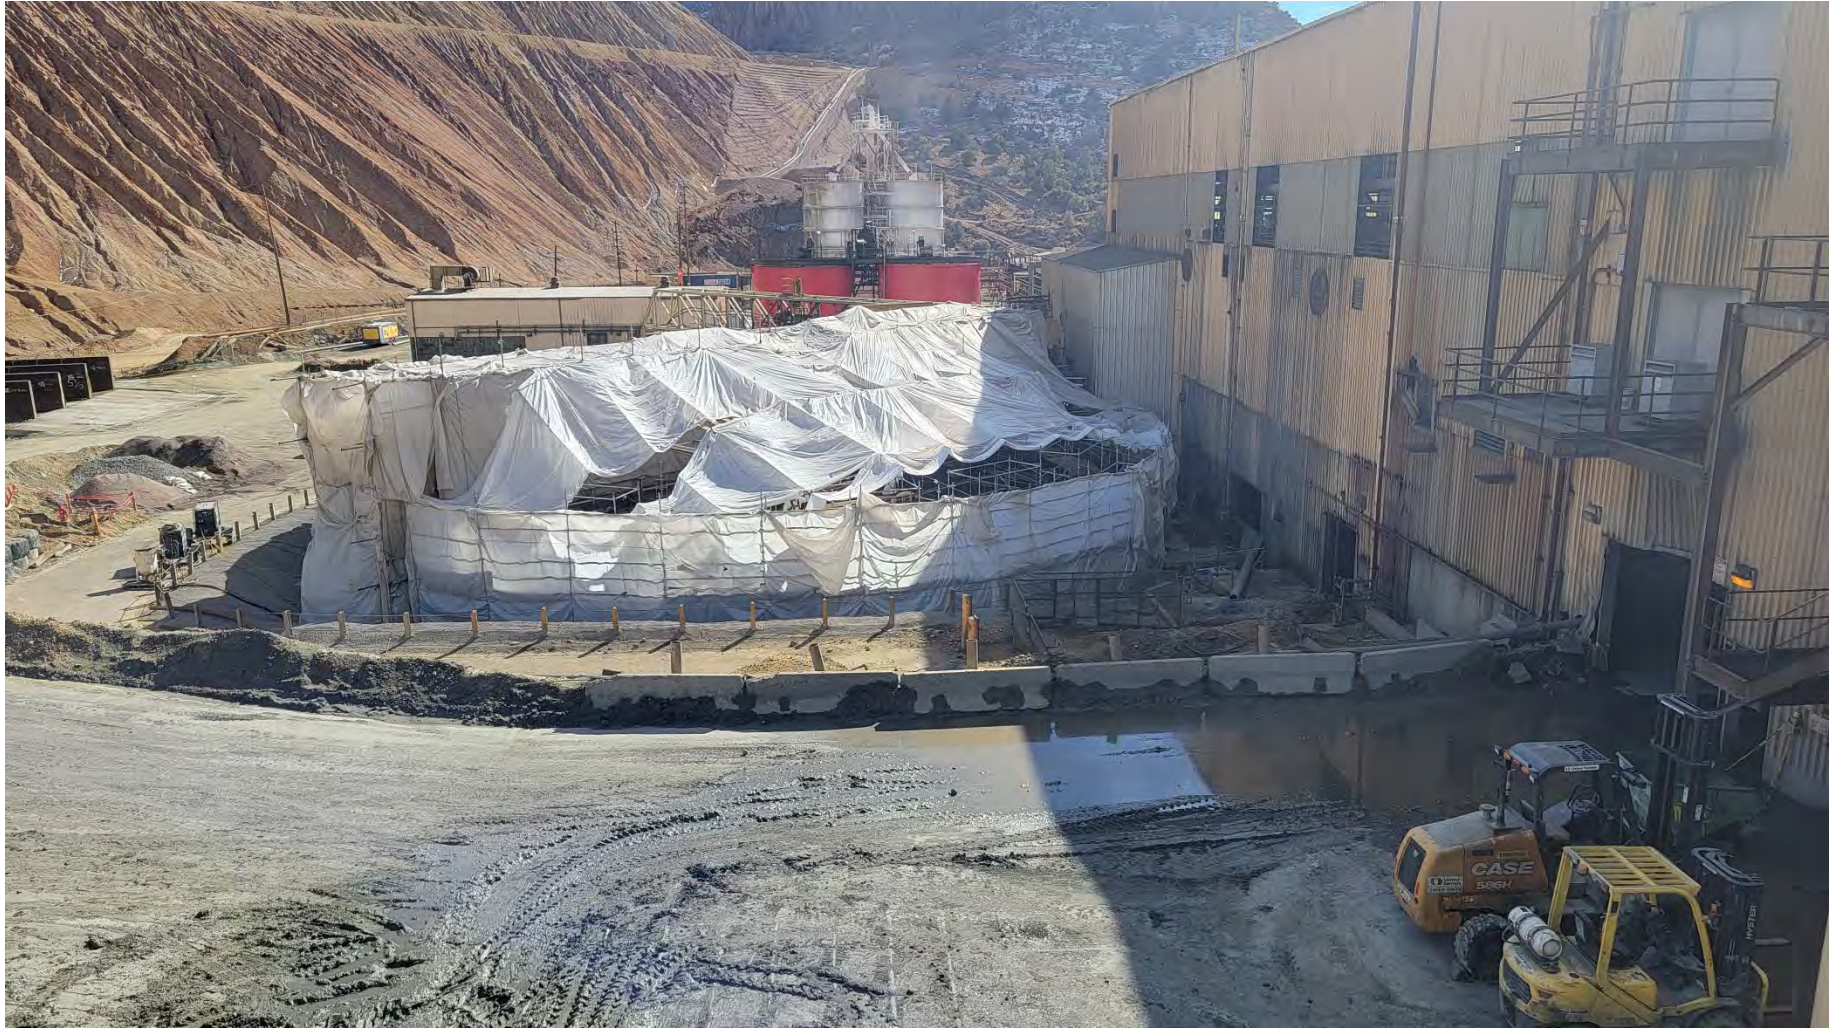
CP-13
External View

Category	Condition			Comments
	Good	Fair	Poor	
Civil				
Condition of Site				Completely zoned off -> Heavy construction occurring
Drainage Around Facility				
Access to Facility				
Building Parking				
Fencing or Security				
Foundation				
Foundation				
Floor Slabs				
If process Facility: Cond of equip fnds				
Structure				
Framing: Walls				
Framing: Roofs				
Framing: Internal				
If Concrete structure				
Mechanical				
HVAC if present				
Water Supply if present				
Waste water if present				
Other utilities if present				
Fire protection if present				
Piping				
if facility is not building				
if facility is process				
Electrical				
Power supply				
Power distribution				
Lighting				
Other utilities if present				
Architectural				
Condition of Flooring				
Wall systems				
roofing				
ceilings				
doors				
windows				
points of egress

under maintenance

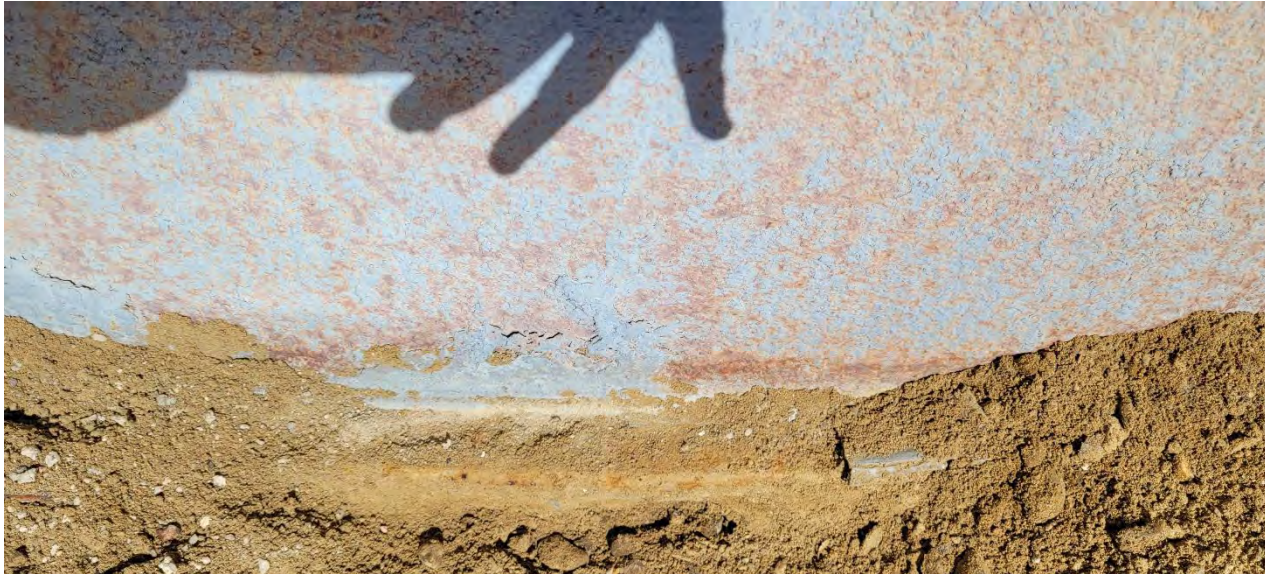
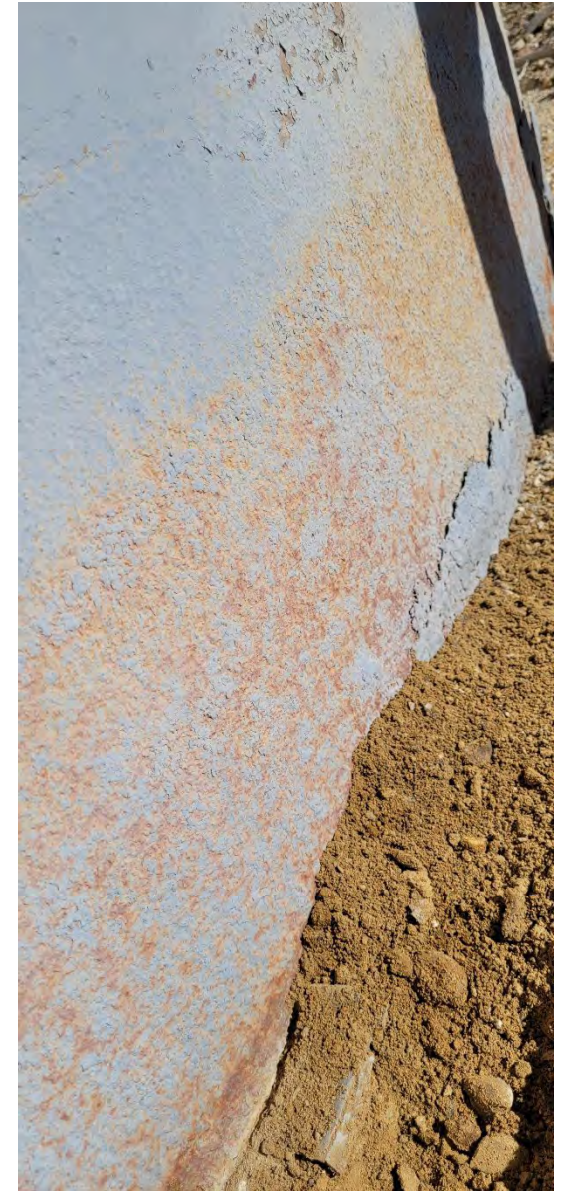
**CP-15 & CP-16
External Damage**

Category	Condition			Comments
	Good	Fair	Poor	
Civil				
Condition of Site	✓			N/A
Drainage Around Facility	✓			
Access to Facility	✓			
Building Parking				
Fencing or Security	✓			
Foundation				
Foundation	✓			
Floor Slabs	✓			
If process Facility: Cond of equip fnds				
Structure				
Framing: Walls				N/A ↓ Steel tanks mmos surface rust outside
Framing: Roofs				
Framing: Internal				
If Concrete structure				
Mechanical				
HVAC if present				↓
Water Supply if present				
Waste water if present				
Other utilities if present				
Fire protection if present				
Piping				
if facility is not building				↓
if facility is process				
Electrical				
Power supply	X			N/A ↓
Power distribution				
Lighting				
Other utilities if present				
Architectural				
Condition of Flooring				N/A ↓
Wall systems				
roofing				
ceilings				
doors				
windows				
points of egress

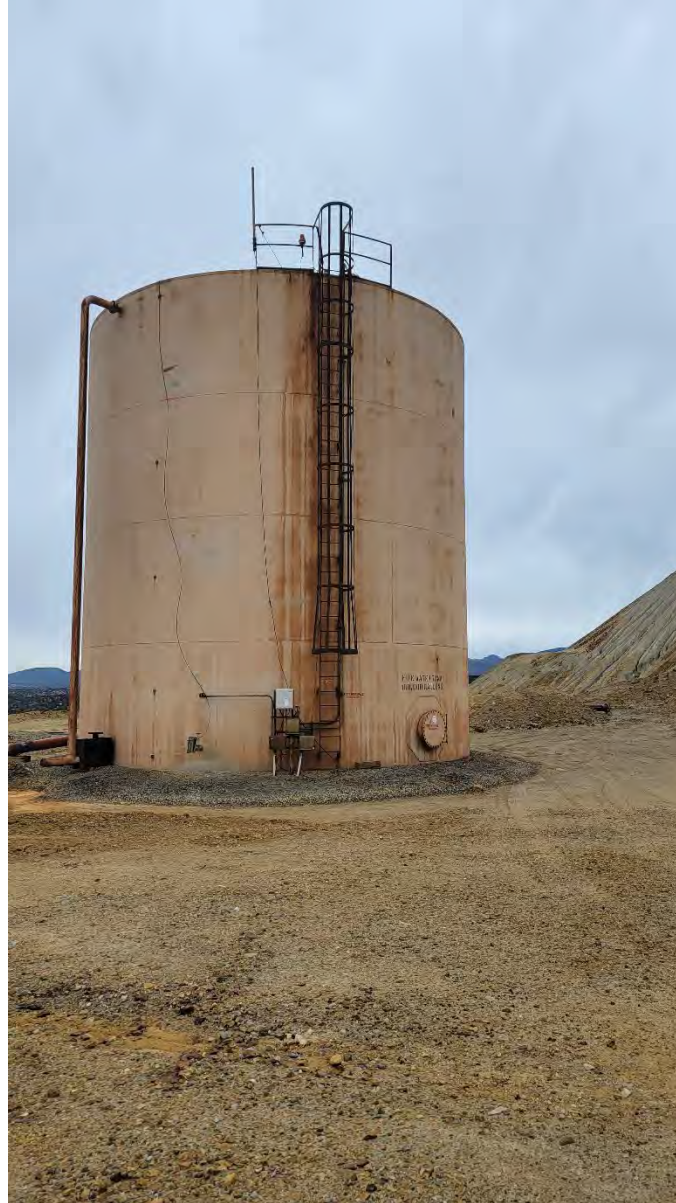
CP-17
External View

Category	Condition			Comments
	Good	Fair	Poor	
Civil				
Condition of Site	X			
Drainage Around Facility	X			
Access to Facility	X			
Building Parking	X			
Fencing or Security				
Foundation				
Foundation				
Floor Slabs				rn nn
If process Facility: Cond of equip fnds				
Structure				
Framing: Walls	X			
Framing: Roofs	X			
Framing: Internal				
If Concrete structure				
Mechanical				
HVAC if present				
Water Supply if present				
Waste water if present				
Other utilities if present				
Fire protection if present				
Piping				
if facility is not building	X			
if facility is process				
Electrical				
Power supply				
Power distribution				
Lighting				
Other utilities if present				
Architectural				
Condition of Flooring				
Wall systems				
roofing				
ceilings				
doors				
windows				
points of egress

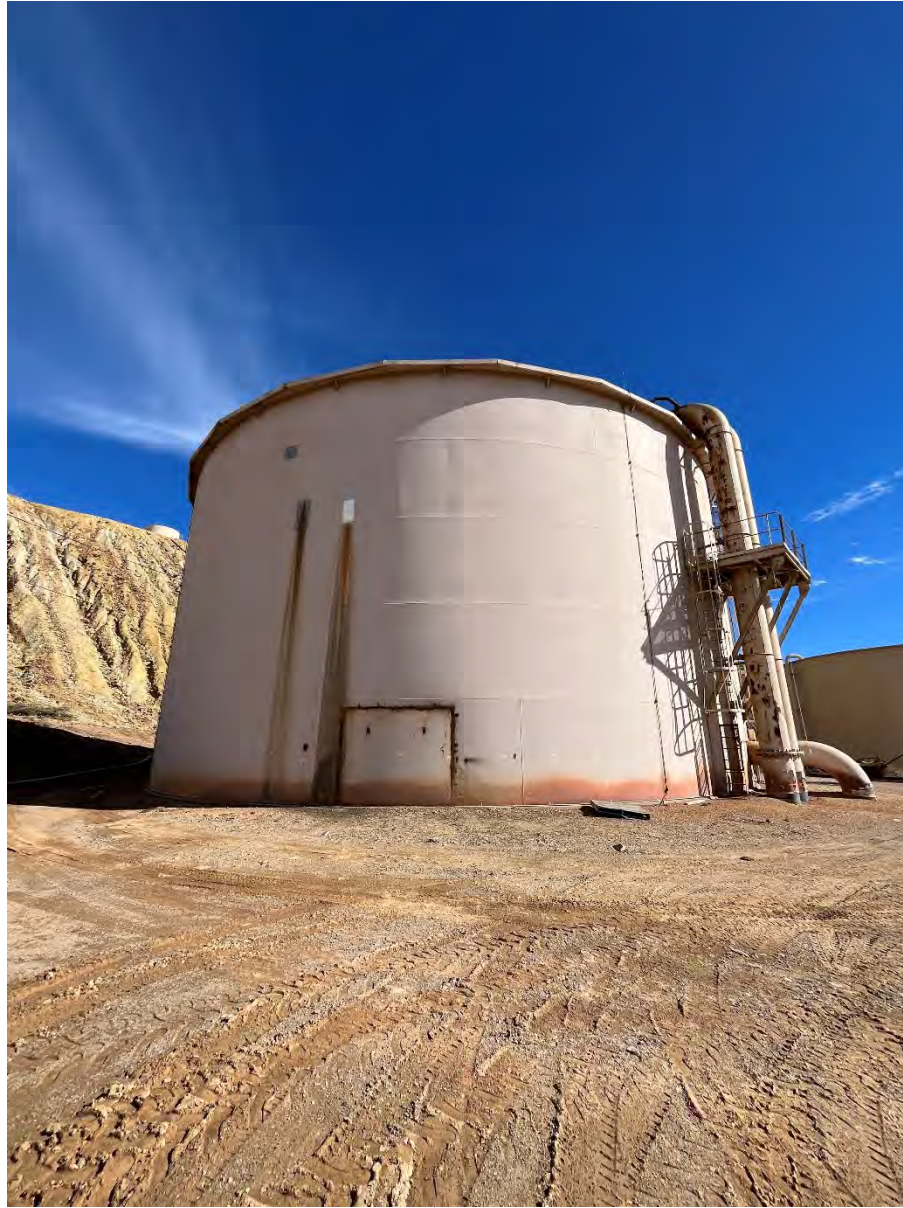
CP-18
External View

Category	Condition			Comments
	Good	Fair	Poor	
Civil				
Condition of Site	X			
Drainage Around Facility	X			
Access to Facility	X			
Building Parking	X			
Fencing or Security				
Foundation				
Foundation	X			
Floor Slabs	X			
If process Facility: Cond of equip fnds				
Structure				
Framing: Walls		X		Note historical leaks [O]
Framing: Roofs				
Framing: Internal				
If Concrete structure				
Mechanical				
HVAC if present				N/A ↓
Water Supply if present				
Waste water if present				
Other utilities if present				
Fire protection if present				
Piping				
if facility is not building	X			Surface rust
if facility is process	X			
Electrical				
Power supply				N/A ↓
Power distribution				
Lighting				
Other utilities if present				
Architectural				
Condition of Flooring				N/A ↓
Wall systems				
roofing				
ceilings				
doors				
windows				
points of egress

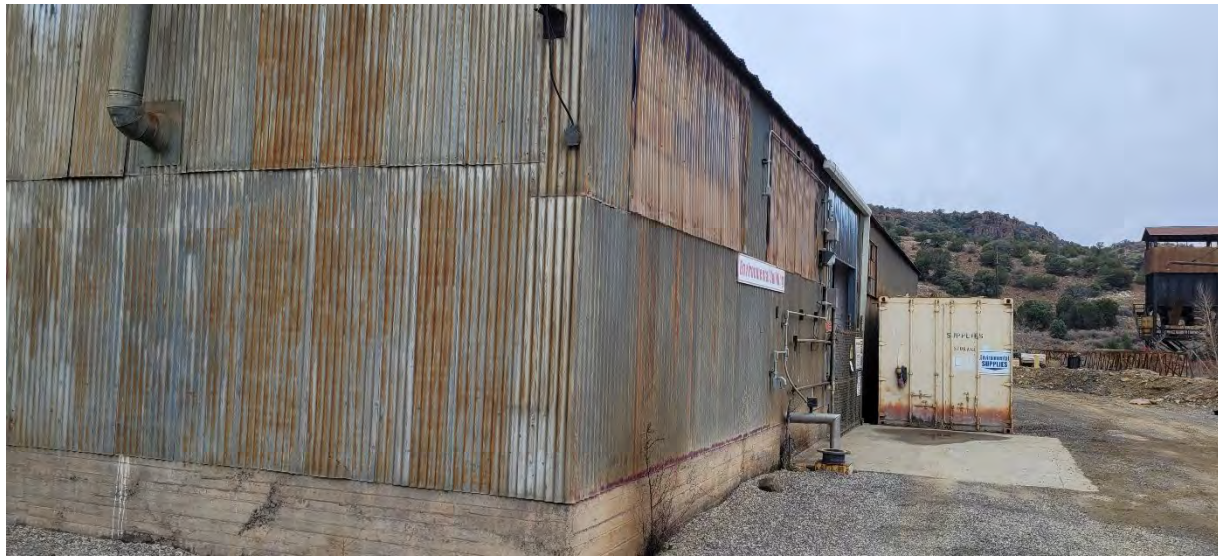
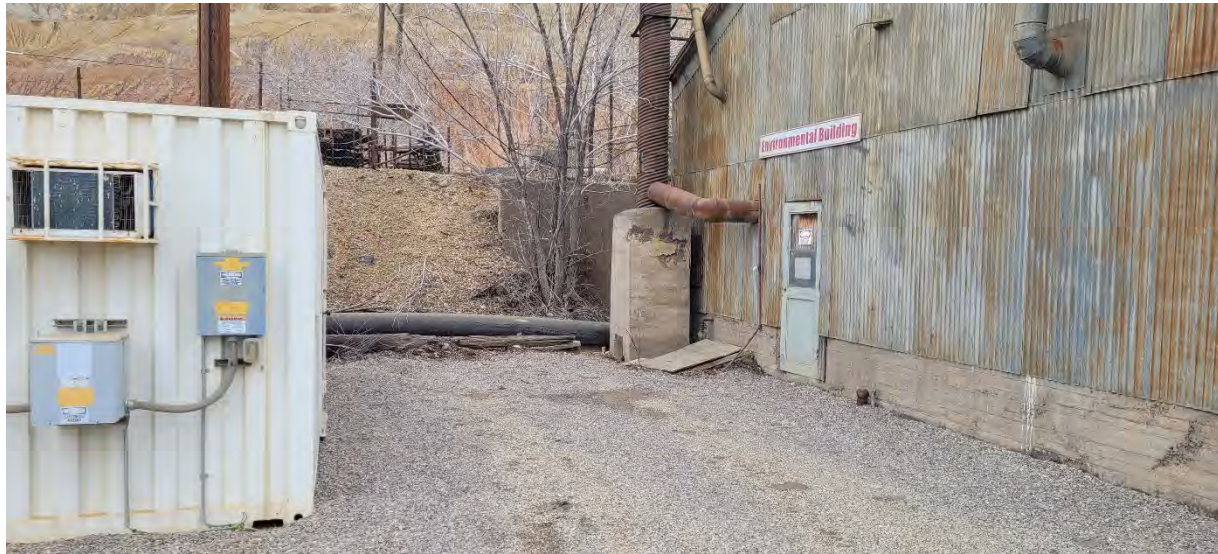
CP-19
External View

Category	Condition			Comments
	Good	Fail	Poor	
Civil				N/A
Condition of Site	X			Warehouse - historical Bldg
Drainage Around Facility	X			
Access to Facility	X			
Building Parking				
Fencing or Security	X			
Foundation				
Foundation	X			
Floor Slabs	X			
If process Facility: Cond of equip fnds				
Structure				
Framing: Walls		X		Tim outside sheeting
Framing: Roofs	X			
Framing: Internal	X			
If Concrete structure				
Mechanical				
HVAC if present	X			one loan heater
Water Supply if present				
Waste water if present				
Other utilities if present				
Fire protection if present				
Piping				
if facility is not building				↓
if facility is process				
Electrical				
Power supply				↓
Power distribution				
Lighting				
Other utilities if present				
Architctural				
Condition of Flooring	X			
Wall systems		X		
roofing	X			
ceilings	X			
doors		X		
windows			X	
points of egress		X

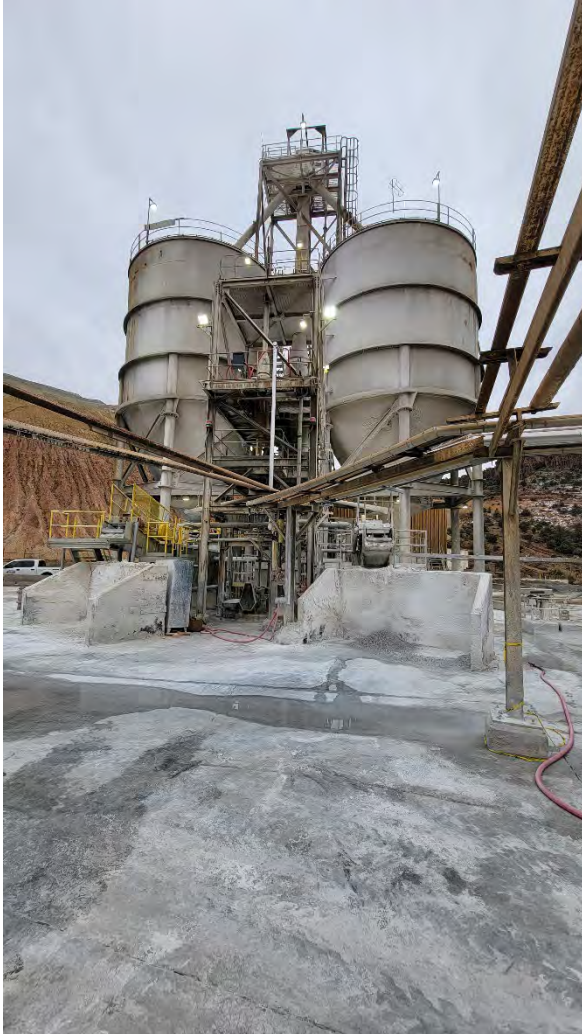
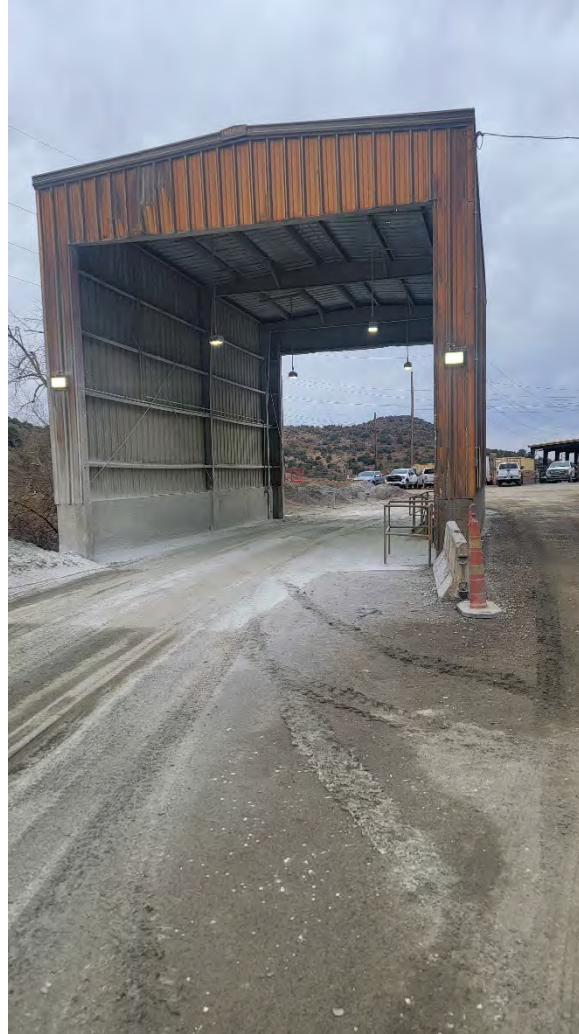
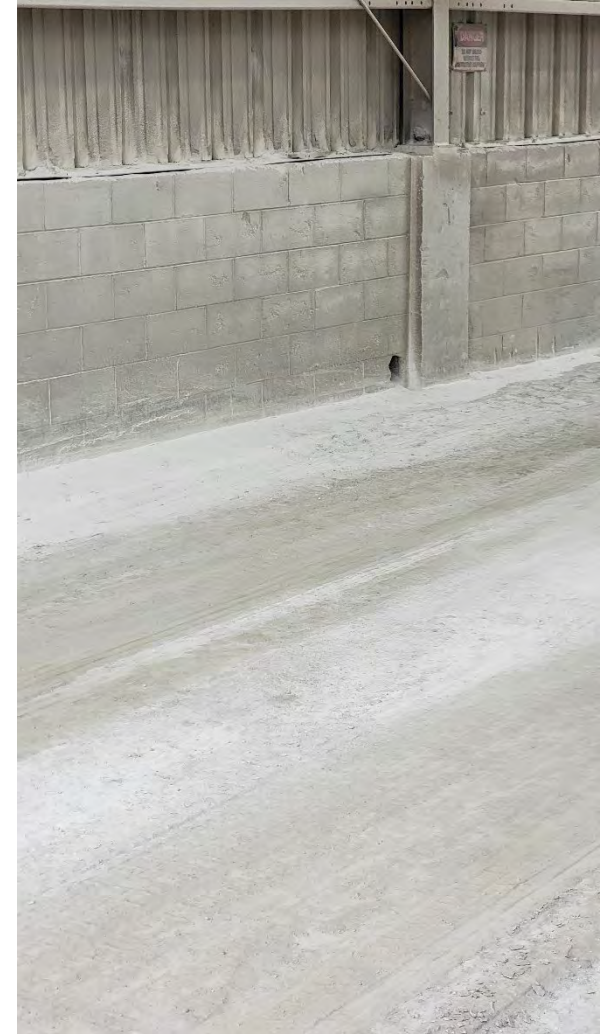
CP-22
External View & Damage

Category	Condition			Comments
	Good	Fair	Poor	
Civil				
Condition of Site	X			
Drainage Around Facility	X			
Access to Facility	X			
Building Parking				
Fencing or Security				
Foundation				
Foundation	X			
Floor Slabs	X			
If process Facility: Cond of equip frnds				
Structure				
Framing: Walls	X			
Framing: Roofs	X			
Framing: Internal	X			
If Concrete structure				
Mechanical				
HVAC if present				
Water Supply if present				
Waste water if present				
Other utilities if present				
Fire protection if present				
Piping				
if facility is not building				
if facility is process				
Electrical				
Power supply	X			
Power distribution	X			
Lighting	X			
Other utilities if present				
Architectural				
Condition of Flooring				
Wall systems				
roofing				
ceilings				
doors				
windows				
points of egress
