PROJECT: 200450-001	TASK 03
PREPARED BY:

PMLU BUILDING INSPECTION FORM

Freeport-McMoran Chino Mine

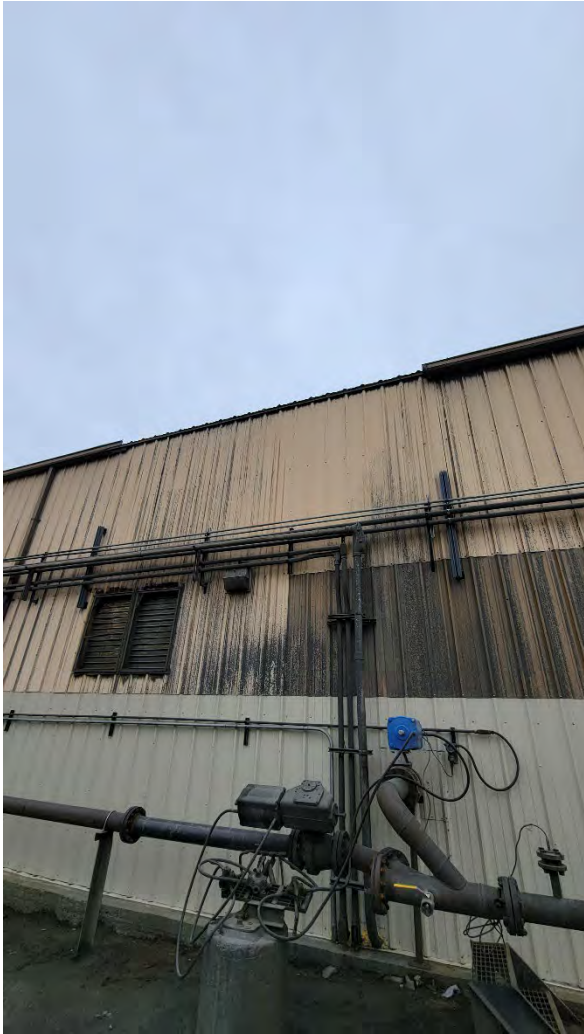
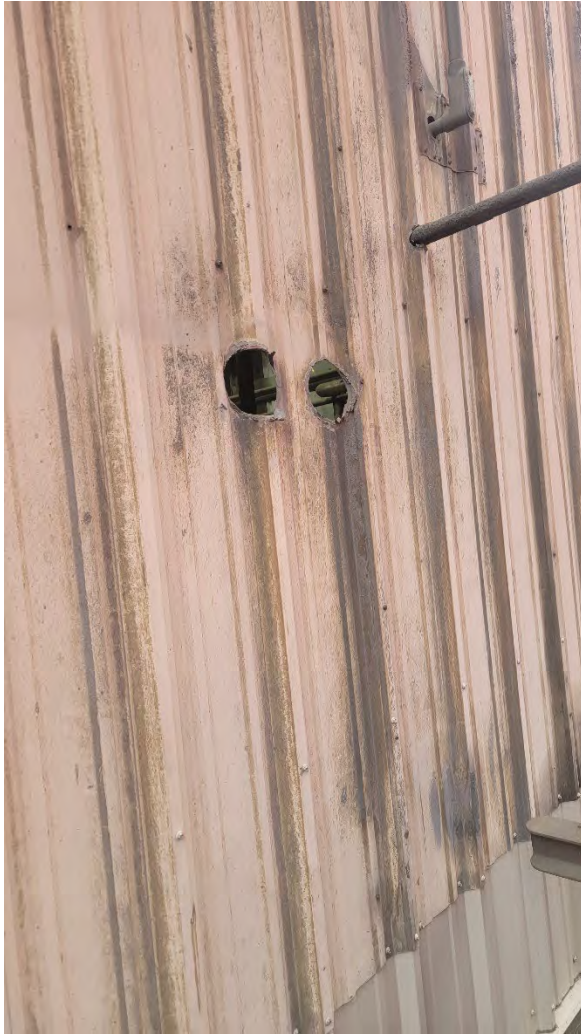
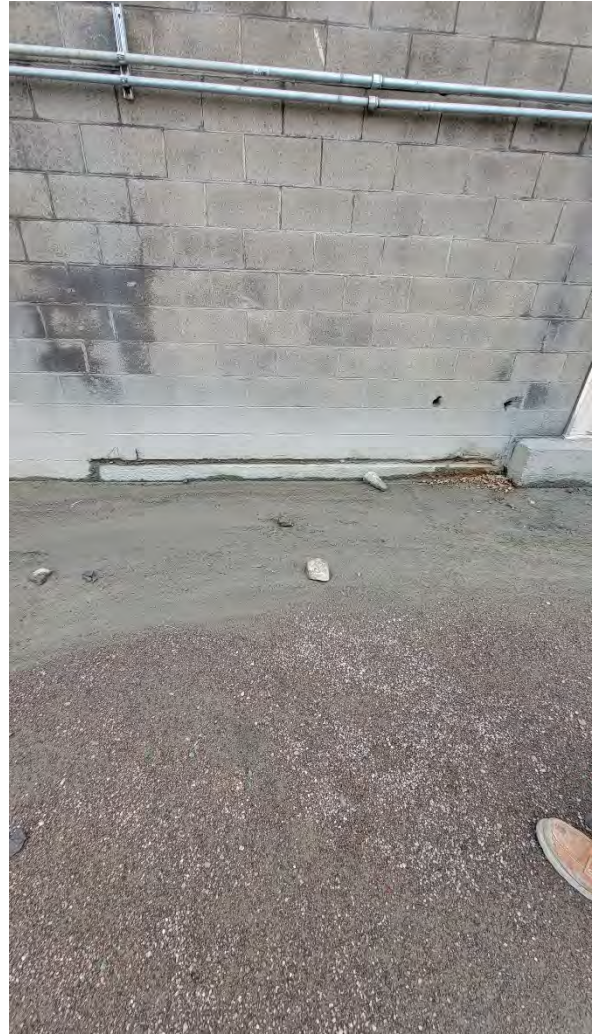
CP-25
External View & Damage

Category	Condition			Comments
	Good	Fair	Poor	
Civil				
Condition of Site	X			missing gutter
Drainage Around Facility		X		
Access to Facility	X			
Building Parking				
Fencing or Security				
Foundation				
Foundation	X			
Floor Slabs	X			
If process Facility: Cond of equip fnds				
Structure				
Framing: Walls	X			
Framing: Roofs	X			
Framing: Internal	X			
If Concrete structure				
Mechanical				
HVAC if present				
Water Supply if present				
Waste water if present				
Other utilities if present				
Fire protection if present				
Piping				
if facility is not building				
if facility is process				
Electrical				
Power supply				
Power distribution				
Lighting				
Other utilities if present				
Architectural				
Condition of Flooring	X			
Wall systems				
roofing				
ceilings				
doors	X			
windows				
points of egress	X

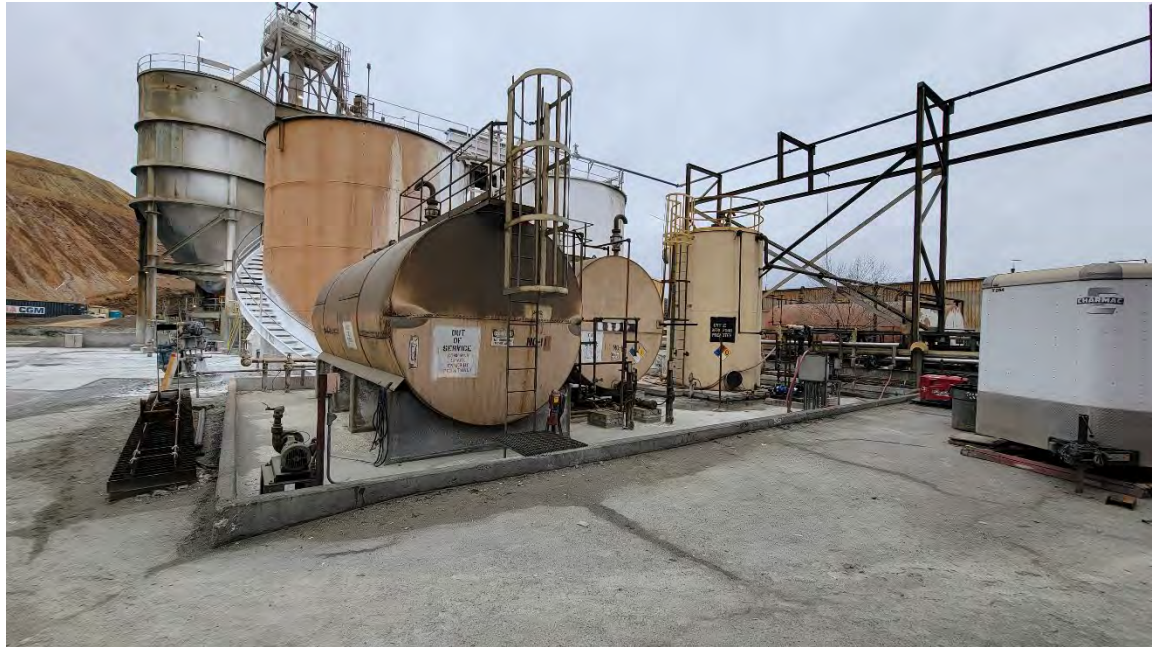
CP-27
External View & Damage

Category	Condition			Comments
	Good	Fair	Poor	
Civil				
Condition of Site	X			nn
Drainage Around Facility	X			
Access to Facility	X			
Building Parking				
Fencing or Security				
Foundation				
Foundation	X			
Floor Slabs	X			
If process Facility: Cond of equip fnds				
Structure				
Framing: Walls	X			Holes inside of tank
Framing: Roofs				
Framing: Internal				
If Concrete structure				
Mechanical				
HVAC if present				
Water Supply if present				
Waste water if present				
Other utilities if present				
Fire protection if present				
Piping				
if facility is not building				
if facility is process				
Electrical				
Power supply				
Power distribution				
Lighting				
Other utilities if present				
Architectural				
Condition of Flooring				
Wall systems				
roofing				
ceilings				
doors				
windows				
points of egress

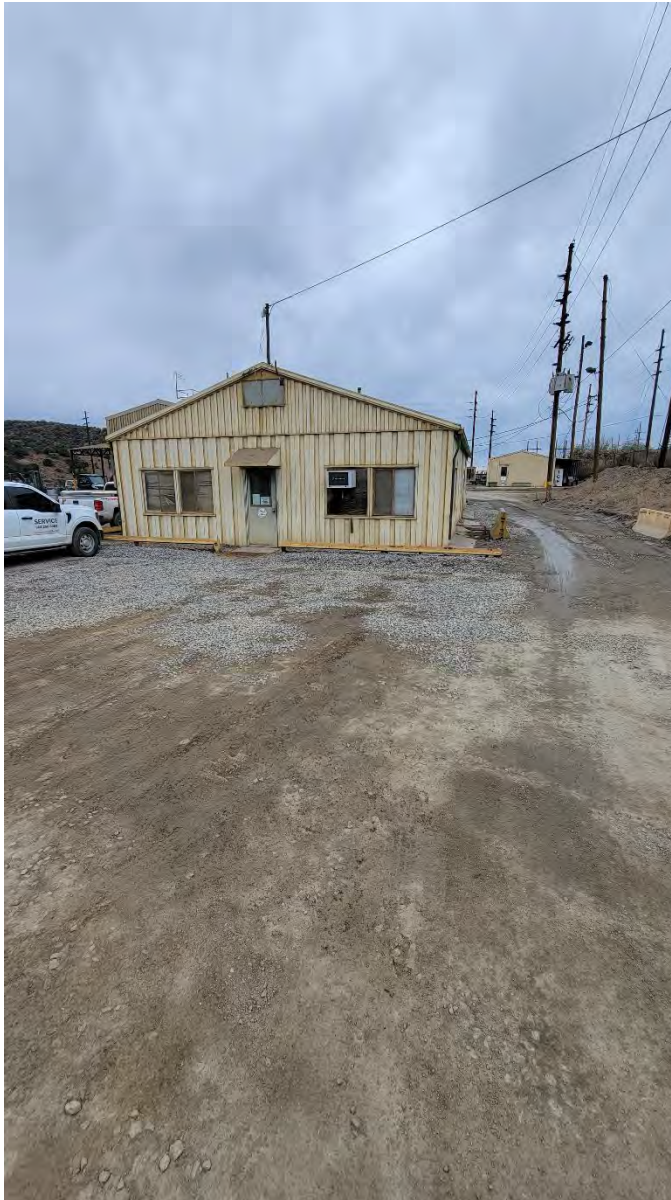
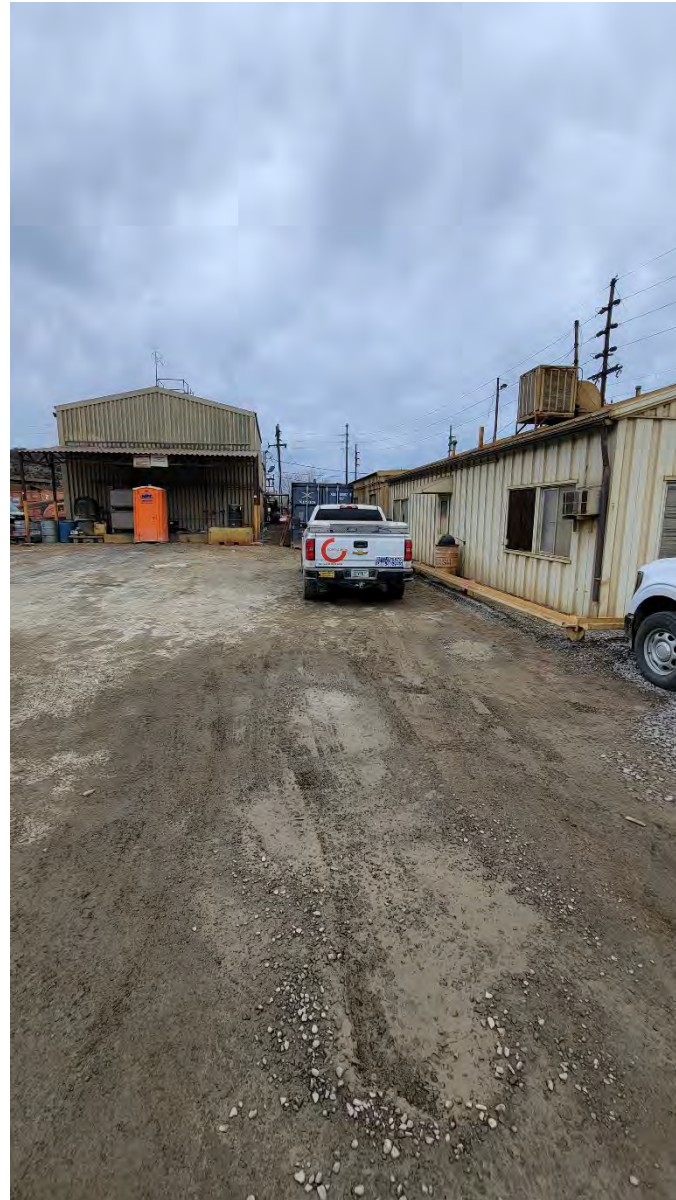
CP-28
External View

Category	Condition			Comments
	Good	Fair	Poor	
Civil				
Condition of Site	X			Roofing between buildings
Drainage Around Facility		X		
Access to Facility	X			
Building Parking	X			
Fencing or Security				
Foundation				
Foundation		X		Cracks in foundations and flooring
Floor Slabs		X		
If process Facility: Cond of equip fnds				
Structure				
Framing: Walls	X			
Framing: Roofs	X			
Framing: Internal	X			
If Concrete structure				
Mechanical				
HVAC if present				n
Water Supply if present	X			
Waste water if present	X			n
Other utilities if present				
Fire protection if present				
Piping				
if facility is not building				
if facility is process				
Electrical				
Power supply	X			
Power distribution	X			
Lighting	X			
Other utilities if present				
Architectural				
Condition of Flooring	X			
Wall systems	X			
roofing	X			
ceilings	X			
doors	X			
windows	X			
points of egress	X

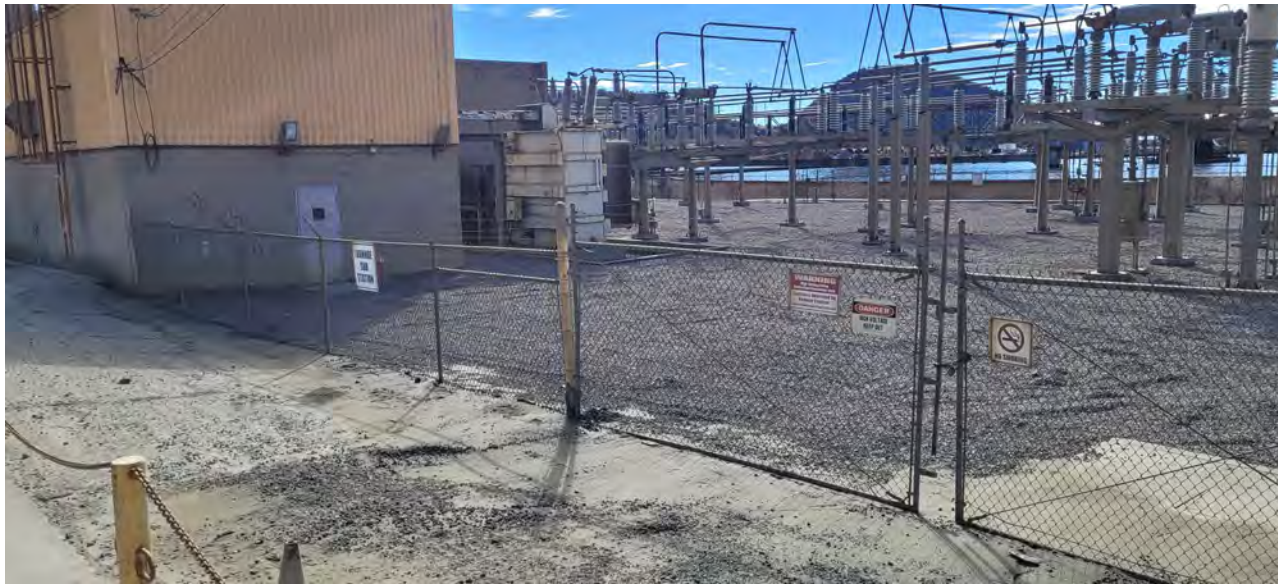
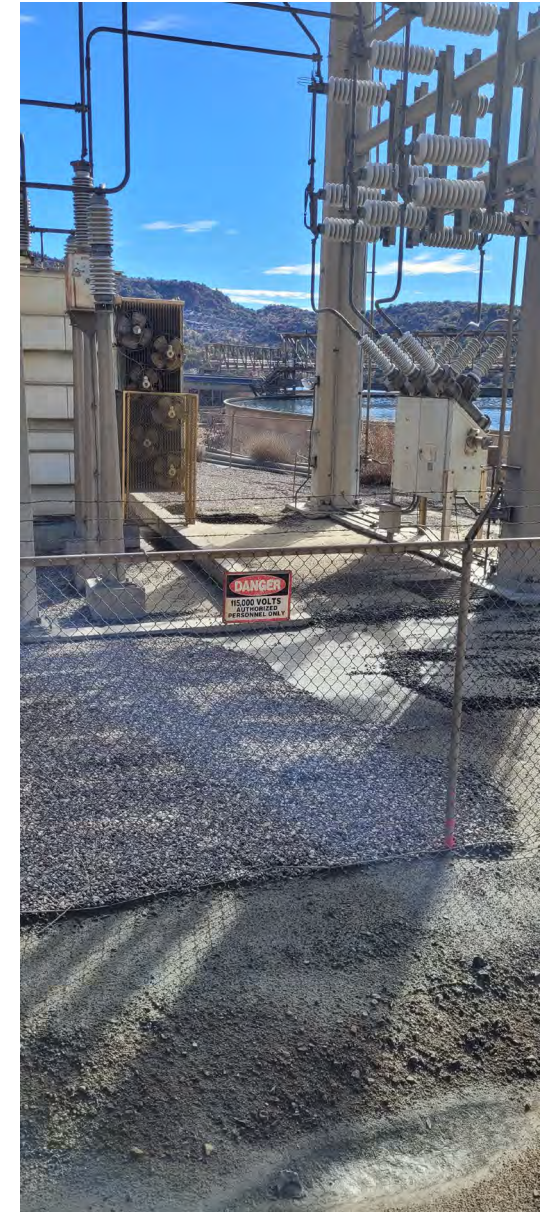
CP-31
External View

Category	Condition			Comments
	Good	Fair	Poor	
Civil				
Condition of Site	X			No entry photo inspect from outside
Drainage Around Facility	X			
Access to Facility	X			
Building Parking				
Fencing or Security	X			
Foundation				
Foundation	X			- plenty of clearance between bolts and concrete edge N/A
Floor Slabs				
If process Facility: Cond of equip fnds				
Structure				
Framing: Walls				N/A
Framing: Roofs				
Framing: Internal				
If Concrete structure				
Mechanical				
HVAC if present				↓
Water Supply if present				
Waste water if present				
Other utilities if present				
Fire protection if present				
Piping				
if facility is not building	X			
if facility is process				
Electrical				
Power supply	X			N/A
Power distribution	X			
Lighting				
Other utilities if present				
Architectural				
Condition of Flooring				↓
Wall systems				
roofing				
ceilings				
doors				
windows				
points of egress

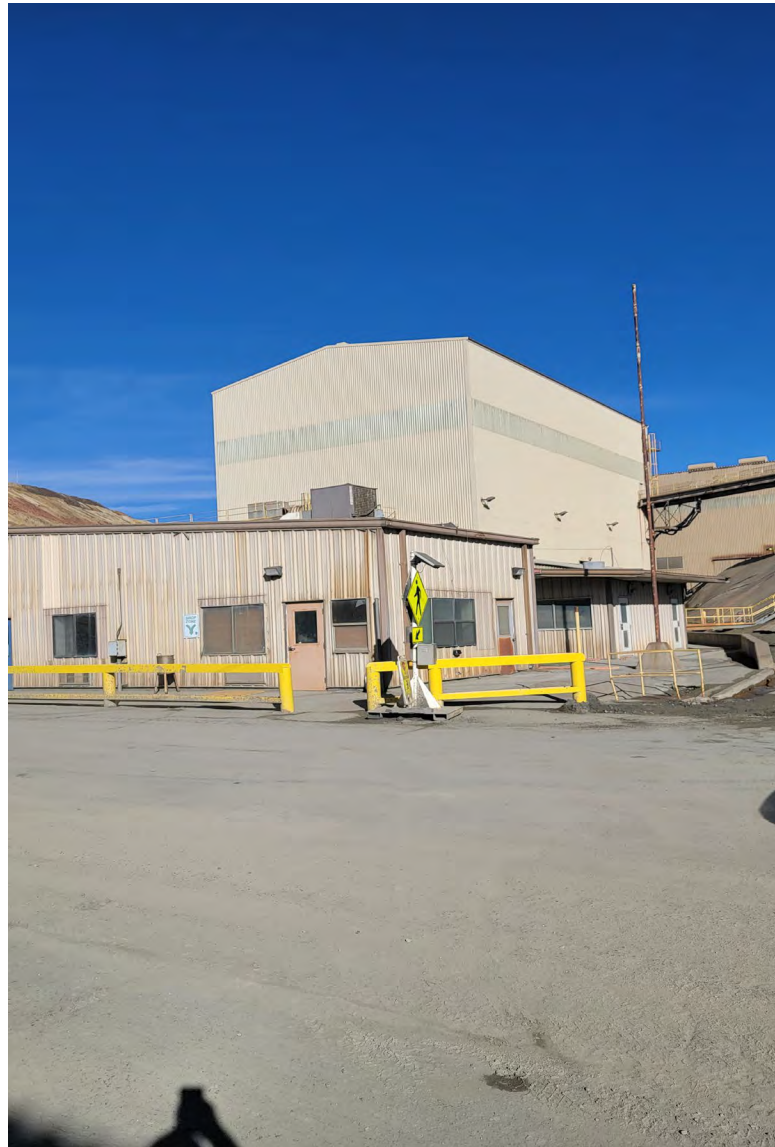
CP-32
External View

Category	Condition			Comments
	Good	Fair	Poor	
Civil				
Condition of Site	X			large Drainage issue up front na
Drainage Around Facility		X		
Access to Facility	X			
Building Parking				
Fencing or Security				
Foundation				
Foundation				cannot see foundation
Floor Slabs				
If process Facility: Cond of equip fnds				
Structure				
Framing: Walls		X		minor cracks, hole in wall, rusted siding
Framing: Roofs				
Framing: Internal				
If Concrete structure				
Mechanical				
HVAC if present				na
Water Supply if present	X			
Waste water if present	X			
Other utilities if present				
Fire protection if present				
Piping				
if facility is not building				
if facility is process				
Electrical				
Power supply	X			
Power distribution	X			
Lighting	X			
Other utilities if present				
Architectural				
Condition of Flooring				doors rusted
Wall systems				
roofing	X			
ceilings	X			
doors		X		
windows				
points of egress	X

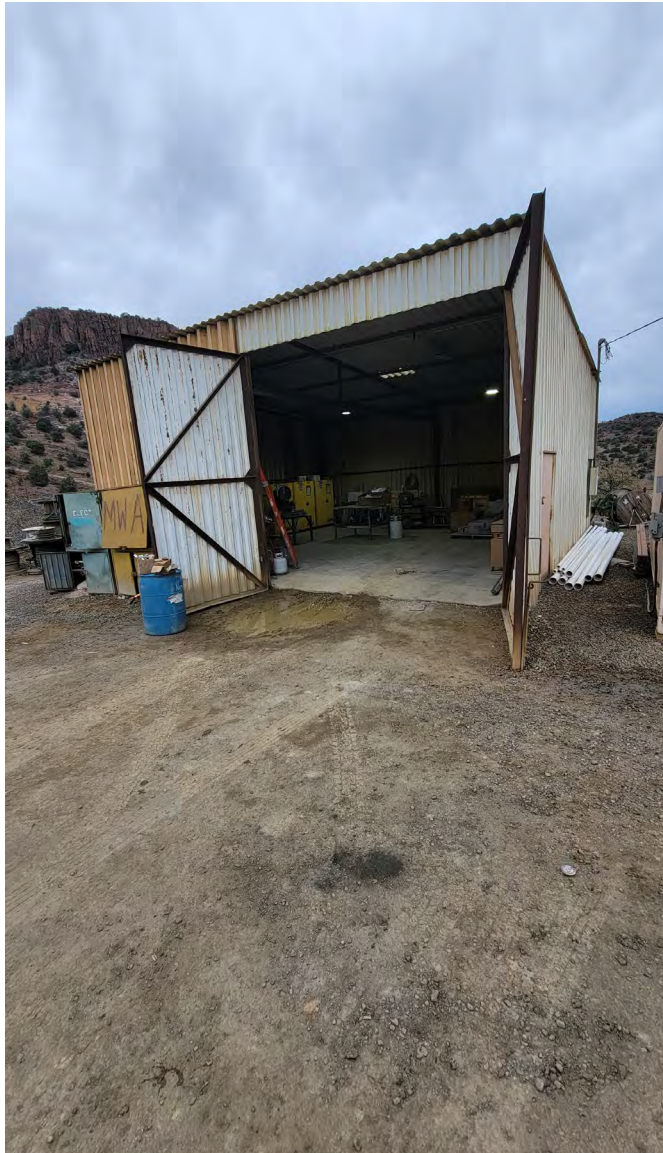
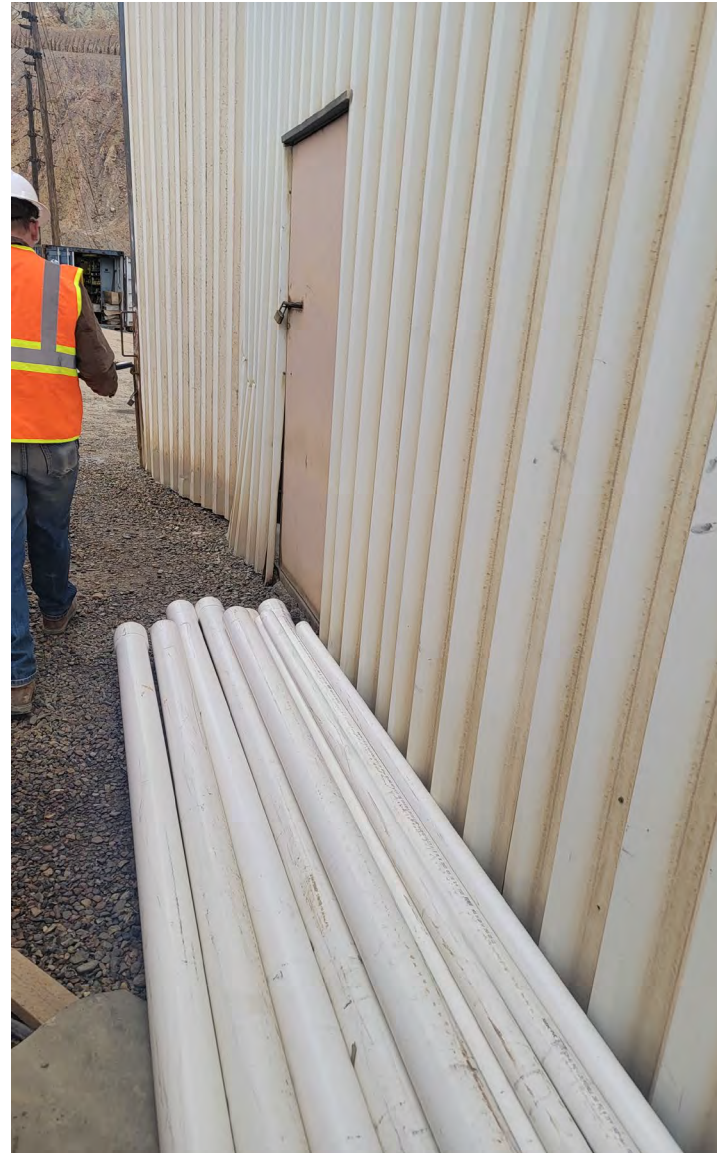
CP-34
External View

Category	Condition			Comments
	Good	Fair	Poor	
Civil				
Condition of Site	X			
Drainage Around Facility	X			
Access to Facility	X			
Building Parking	X			
Fencing or Security				
Foundation				
Foundation	X			
Floor Slabs	X			
If process Facility: Cond of equip fnds				
Structure				
Framing: Walls	X	V		loose site Annual
Framing: Roofs	X			
Framing: Internal	X			
If Concrete structure				
Mechanical				
HVAC if present				
Water Supply if present				
Waste water if present				
Other utilities if present				
Fire protection if present				
Piping				
if facility is not building				
if facility is process				
Electrical				
Power supply	X			
Power distribution	X			
Lighting	X			
Other utilities if present				
Architectural				
Condition of Flooring				
Wall systems				
roofing				
ceilings				
doors				
windows				
points of egress

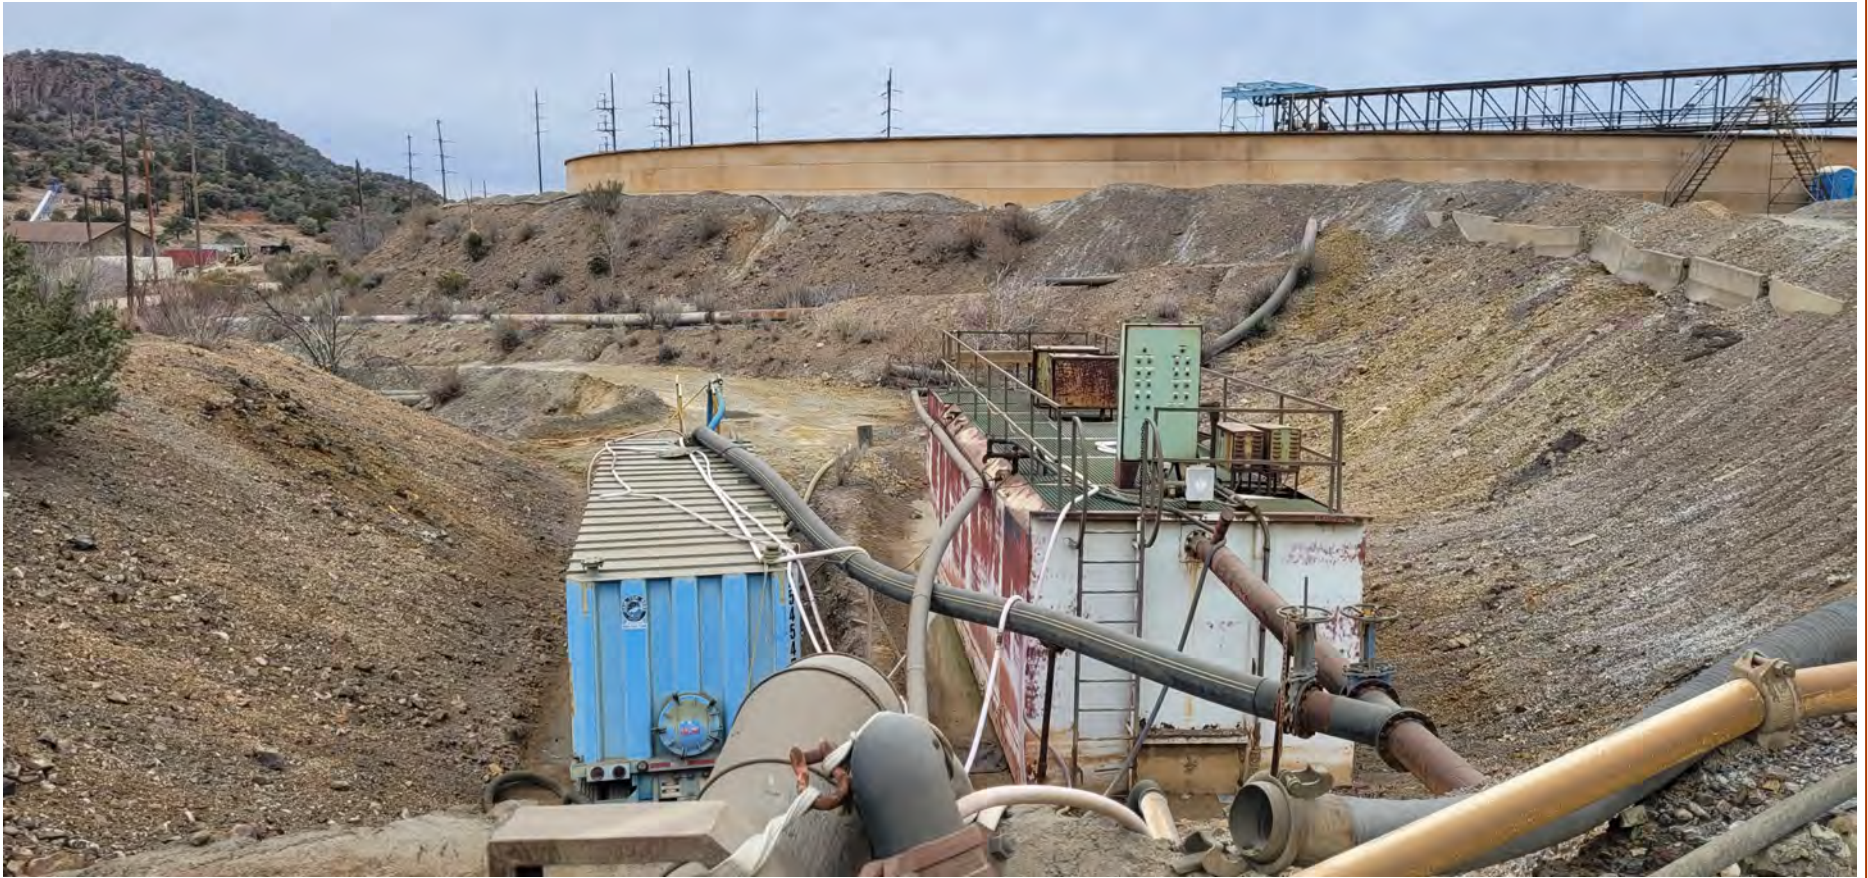
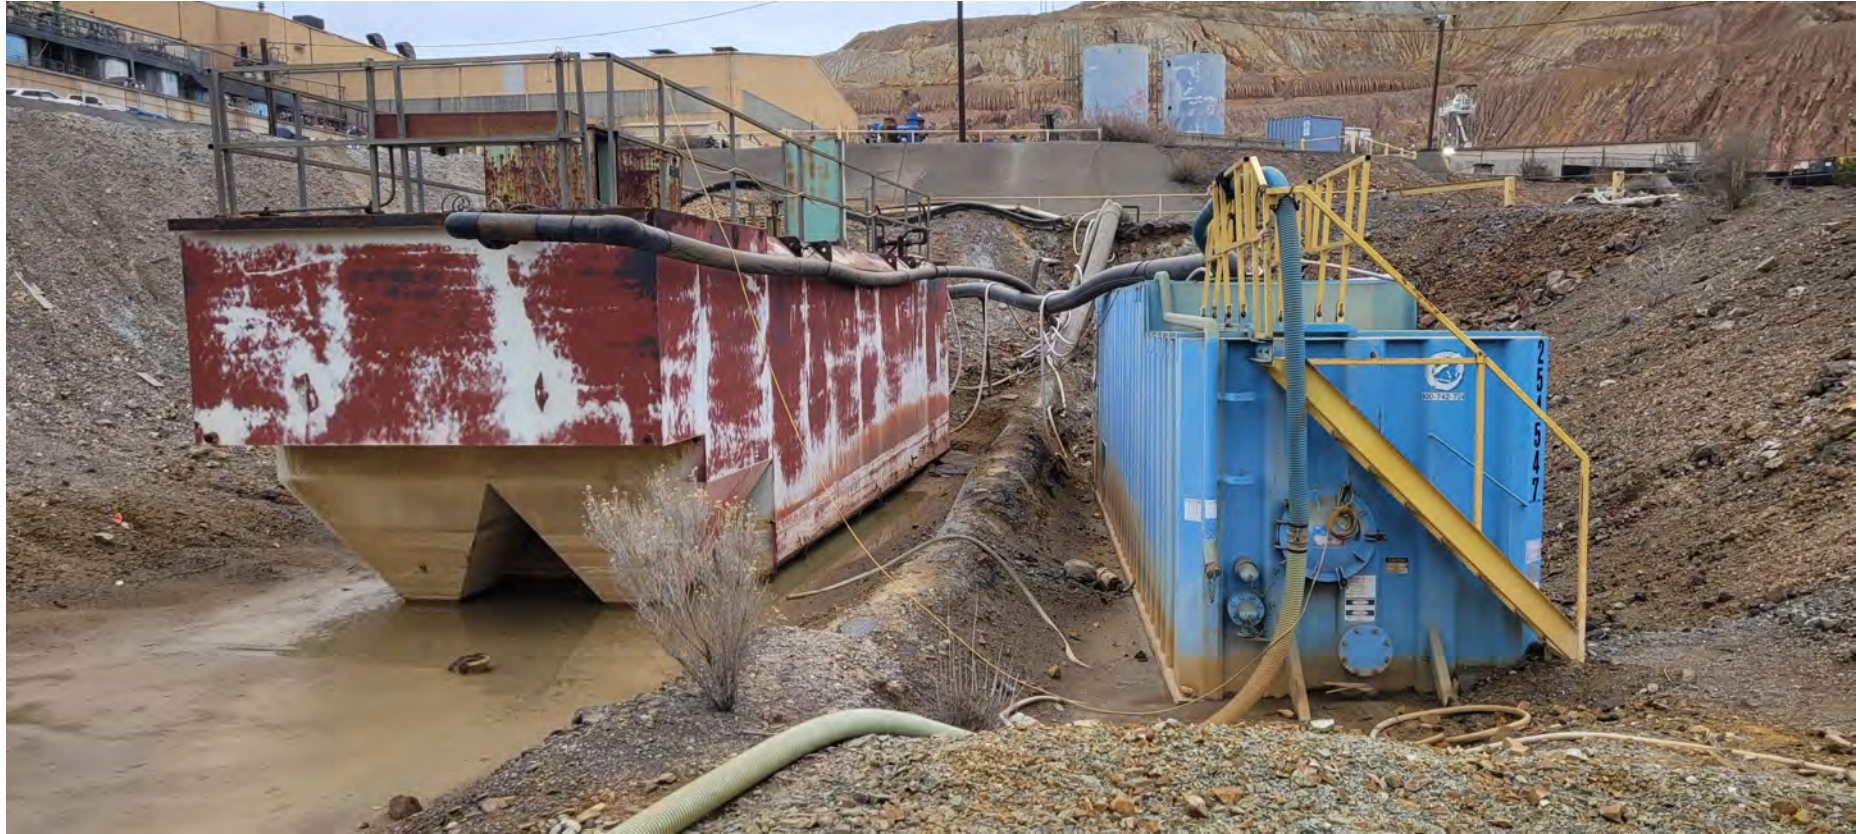
CP-36
External View

Category	Condition			Comments
	Good	Fair	Poor	
Civil				N/A
Condition of Site		X		"Free" tanks - slips trips + falls
Drainage Around Facility			X	
Access to Facility	X	X		
Building Parking			X	
Fencing or Security			X	
Foundation				
Foundation				X X
Floor Slabs				
If process Facility: Cond of equip fnds				
Structure				
Framing: Walls		X		Surface react
Framing: Roofs				
Framing: Internal				
If Concrete structure				
Mechanical				
HVAC if present				
Water Supply if present				
Waste water if present				
Other utilities if present				
Fire protection if present				
Piping				
if facility is not building				X
if facility is process	X			
Electrical				
Power supply	X			↓
Power distribution				
Lighting				
Other utilities if present				
Architectural				
Condition of Flooring				↓
Wall systems				
roofing				
ceilings				
doors				
windows				
points of egress

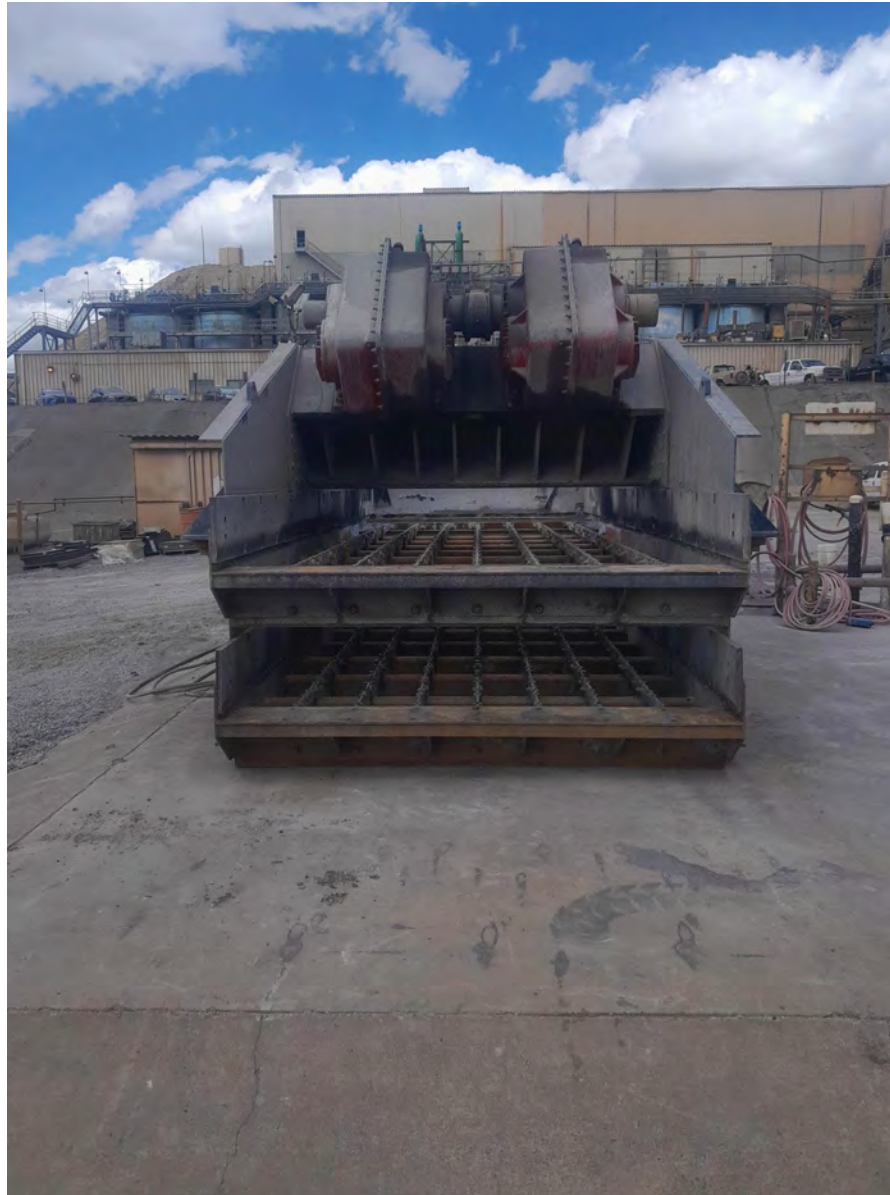
CP-37
External View

Category	Condition			Comments
	Good	Fair	Poor	
Civil				
Condition of Site	X			
Drainage Around Facility	X			
Access to Facility	X			
Building Parking	X			
Fencing or Security				
Foundation				
Foundation		X		
Floor Slabs		X		
If process Facility: Cond of equip fnds				
Structure				
Framing: Walls				na
Framing: Roofs				
Framing: Internal				
If Concrete structure				
Mechanical				
HVAC if present				na
Water Supply if present	X			
Waste water if present				
Other utilities if present				
Fire protection if present				
Piping				
if facility is not building	X			na
if facility is process				
Electrical				
Power supply				na
Power distribution				
Lighting				
Other utilities if present				
Architectural				
Condition of Flooring				na
Wall systems				
roofing				
ceilings				
doors				
windows				
points of egress

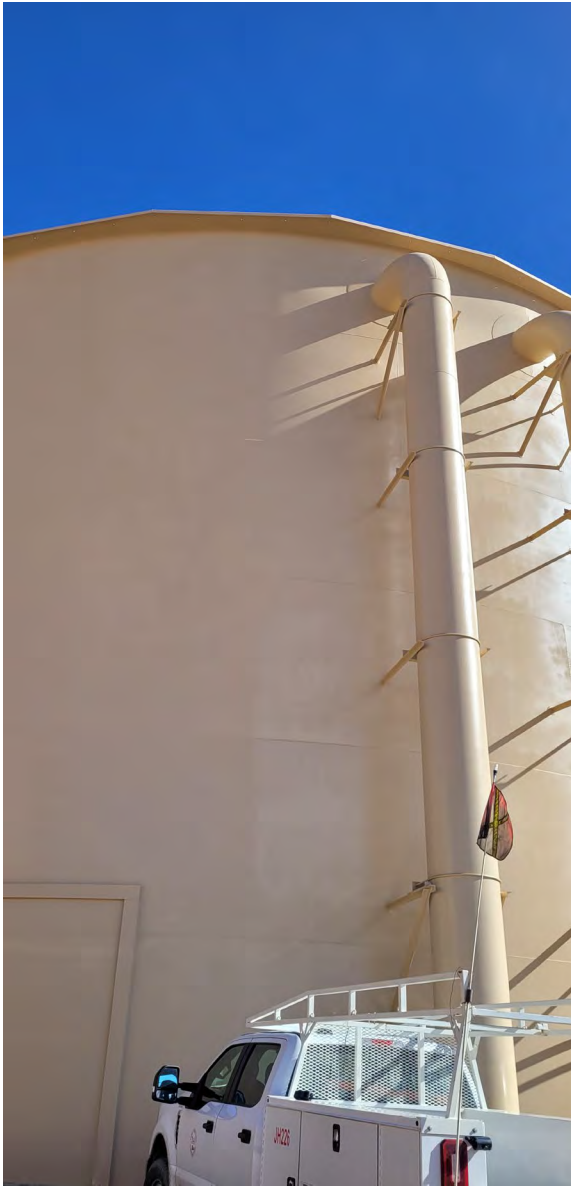
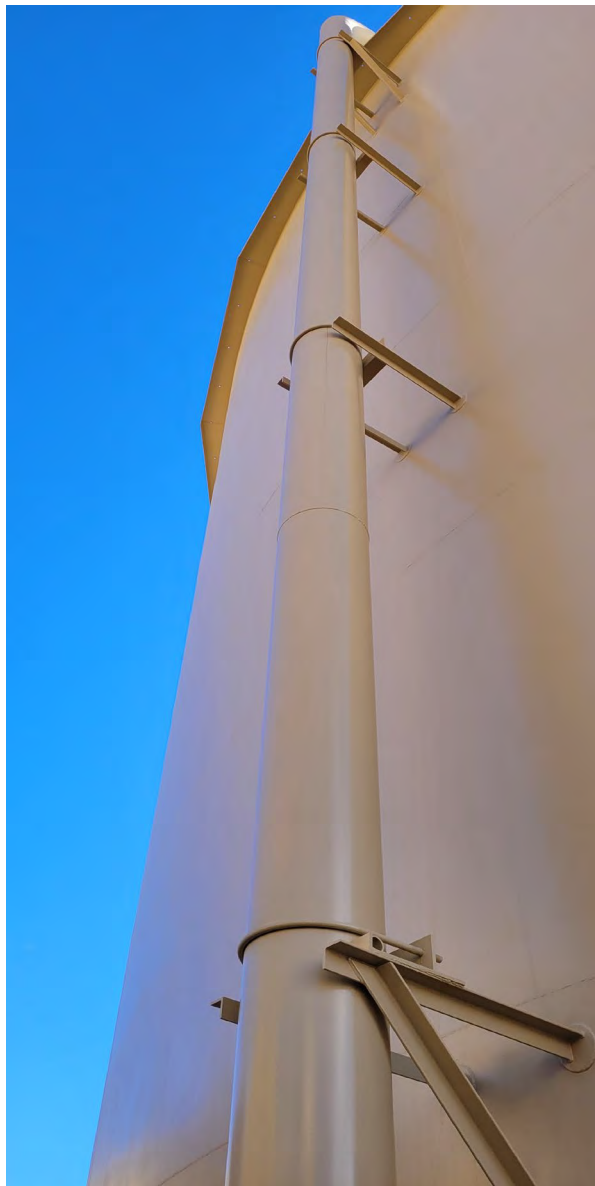
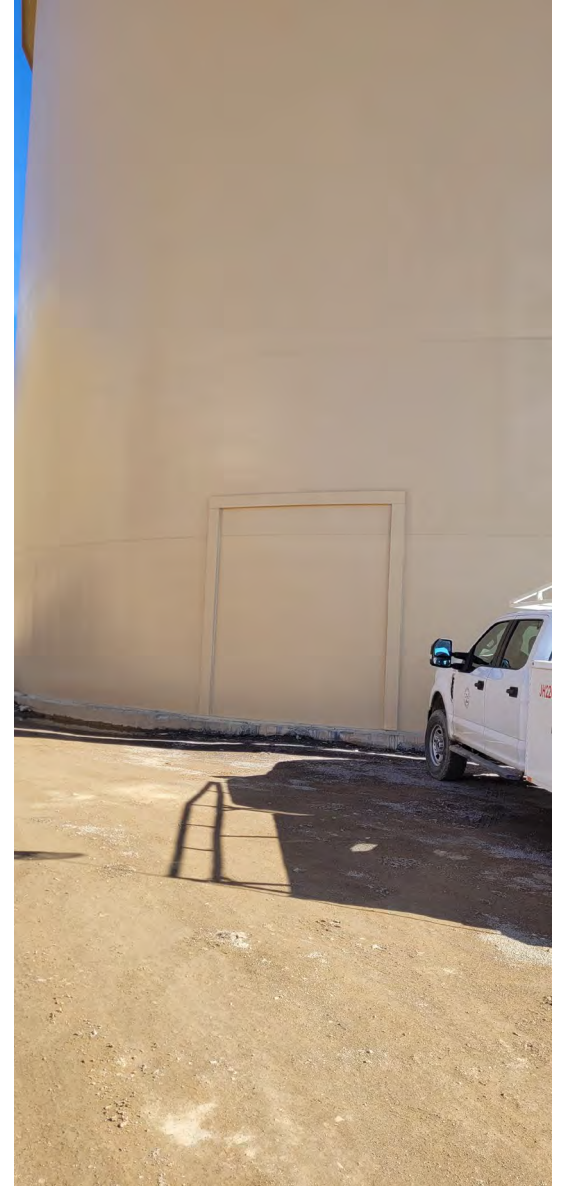
CP-38
External View

Category	Condition			Comments
	Good	Fair	Poor	
Civil				
Condition of Site	X			<p>pooling & rusting of sheeting</p> <p>Water Tank + containment all good</p> <p>Add containment as separate feat.</p>
Drainage Around Facility			X	
Access to Facility	X			
Building Parking	N/A			
Fencing or Security	N/A			
Foundation				
Foundation	X			
Floor Slabs	X			
If process Facility: Cond of equip fnds	X			
Structure				
Framing: Walls	MD		X	<p>Sheeting @ foundation contact is rusted away</p>
Framing: Roofs	X			
Framing: Internal	X			
If Concrete structure	N/A			
Mechanical				
HVAC if present	N/A			
Water Supply if present	X			
Waste water if present	N/A		N/A	
Other utilities if present	X		N/A	
Fire protection if present				
Piping				
if facility is not building				
if facility is process	X			
Electrical				
Power supply	X			
Power distribution	X			
Lighting	X			
Other utilities if present				
Architectural				
Condition of Flooring				<p>N/A</p> <p>↓</p>

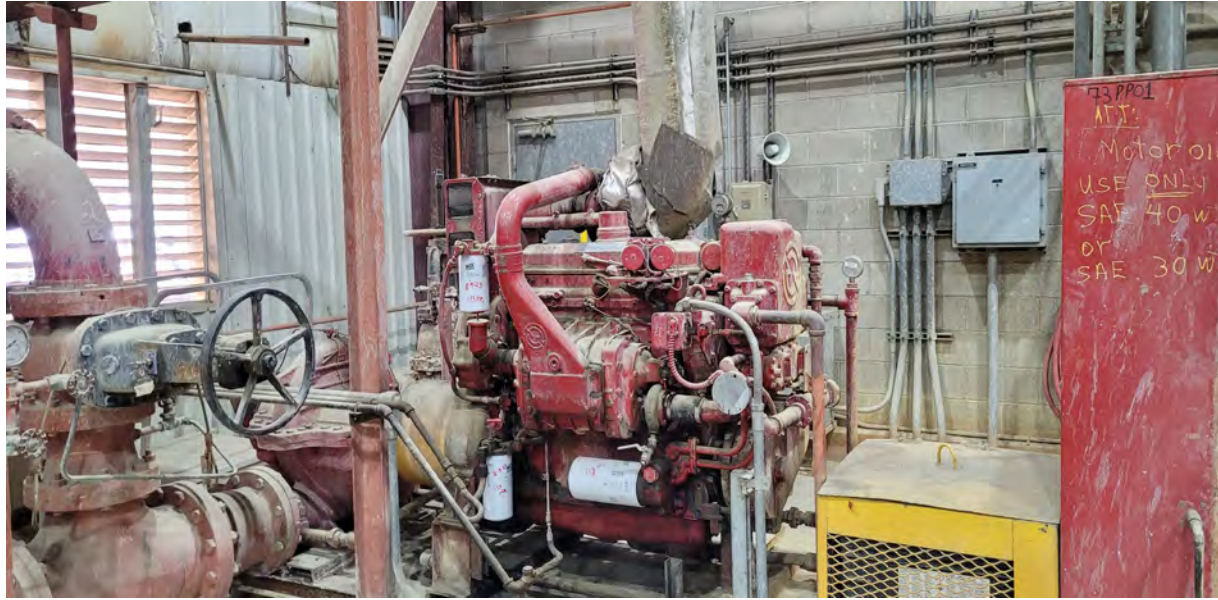
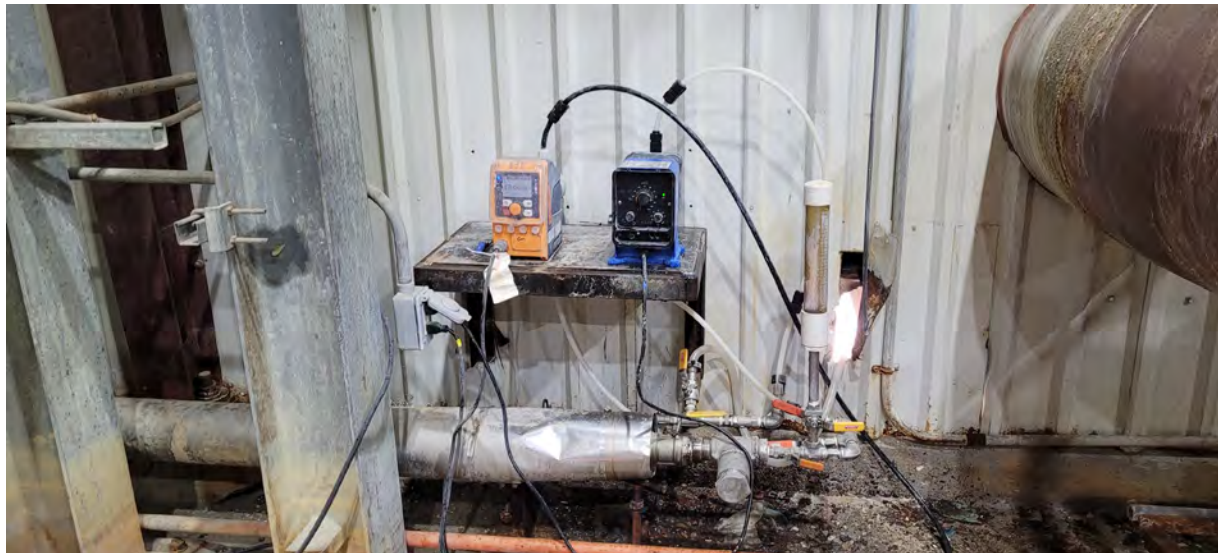
CP-38
Internal Damage

Category	Condition			Comments
	Good	Fair	Poor	
Civil				
Condition of Site	X			Converted to storage
Drainage Around Facility	X			
Access to Facility	X			
Building Parking			X	
Fencing or Security			X	
Foundation				
Foundation	X			
Floor Slabs	X			
If process Facility: Cond of equip fnds				
Structure				
Framing: Walls	X			- Some minor exterior elem damage
Framing: Roofs	X			
Framing: Internal	X			
If Concrete structure				
Mechanical				
HVAC if present				↓
Water Supply if present				
Waste water if present				
Other utilities if present				
Fire protection if present				
Piping				
if facility is not building				↓
if facility is process				
Electrical				
Power supply				↓
Power distribution				
Lighting				
Other utilities if present				
Architectural				
Condition of Flooring				X
Wall systems				
roofing				
ceilings				
doors			X	
windows			X	
points of egress	X

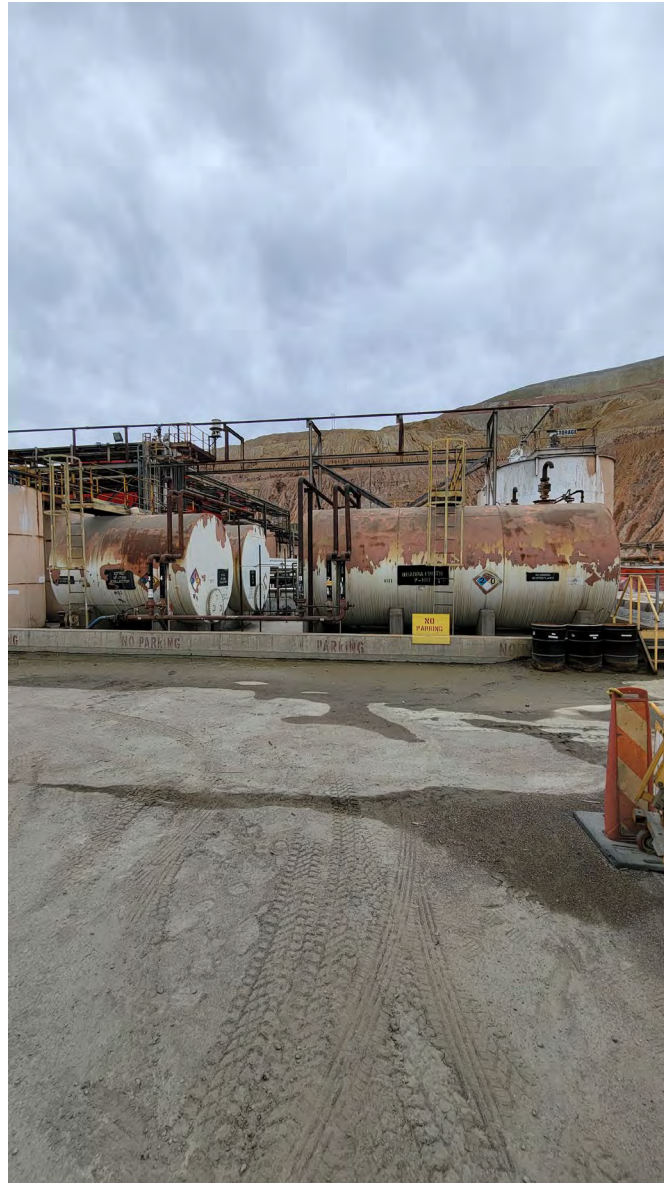
CP-40
External View

Category	Condition			Comments
	Good	Fair	Poor	
Civil				
Condition of Site	X			
Drainage Around Facility	X			
Access to Facility	X			
Building Parking				
Fencing or Security				
Foundation				
Foundation	X			
Floor Slabs		X		cracking floor slabs
If process Facility: Cond of equip fnds				
Structure				
Framing: Walls				
Framing: Roofs				
Framing: Internal				
If Concrete structure				
Mechanical				
HVAC if present				
Water Supply if present				
Waste water if present				
Other utilities if present				
Fire protection if present				
Piping				
if facility is not building	X			
if facility is process				
Electrical				
Power supply				
Power distribution				
Lighting				
Other utilities if present				
Architectural				
Condition of Flooring				
Wall systems				
roofing				
ceilings				
doors				
windows				
points of egress

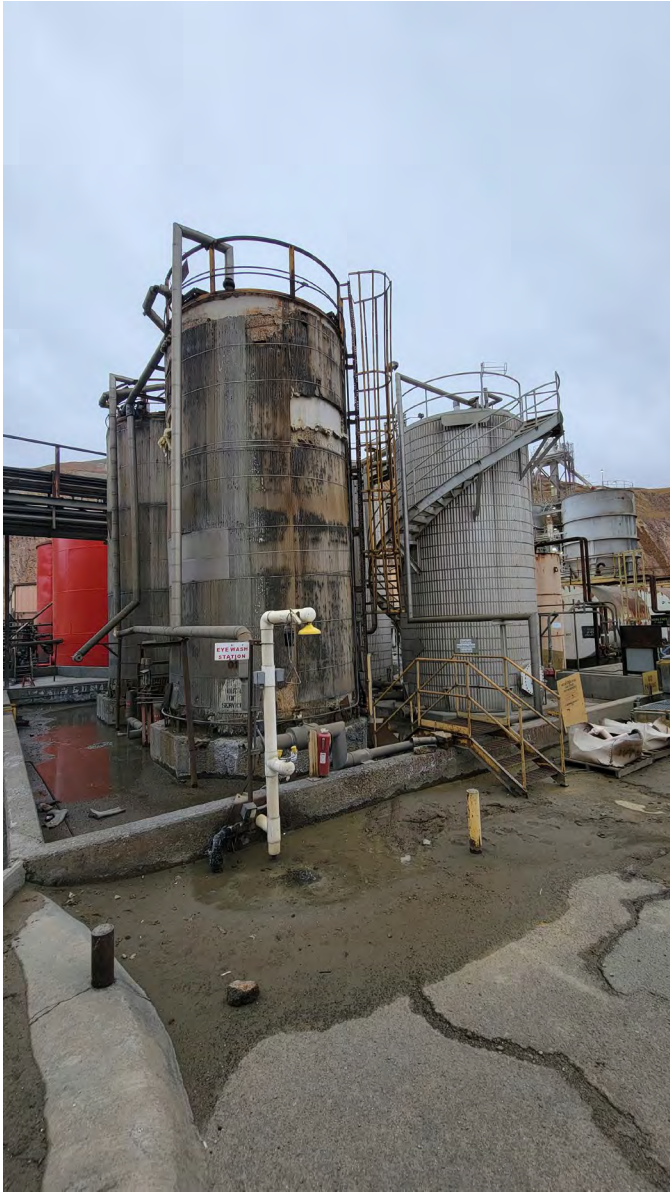
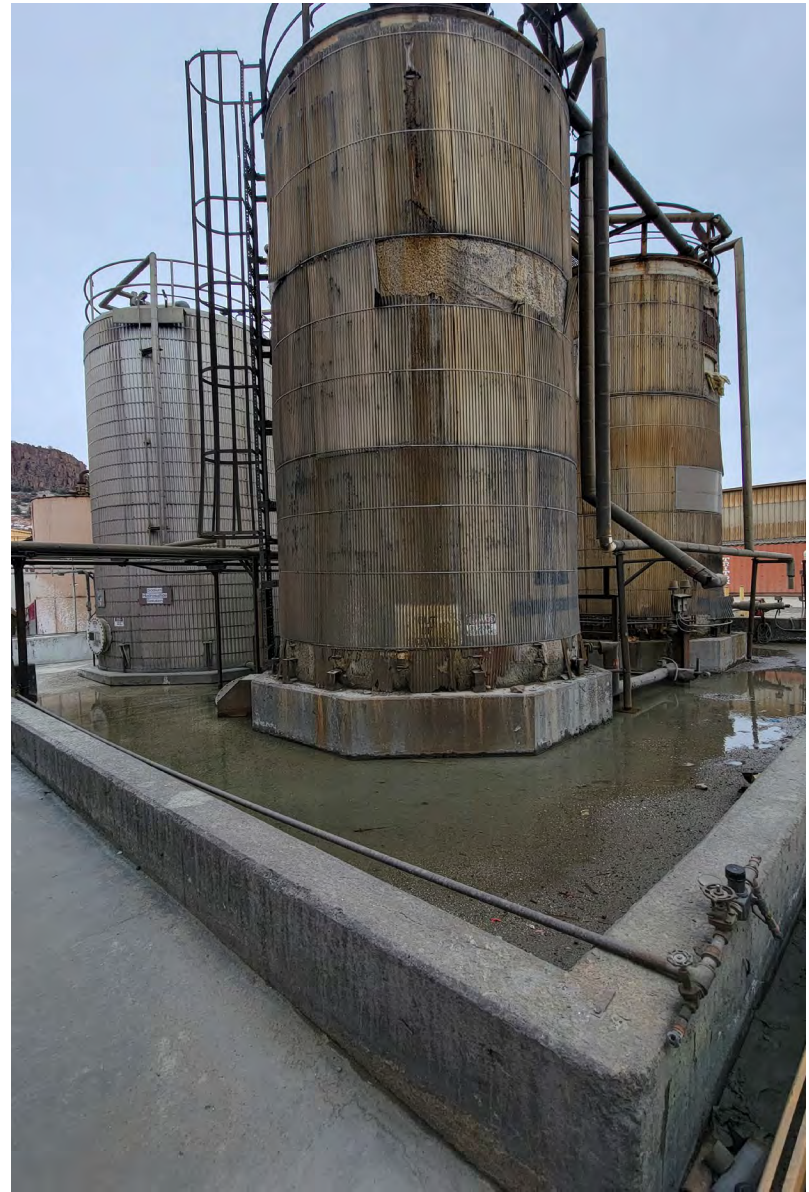
CP-41
External View

Category	Condition			Comments
	Good	Fair	Poor	
Civil				
Condition of Site	X			water pooling around Base N9
Drainage Around Facility		X		
Access to Facility	X			
Building Parking				
Fencing or Security				
Foundation				
Foundation	X			
Floor Slabs				
If process Facility: Cond of equip frnds				
Structure				
Framing: Walls	X			
Framing: Roofs				
Framing: Internal				
If Concrete structure				
Mechanical				
HVAC if present				
Water Supply if present				
Waste water if present				
Other utilities if present				
Fire protection if present				
Piping				
if facility is not building				
if facility is process				
Electrical				
Power supply				
Power distribution				
Lighting				
Other utilities if present				
Architectural				
Condition of Flooring				
Wall systems				
roofing				
ceilings				
doors				
windows				
points of egress
