PROJECT: 200450-001	TASK 03
PREPARED BY:

PMLU BUILDING INSPECTION FORM

Freeport-McMoran Chino Mine

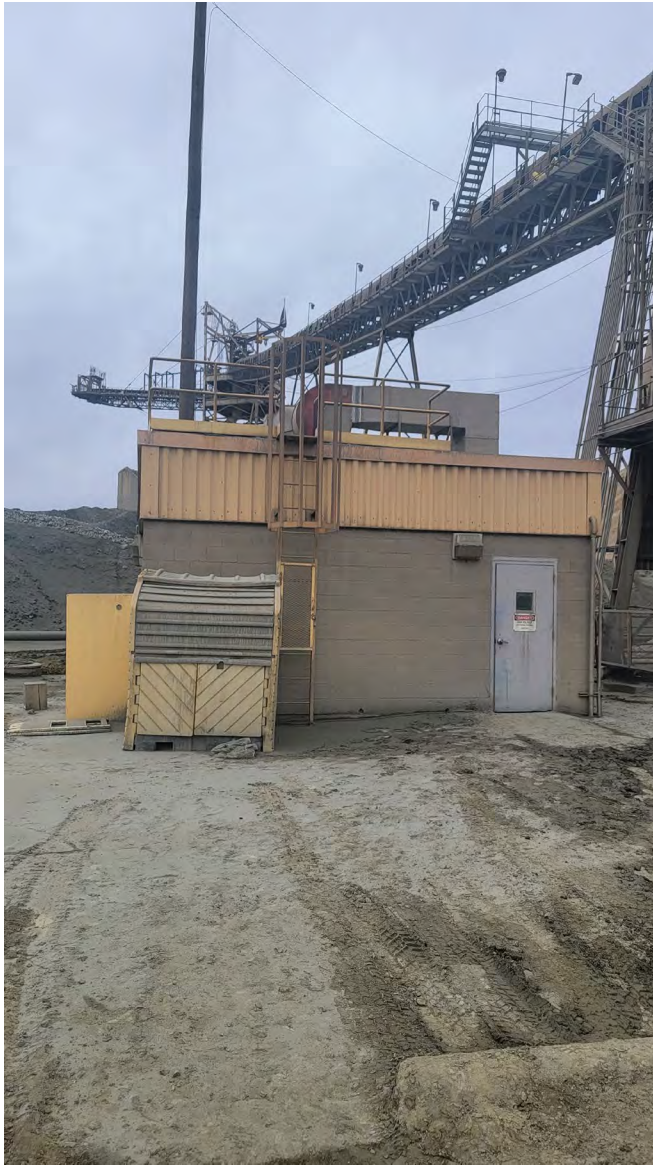
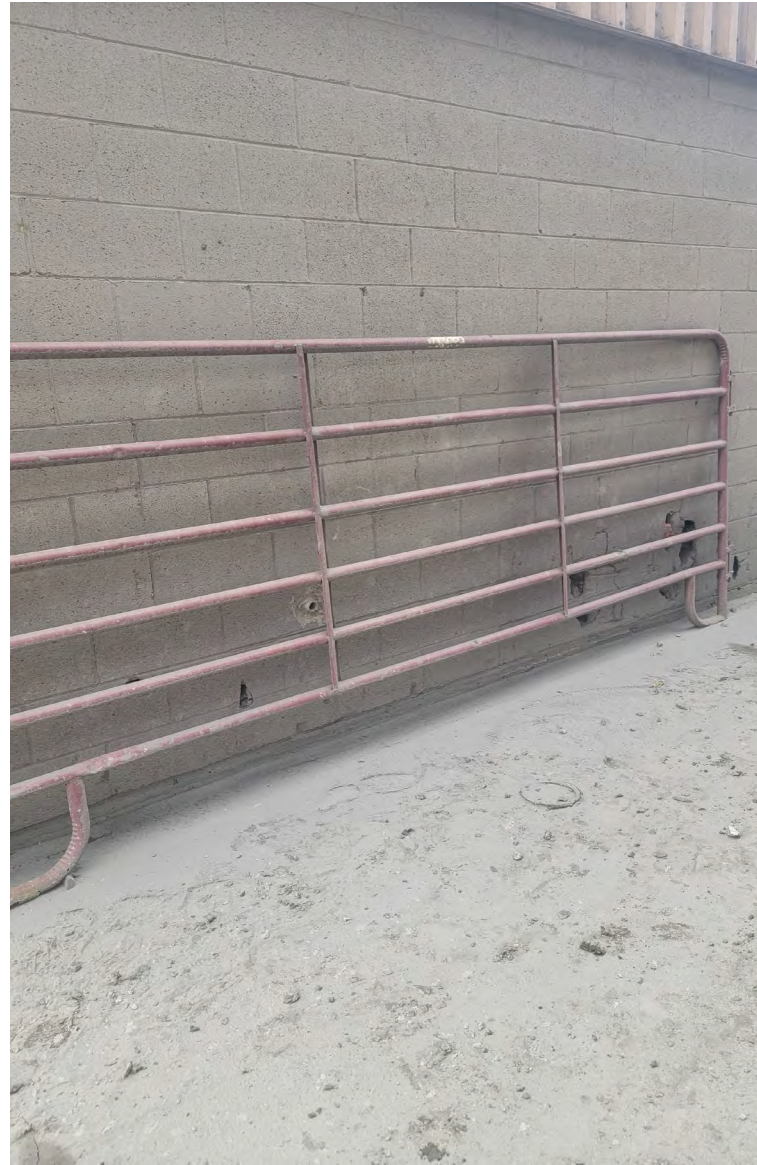
CP-44
External View

Category	Condition			Comments
	Good	Fair	Poor	
Civil				
Condition of Site	X			
Drainage Around Facility	X			
Access to Facility	X			
Building Parking	X			
Fencing or Security				
Foundation				
Foundation	X			
Floor Slabs	X			
If process Facility: Cond of equip frnds				
Structure				
Framing: Walls		X		Holes in wall
Framing: Roofs	X			
Framing: Internal				
If Concrete structure				
Mechanical				
HVAC if present				
Water Supply if present				
Waste water if present				
Other utilities if present				
Fire protection if present				
Piping				
if facility is not building				
if facility is process				
Electrical				
Power supply	X			
Power distribution	X			
Lighting	X			
Other utilities if present				
Architectural				
Condition of Flooring	X			
Wall systems	X			
roofing	X			
ceilings	X			
doors	X			
windows	X			
points of egress		X		1 Door

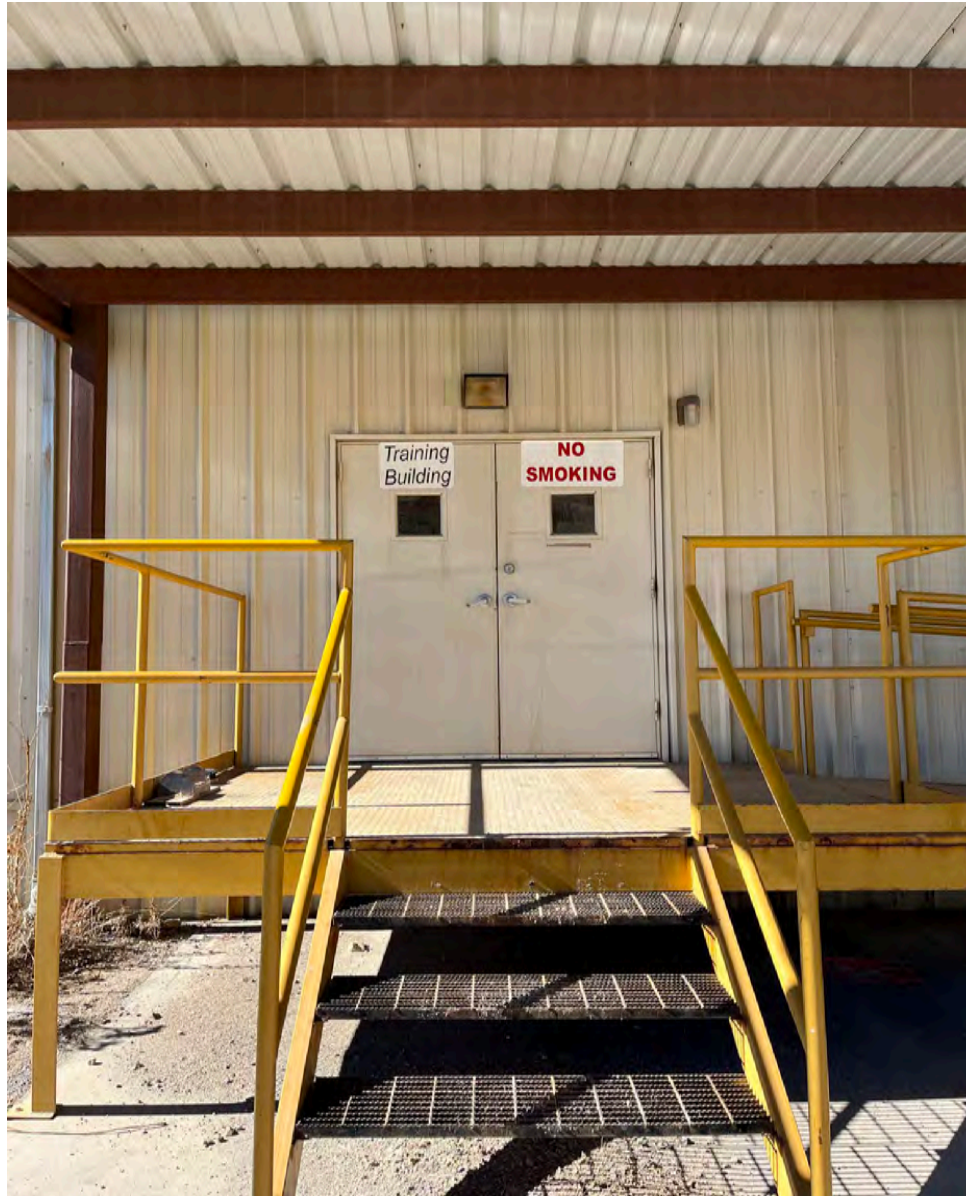
CP-45
External View

Category	Condition			Comments
	Good	Fair	Poor	
Civil				
Condition of Site	X			
Drainage Around Facility	X			
Access to Facility				
Building Parking				
Fencing or Security				
Foundation				
Foundation		X		Cracked floor
Floor Slabs		X		
If process Facility: Cond of equip fnds				
Structure				
Framing: Walls		X		Dents in surrounding walls
Framing: Roofs				
Framing: Internal				
If Concrete structure				
Mechanical				
HVAC if present				
Water Supply if present				
Waste water if present				
Other utilities if present				
Fire protection if present				
Piping				
if facility is not building				
if facility is process				
Electrical				
Power supply				
Power distribution				
Lighting				
Other utilities if present				
Architectural				
Condition of Flooring				
Wall systems				
roofing				
ceilings				
doors				
windows				
points of egress

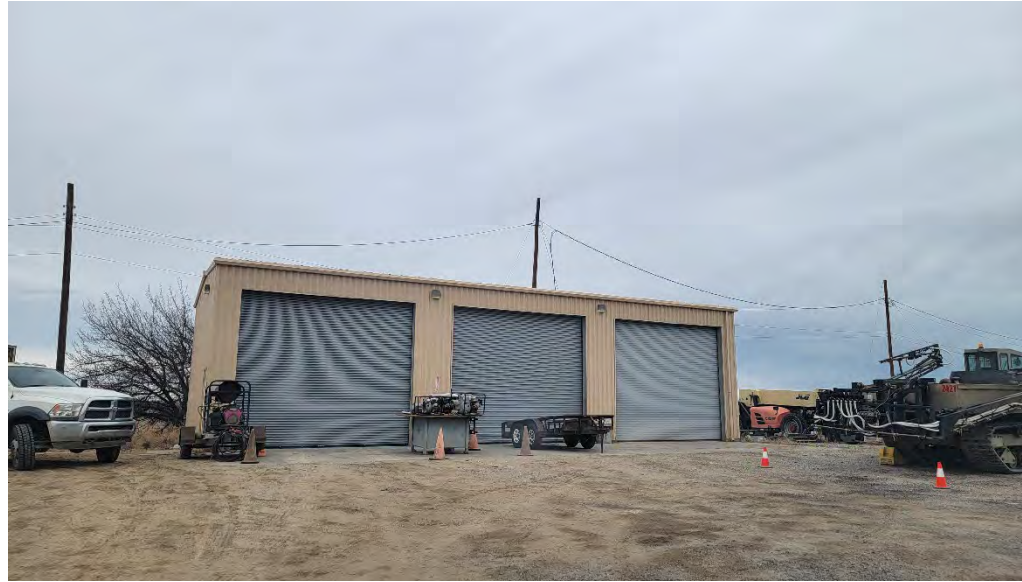
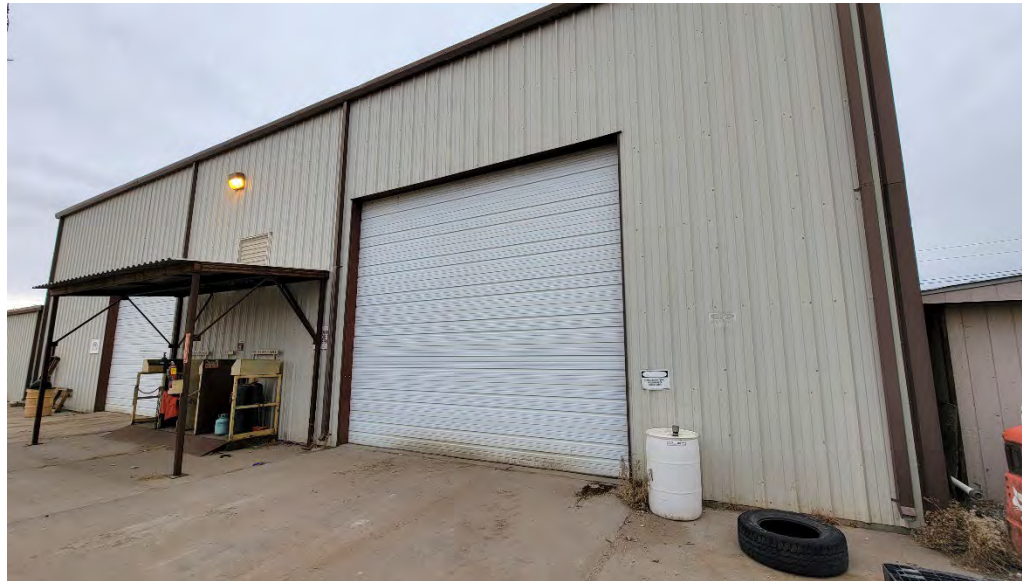
Category	Condition			Comments
	Good	Fair	Poor	
Civil				
Condition of Site	X			
Drainage Around Facility	X			
Access to Facility	X			
Building Parking	X			
Fencing or Security	X			
Foundation				
Foundation		X		crack
Floor Slabs	X			
If process Facility: Cond of equip fnds				
Structure				
Framing: Walls				
Framing: Roofs				
Framing: Internal				
If Concrete structure				
Mechanical				
HVAC if present	X			
Water Supply if present	X			
Waste water if present	X			
Other utilities if present				
Fire protection if present				na
Piping				
if facility is not building				
if facility is process				
Electrical				
Power supply	X			
Power distribution	X			
Lighting	X			
Other utilities if present				
Architectural				
Condition of Flooring		X		crack floor
Wall systems	X			
roofing	X			
ceilings	X			
doors	X			
windows	X			
points of egress	X

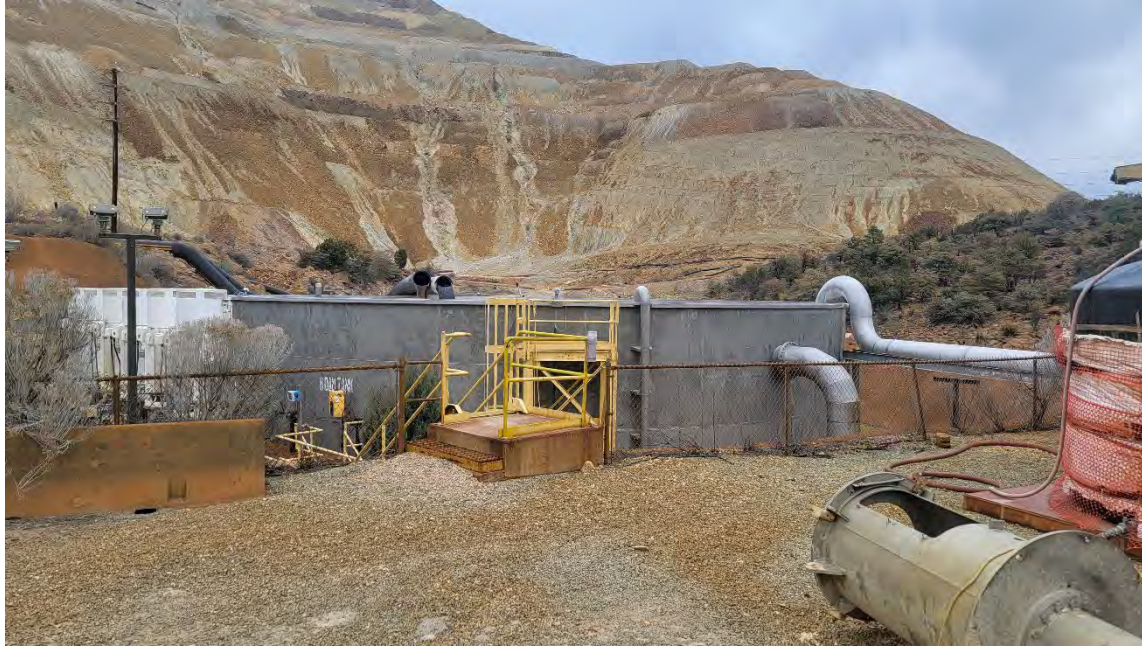
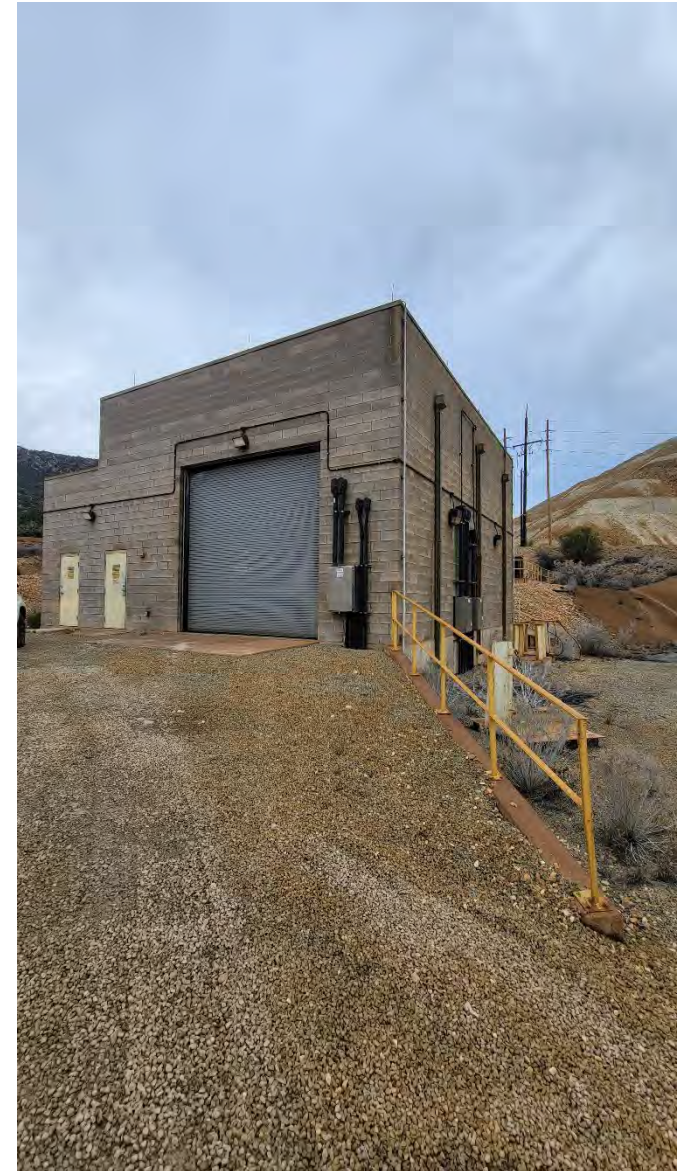
RES08
External View

Category	Condition			Comments
	Good	Fair	Poor	
Civil				
Condition of Site	X			
Drainage Around Facility	X			
Access to Facility	X			
Building Parking	X			
Fencing or Security				
Foundation				
Foundation	X			
Floor Slabs	X			
If process Facility: Cond of equip fnds				
Structure				
Framing: Walls	X			
Framing: Roofs				
Framing: Internal				
If Concrete structure				
Mechanical				
HVAC if present				
Water Supply if present				
Waste water if present				
Other utilities if present				
Fire protection if present				
Piping				
if facility is not building				
if facility is process				
Electrical				
Power supply				
Power distribution				
Lighting				
Other utilities if present				
Architectural				
Condition of Flooring				
Wall systems				
roofing				
ceilings				
doors				
windows				
points of egress

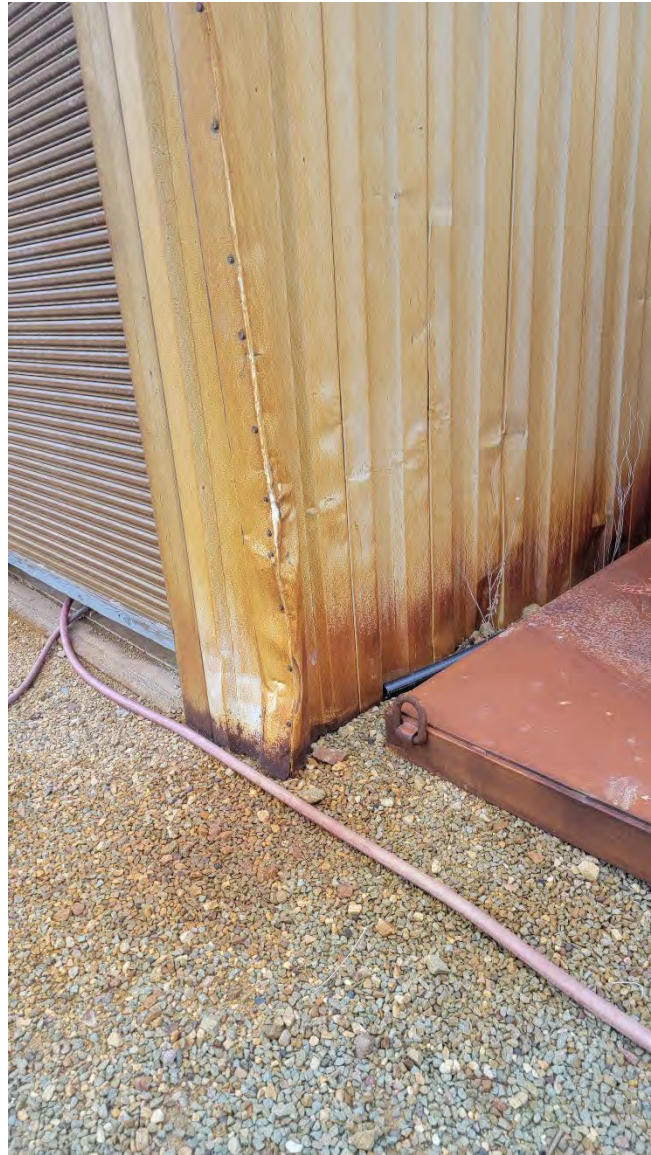
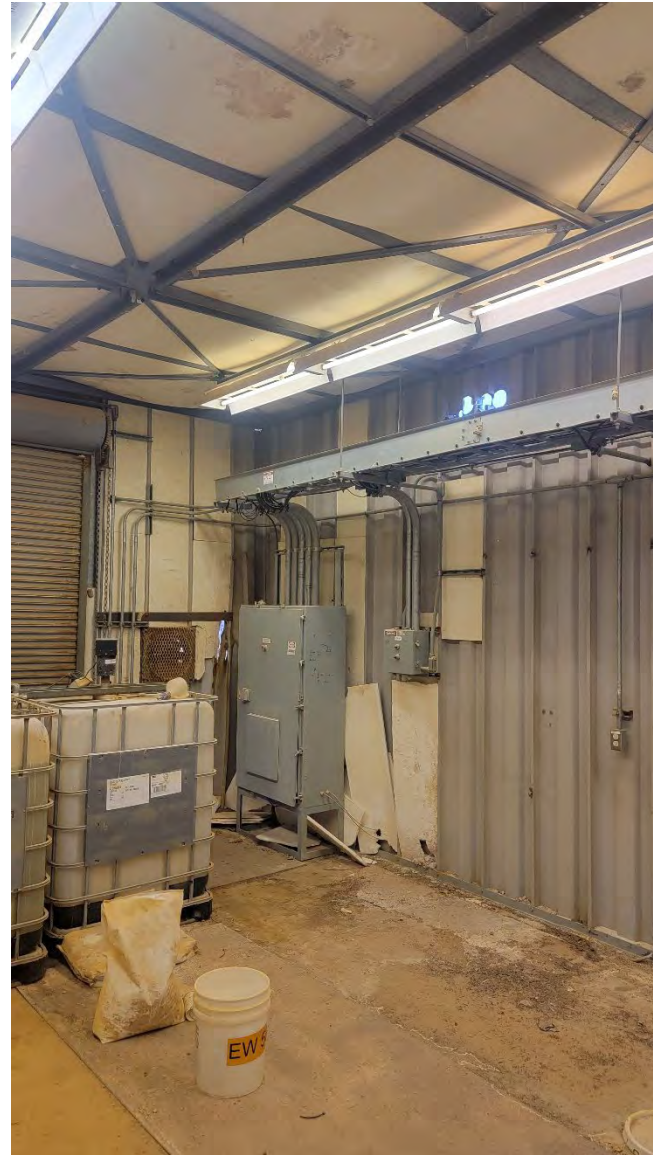
RES08
External Damage & Internal View
