MK006PR
SECTION 25
MINE

**PRIOR RECLAMATION INSPECTION REPORT
AND
RECOMMENDATION FOR RELEASE OR PERMIT REQUIREMENT**

**Section 13, (T 14N R 10W), Section 15 (T 14N, R 10W), Section 23 (T 14N, R 10W),
Section 25 (T 14N, R 10W) and Section 32 (T 14N, R 10W) Mines**

**New Mexico Energy, Minerals and Natural Resources Department
Mining and Minerals Division
Mining Act Reclamation Bureau**

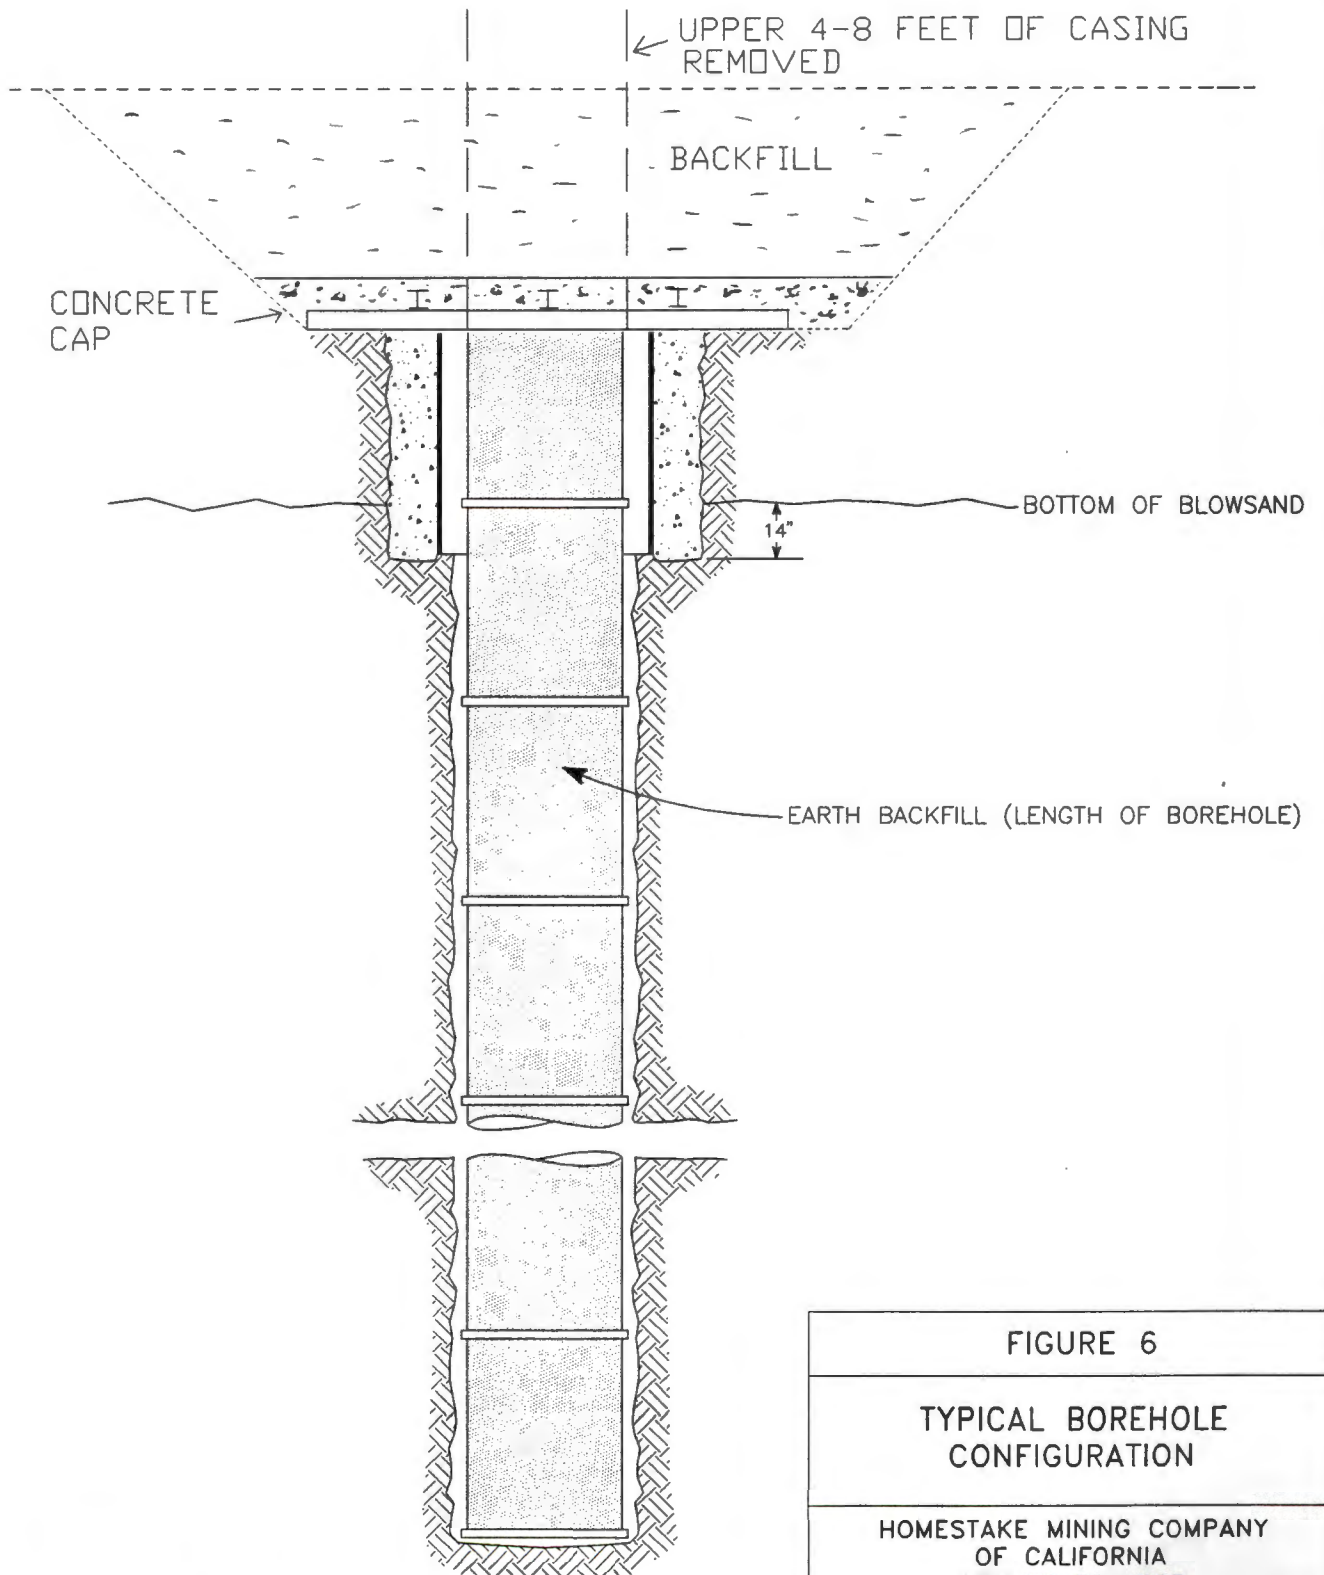
FIGURE 6

original ground surface. Each borehole has a 2.0 foot thick, reinforced concrete cap, as shown on Figure 6. The vertical shaft was backfilled to within two (2) feet of the surface and capped with a reinforced concrete cap as shown in Figure 7.

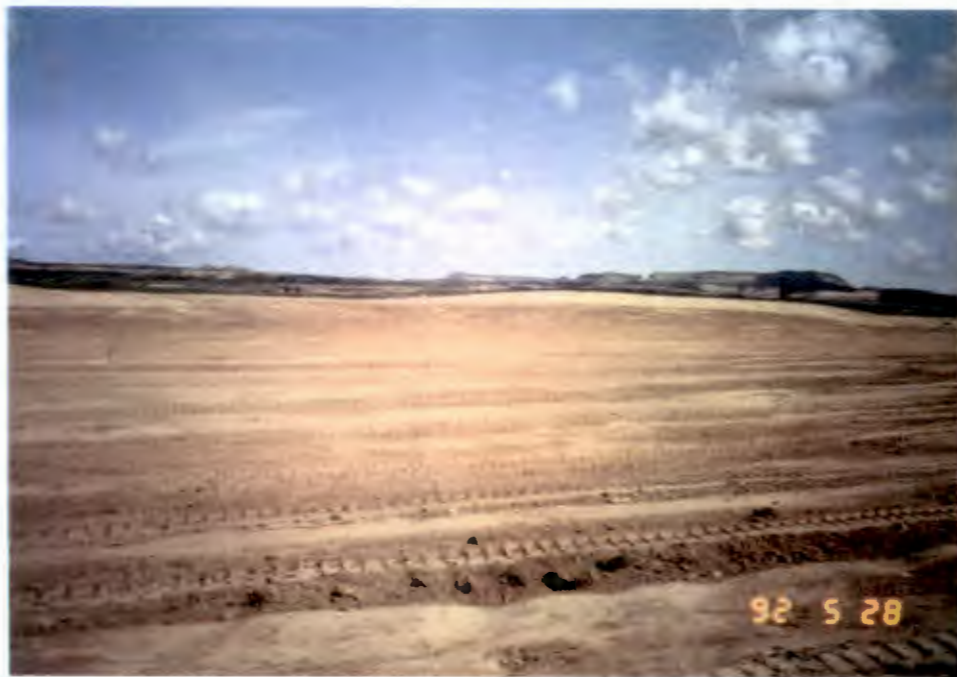
PHOTO 25D

Some of these reclamation activities are shown in photos 25A-25D.
