Attachment A: MMD Technical Comments

No Agua Mine Revision 23-1

Permit No. TA005RE

Name of Operator: Imerys Perlite USA Inc. **Permit Update:** 5-year Closeout Plan Revision 23-1

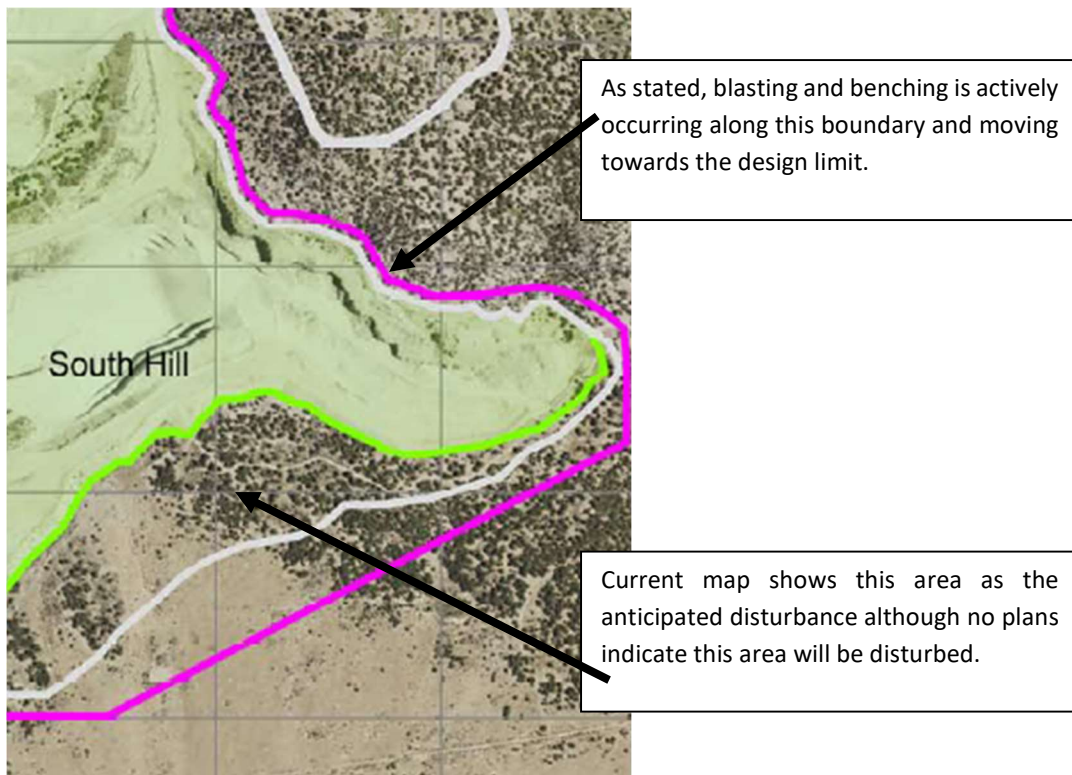
In the eastern portion of South Hill, the 5 Year Disturbance boundary has been pushed out so that it is at the limit of the 2016 Design Limit. This is to accommodate mining in this area.

Area to the south of South Hill will be disturbed to source borrow material for the Test Plot Program. Core drilling and mine development in this area is also possible.

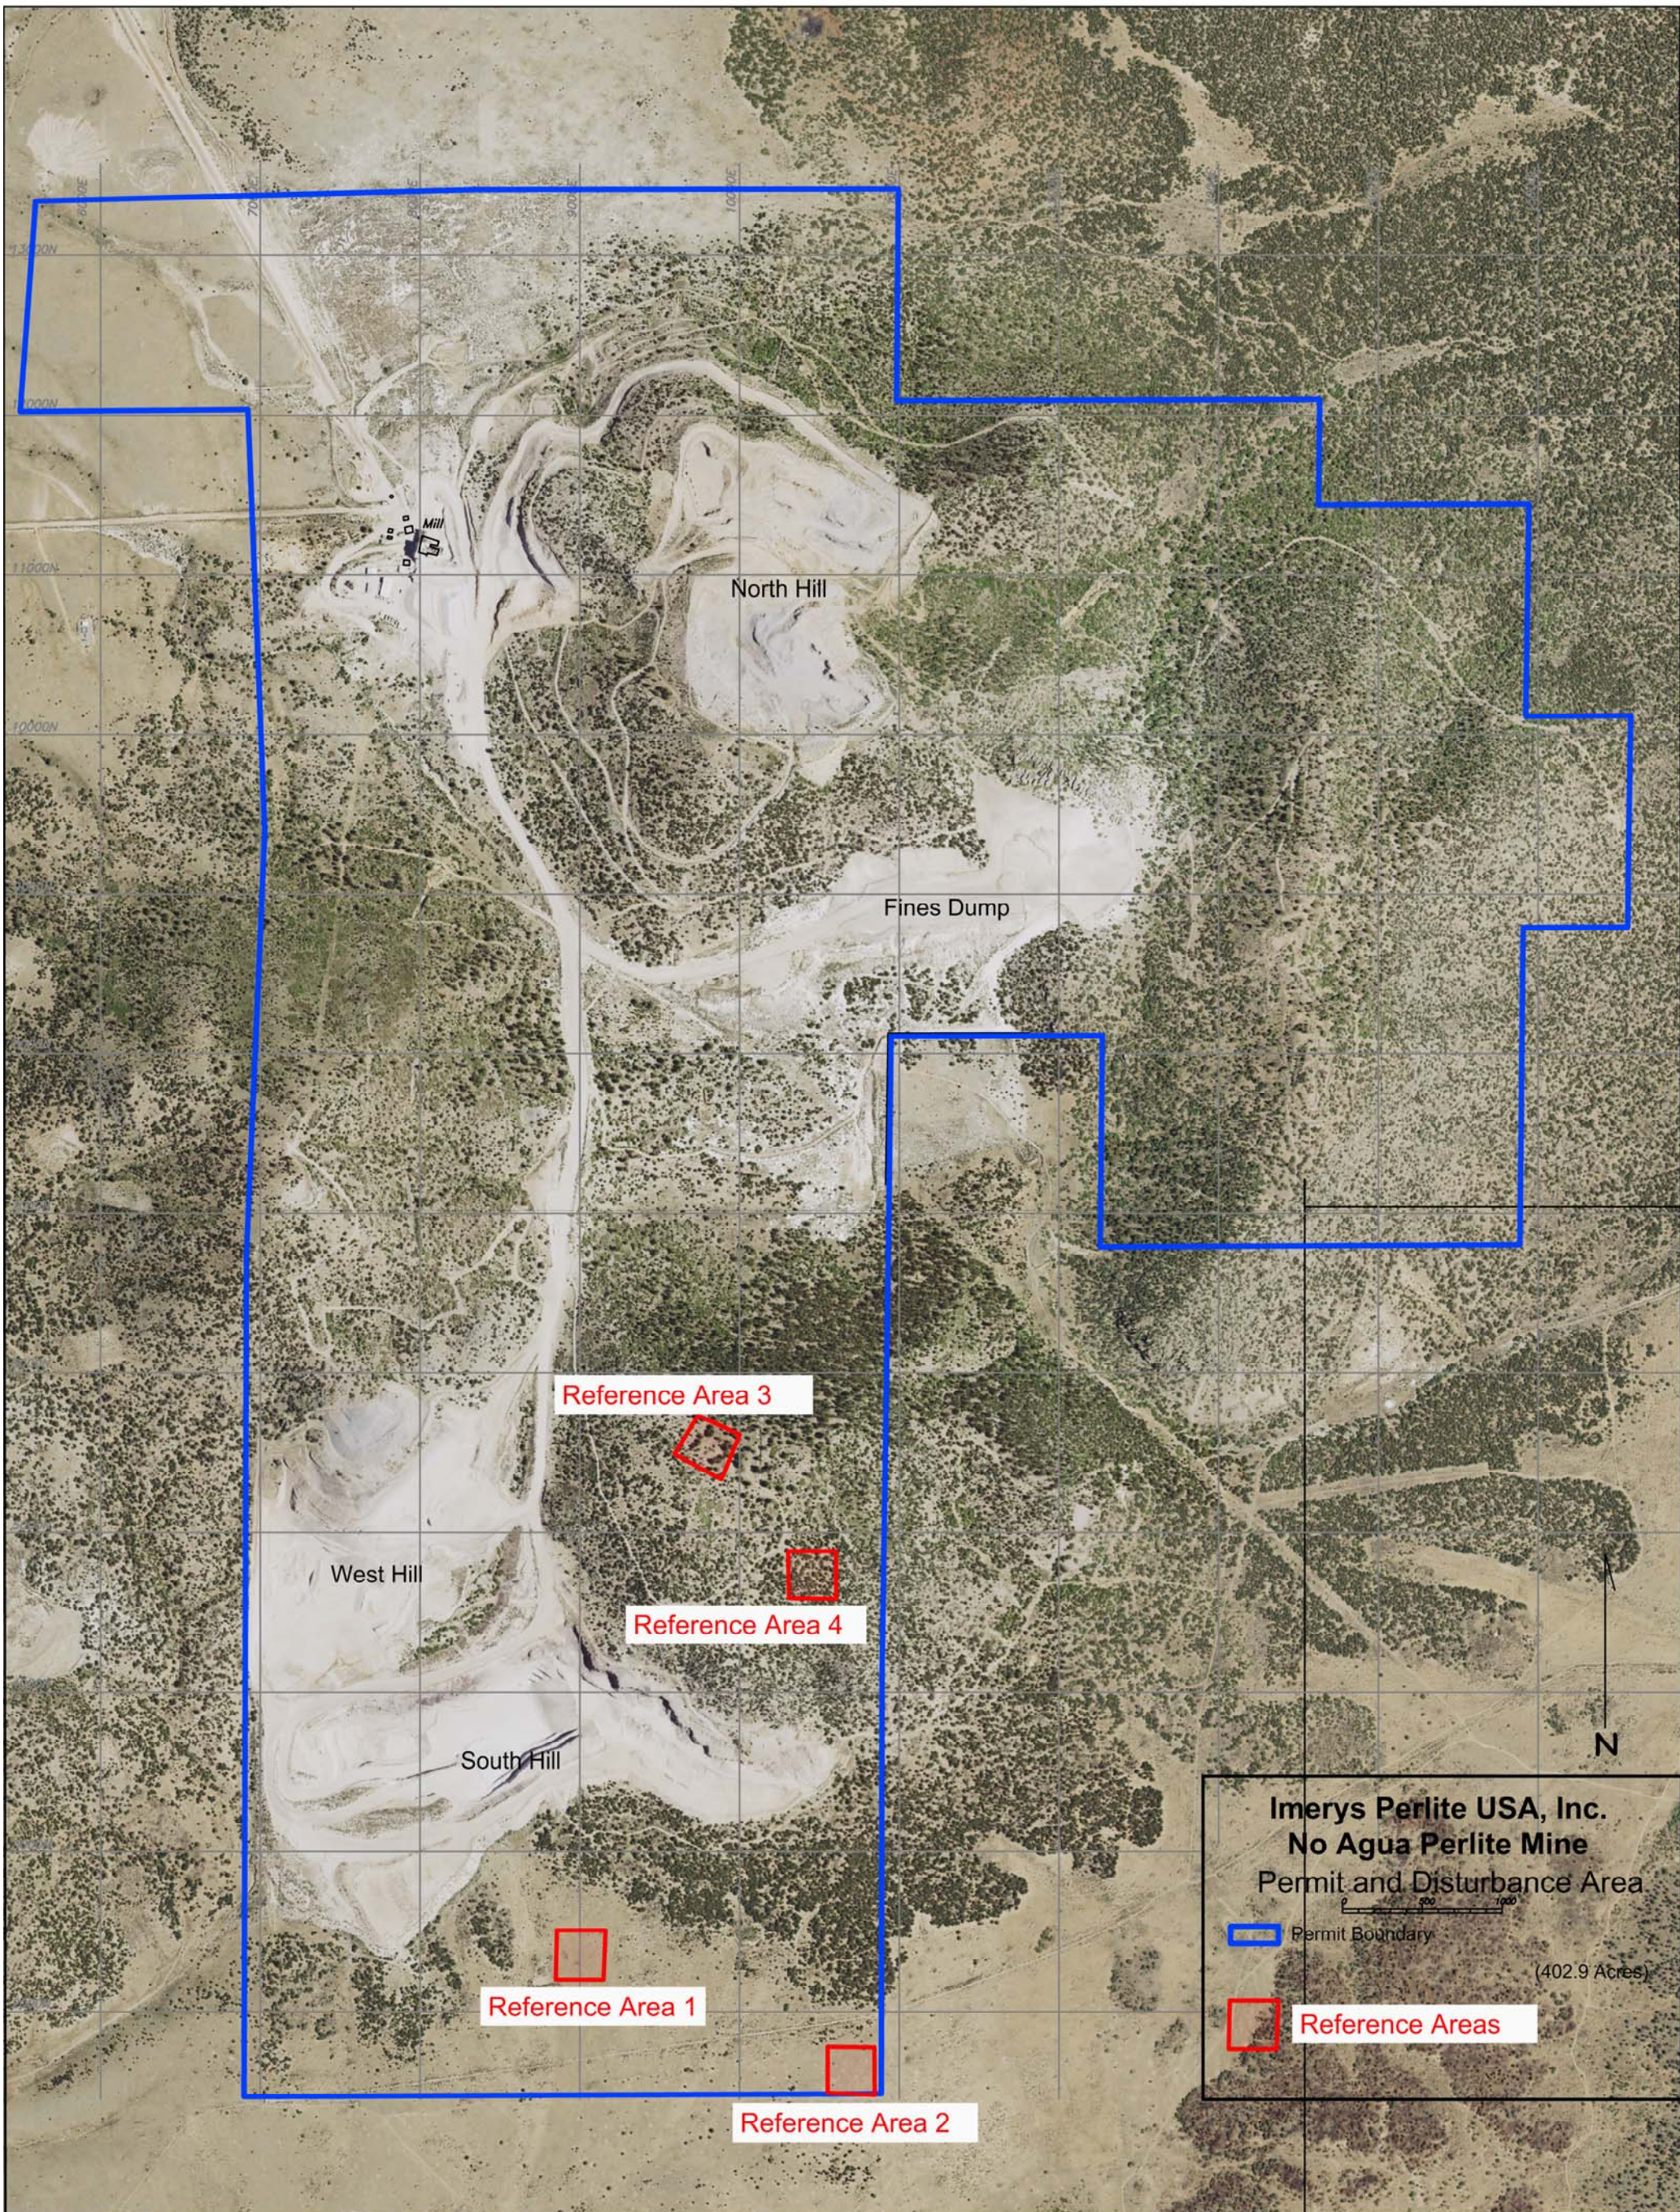
Reference Area Locations

The previous iteration of the Closeout Plan specified comparison to four Reference Areas delineated by a consultant in 1999. Since that time, it has become apparent that Reference Area 1 and Reference Area 2 are dissimilar to the areas of the mine requiring reclamation. Both Areas 1 and 2 are located on the flat to the south of the mine, and both are devoid or nearly devoid of trees. Hence, the standard going forward will be based only on Reference Area 3 and Reference Area 4. Figure 4 shows the location of all four original Reference Areas.

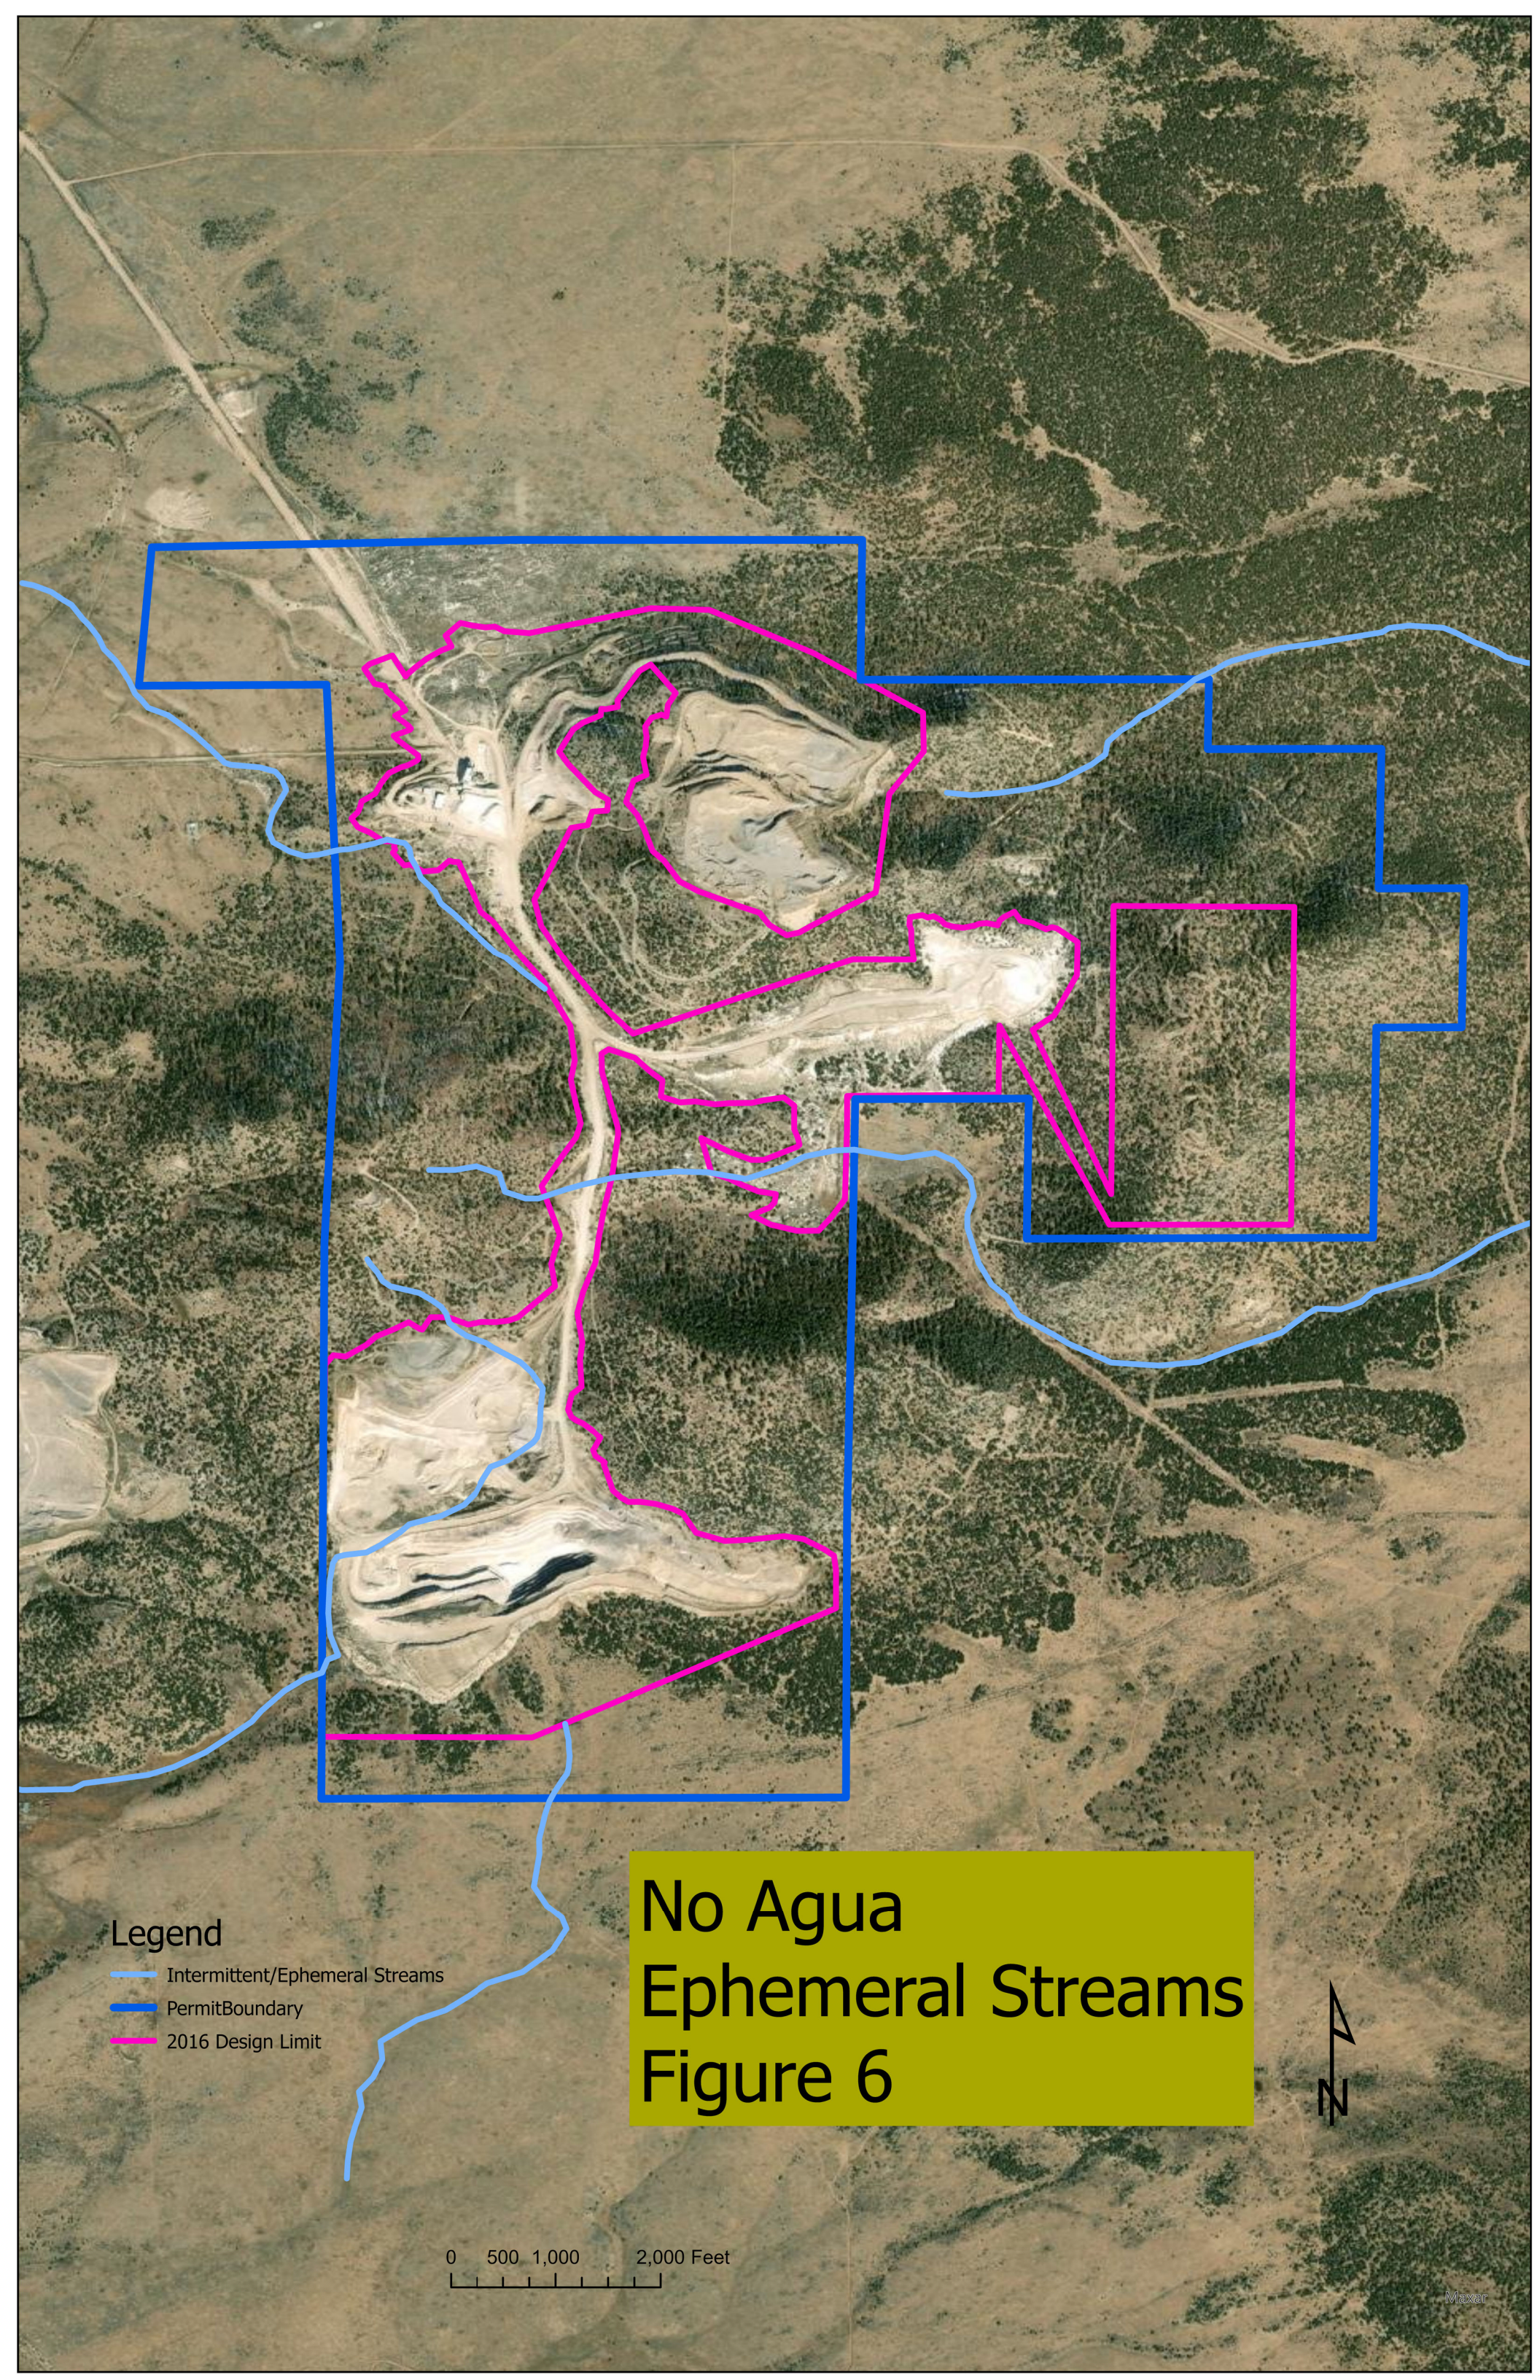
Ephemeral Streams

No Agua
Ephemeral Streams
Figure 6

Please see Figure 6.

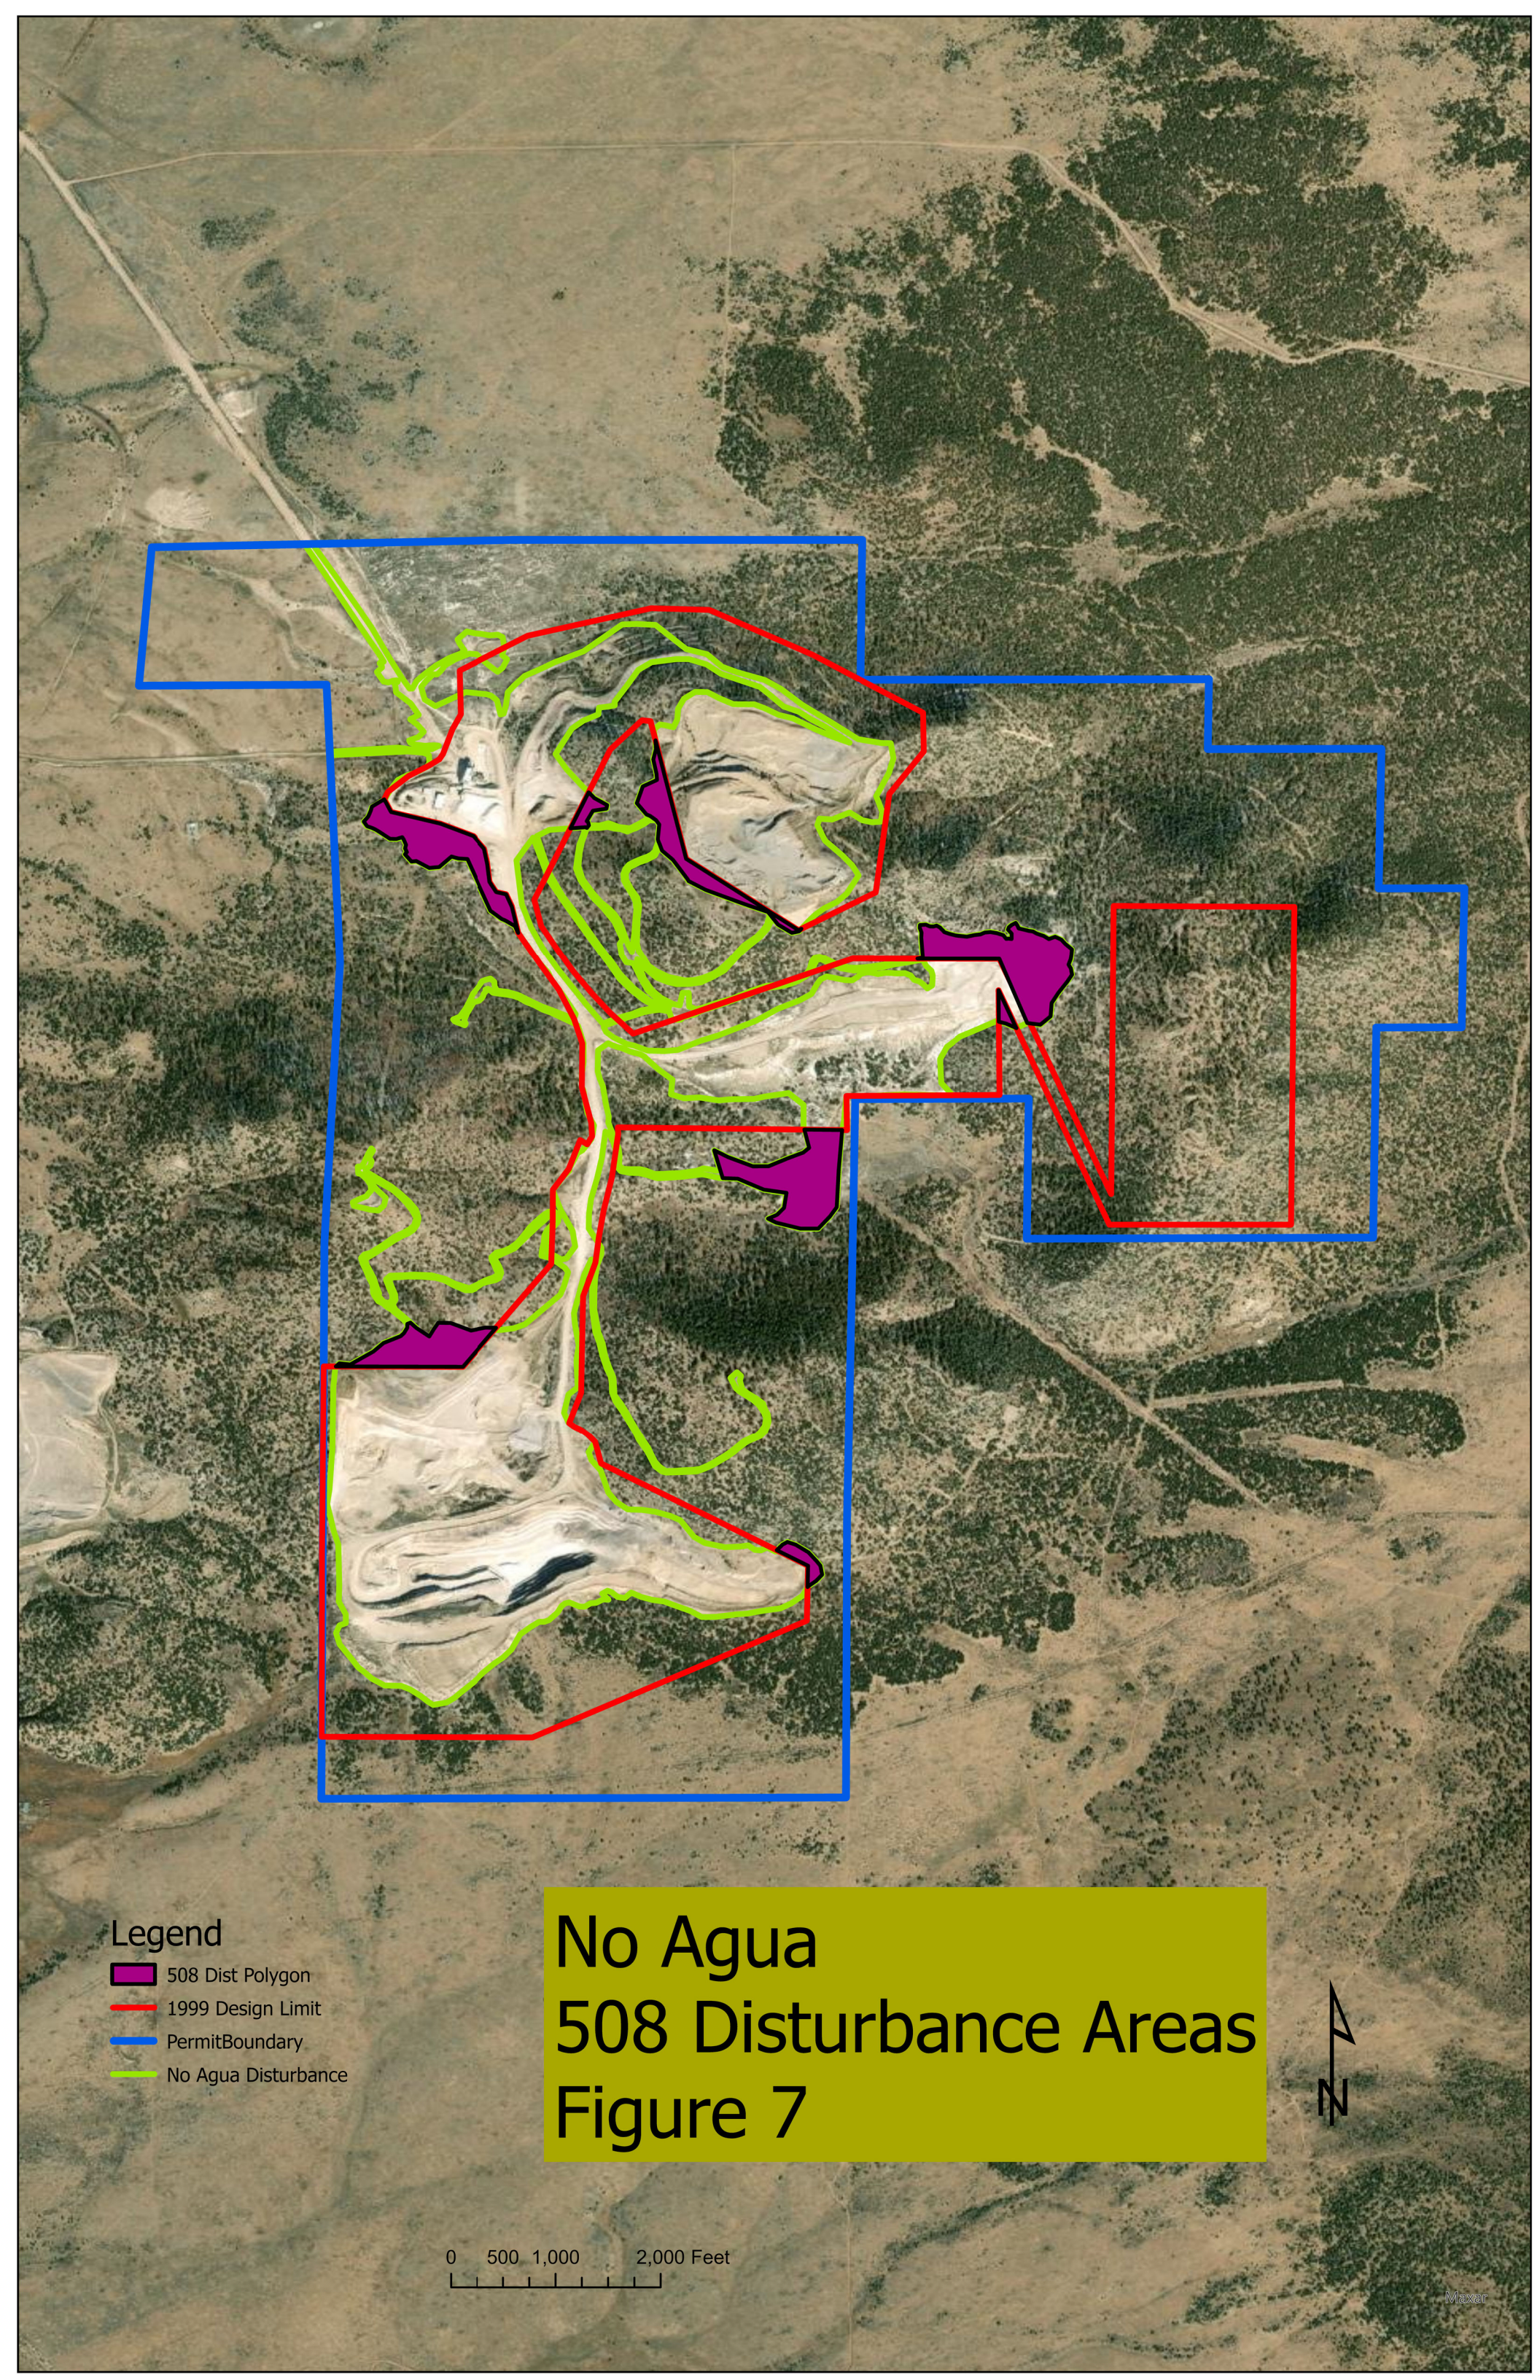
Figure 7

508 Disturbance Areas

**No Agua
508 Disturbance Areas
Figure 7**

See Closeout Plan Figure 7.

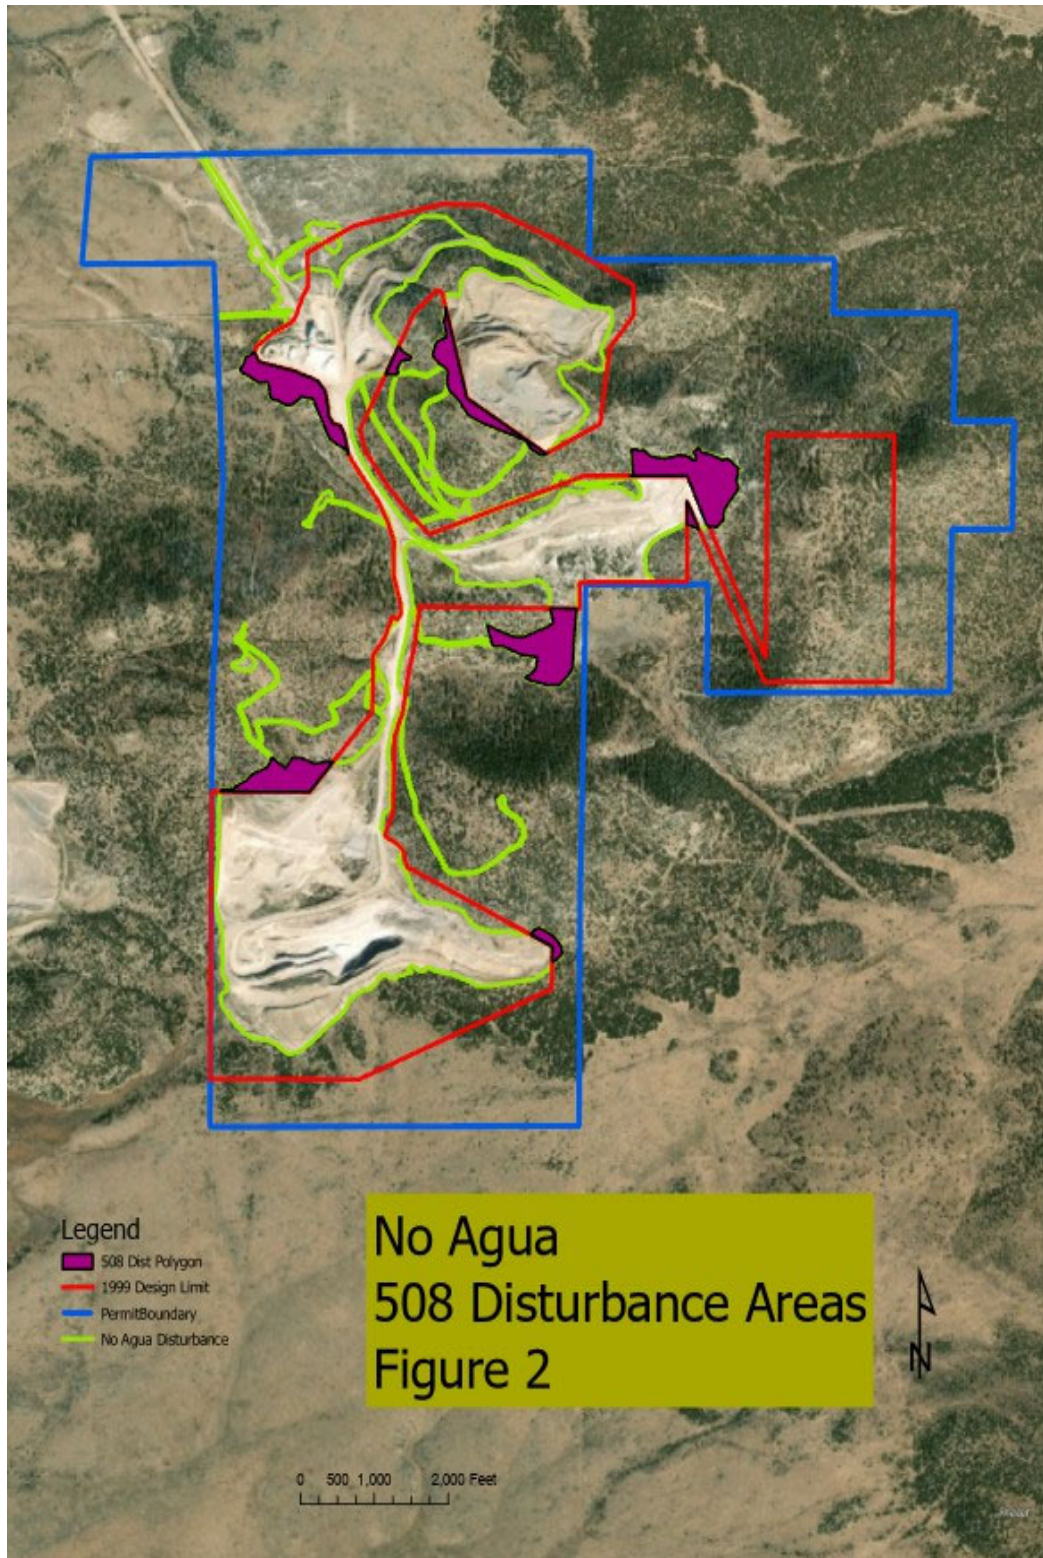
Figure 3

Current disturbances by type are depicted in Figure 3.
