# Post Mine Land Use Building Inspections

**Freeport-McMoRan Inc.  
Chino Mines Company  
99 Santa Rita Mine Road  
Vanadium, New Mexico 88043**

**Telesto Solutions Inc.  
750 14<sup>th</sup> Street SW  
Loveland, Colorado 80537**

**March 2024**

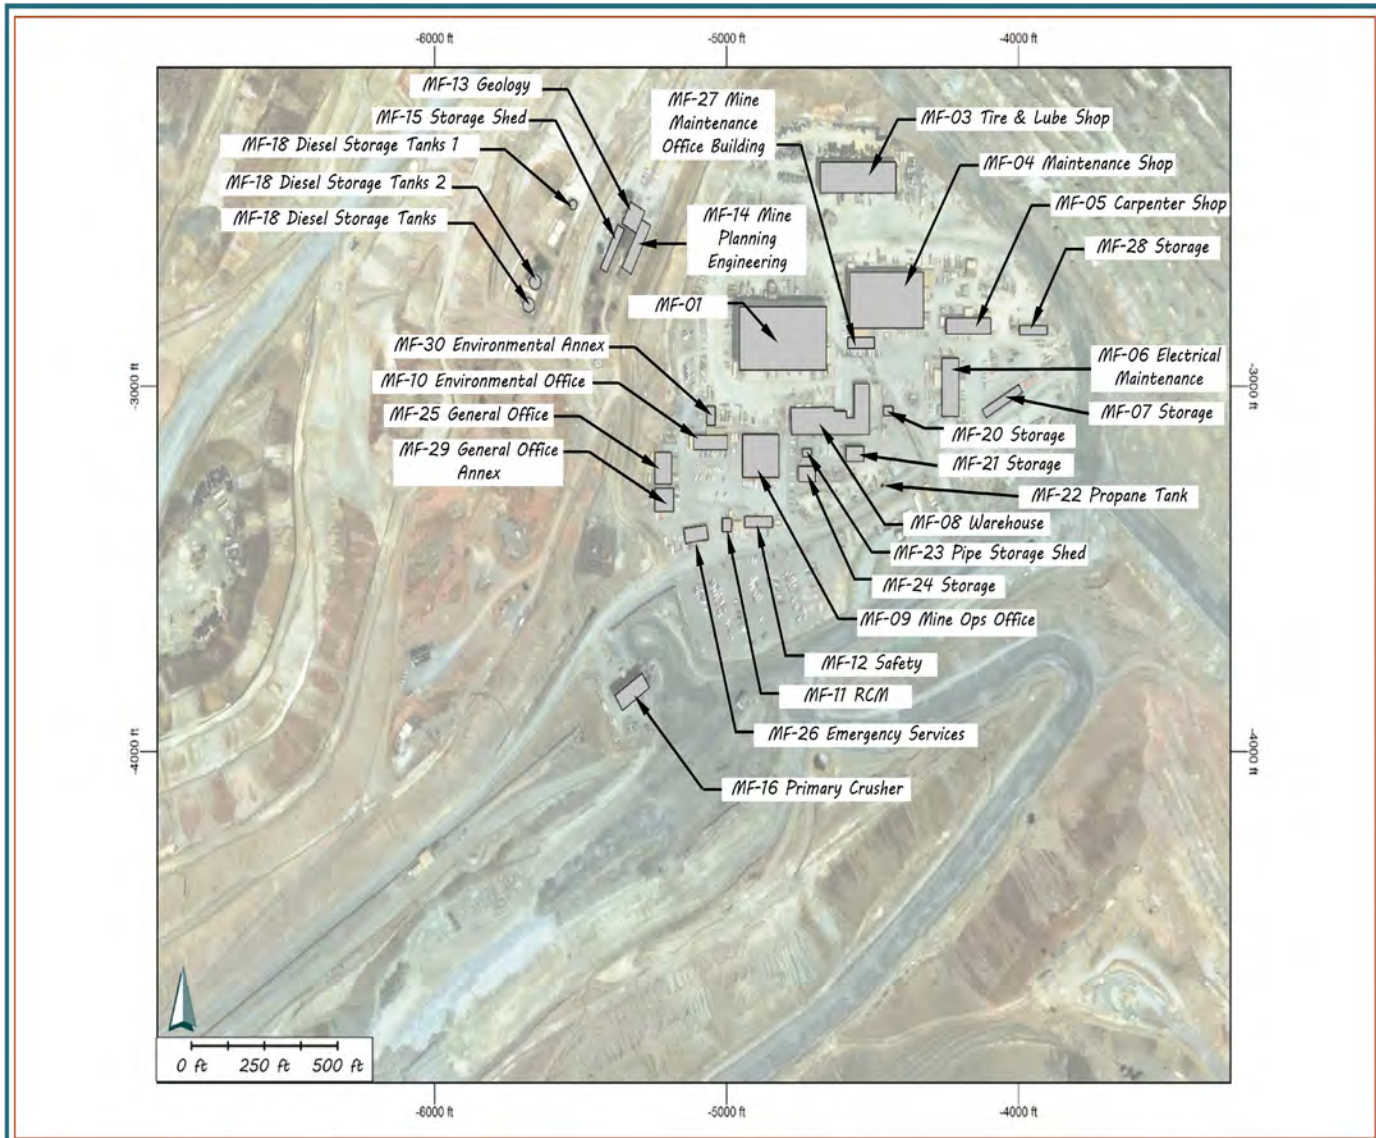
**Figure 1 Mine Facilities Area Building**

Figure 1 displays the 23 buildings inspected in the Mine Maintenance Facilities Area. Table 1 provides a list of these buildings, and a general description of their current use. Attachment A provides the original inspection field sheets and building photographs.

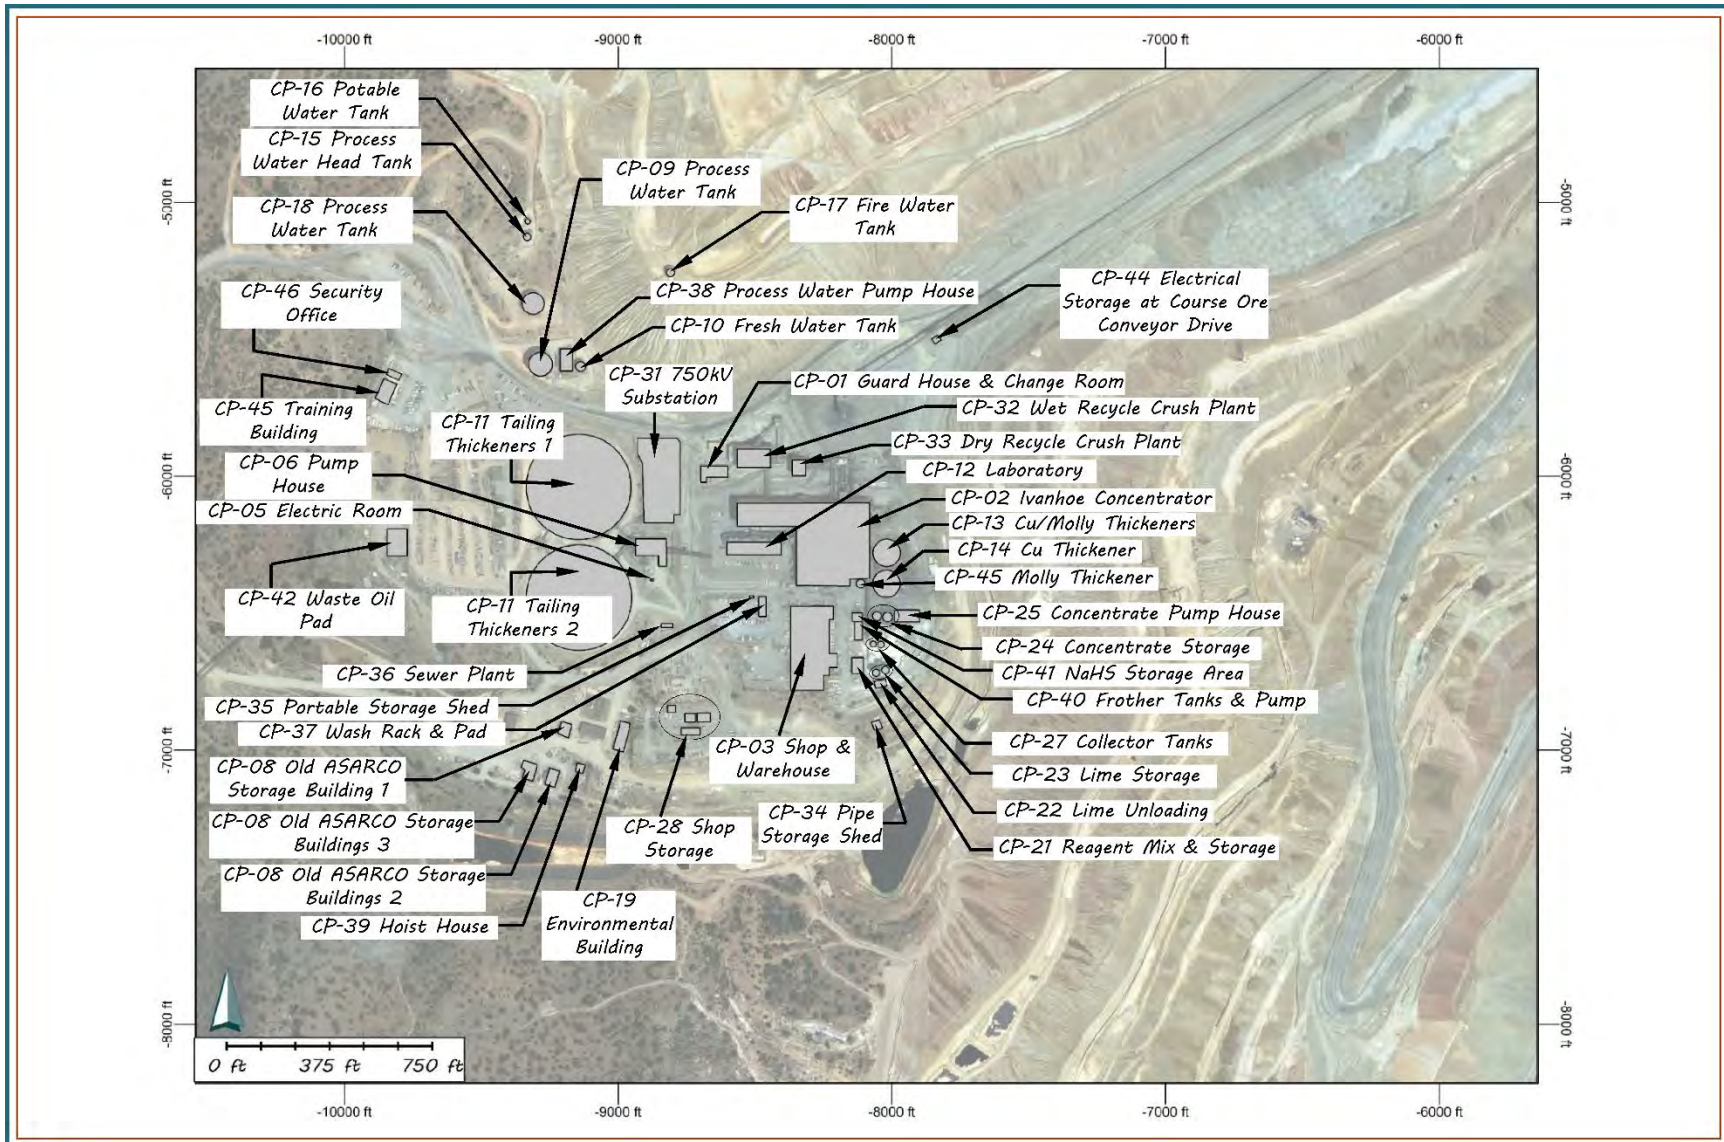
**Figure 3 Concentrator Area Buildings**

Figure 3 displays the 37 buildings inspected in the Concentrator Area. Table 3 provides a list of the buildings in this area, and a general description of their current use. Attachment C provides the original inspection field sheets and building photographs.

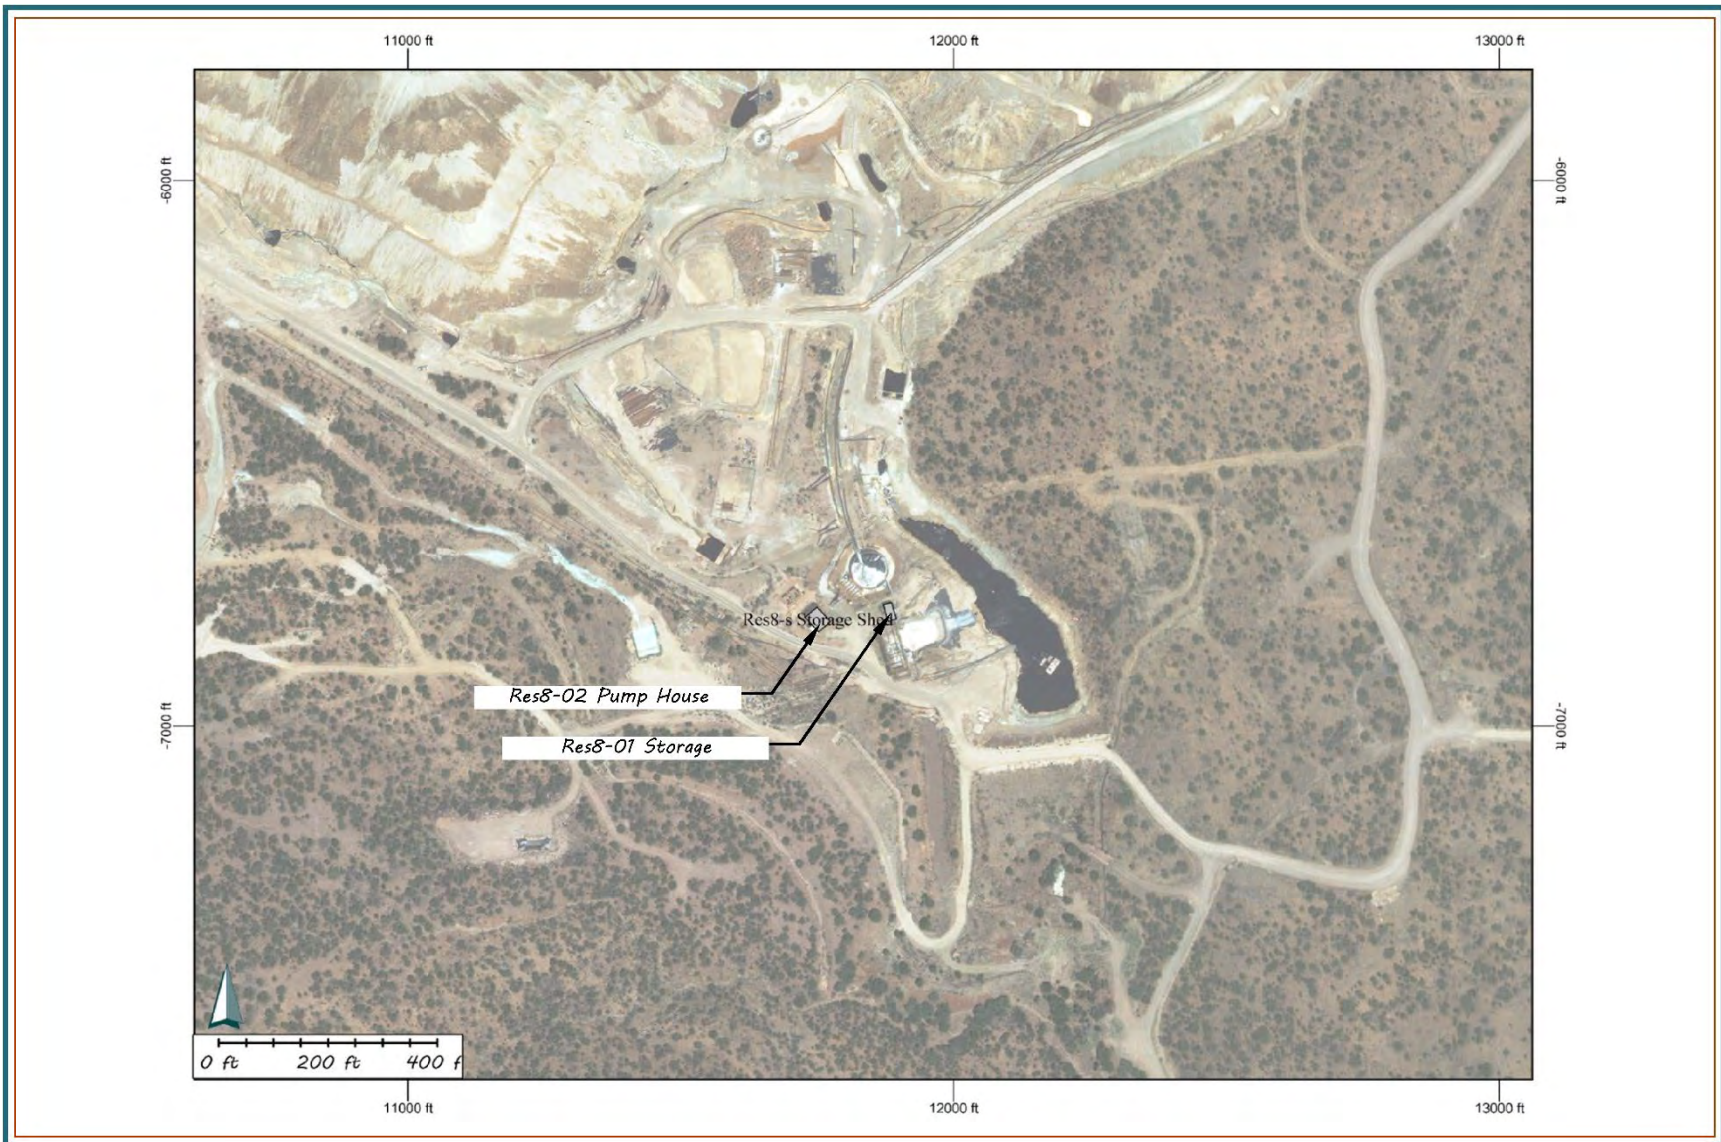
**Figure 4** Miscellaneous Area Buildings–Reservoir 8

Figures 4 and 5 displays the buildings inspected in the Reservoir 8 and Tailings Areas. In all the team inspected 23 buildings. Table 4 provides a list of the buildings in the MF area, and a general description of their current use. Attachment D provides the original inspection field sheets and building photographs.

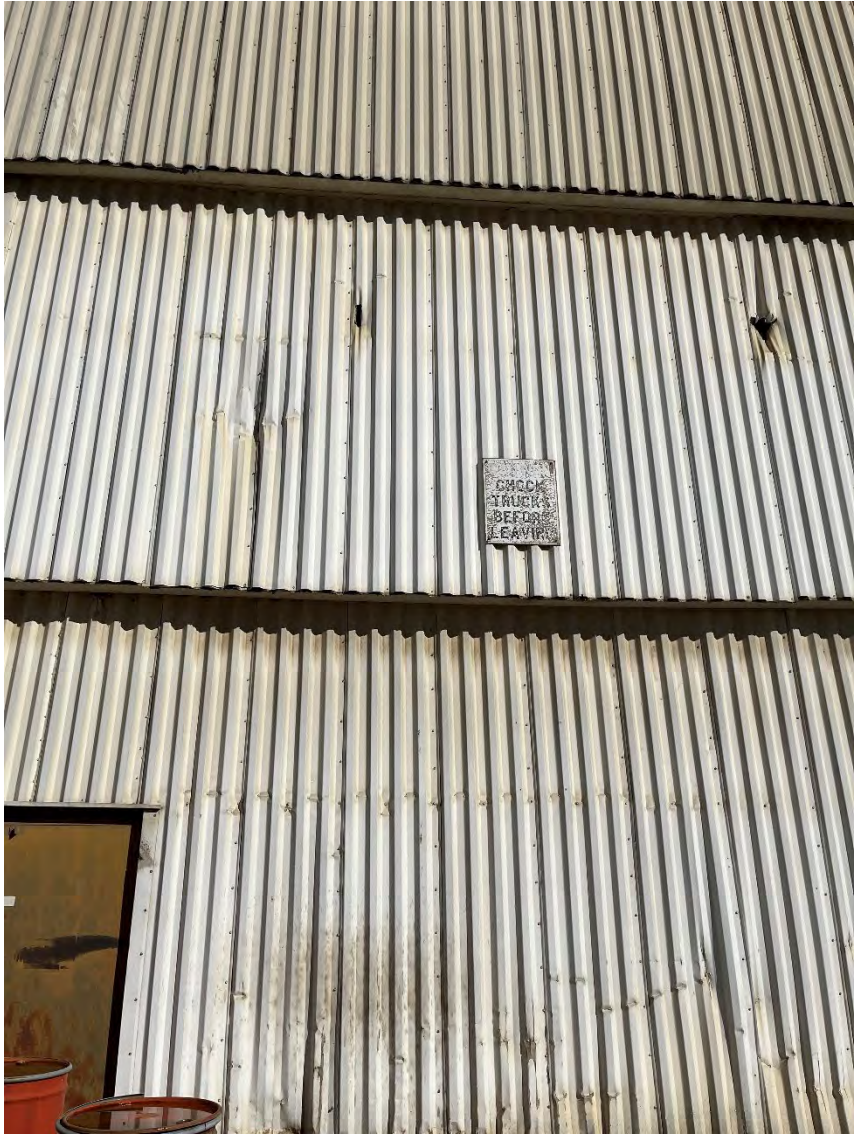
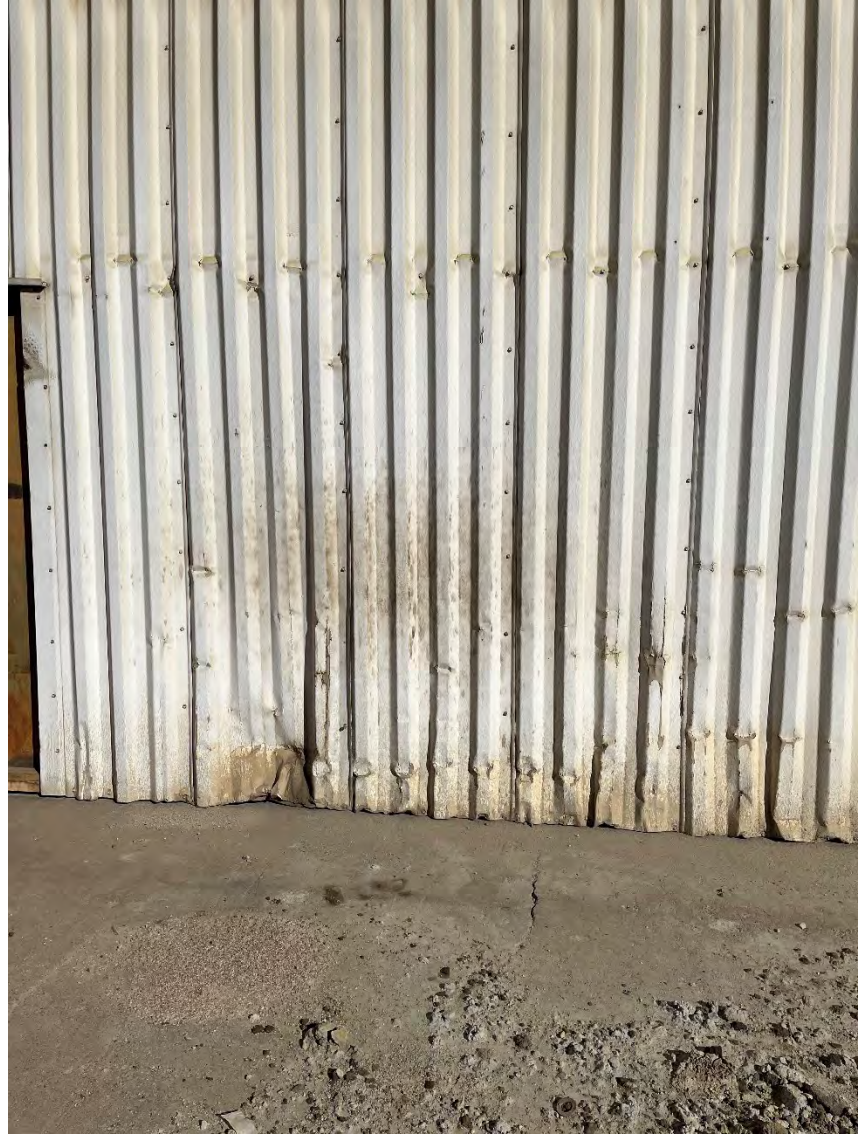
**MF-01**  
**External Damage**

Category	Condition			Comments
	Good	Fair	Poor	
<b>Civil</b>				
Condition of Site		X		- Poor between shops, N side poor also - N/A - N/A
Drainage Around Facility			X	
Access to Facility	X			
Building Parking				
Fencing or Security				
<b>Foundation</b>				
Foundation	X			
Floor Slabs	X			
If process Facility: Cond of equip fnds				
<b>Structure</b>				
Framing: Walls	X			
Framing: Roofs	X			
Framing: Internal	X			
If Concrete structure				
<b>Mechanical</b>				
HVAC if present	X			- Not observed
Water Supply if present	X			
Waste water if present	X			
Other utilities if present				
Fire protection if present				
<b>Piping</b>				
if facility is not building				
if facility is process				
<b>Electrical</b>				
Power supply	X			
Power distribution	X			
Lighting	X			
Other utilities if present				
<b>Architectural</b>				
Condition of Flooring	X			- Banged up - Can't observe - East door entry cracked
Wall systems		X		
roofing

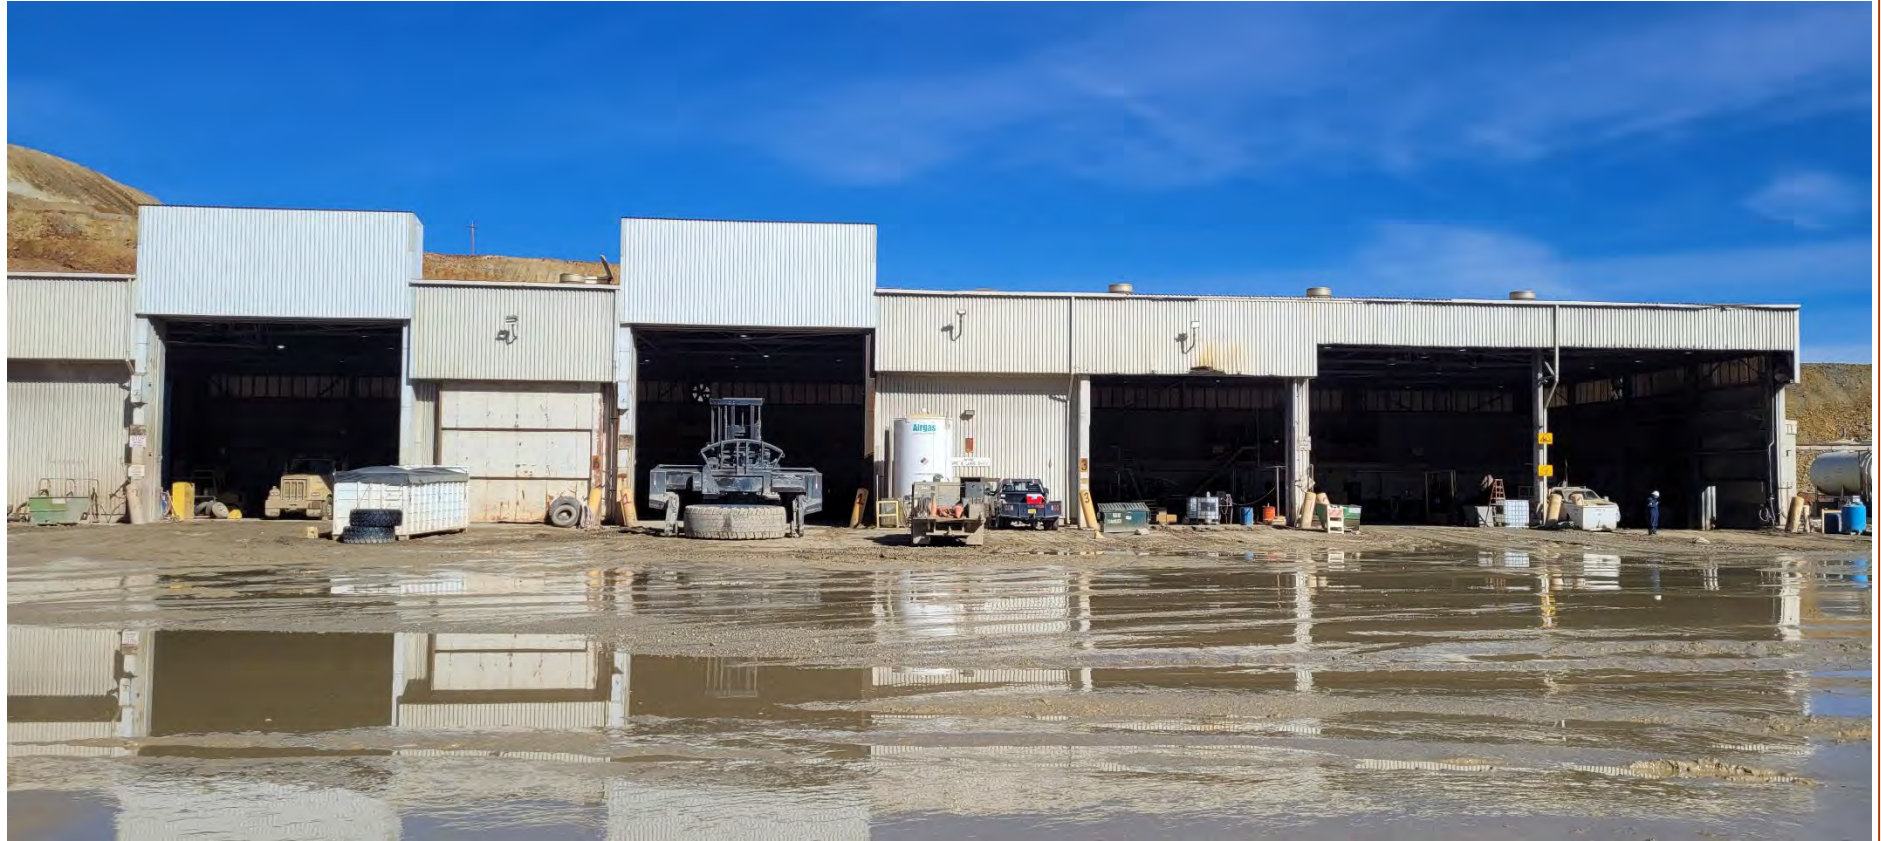
**MF-03**  
**External View**

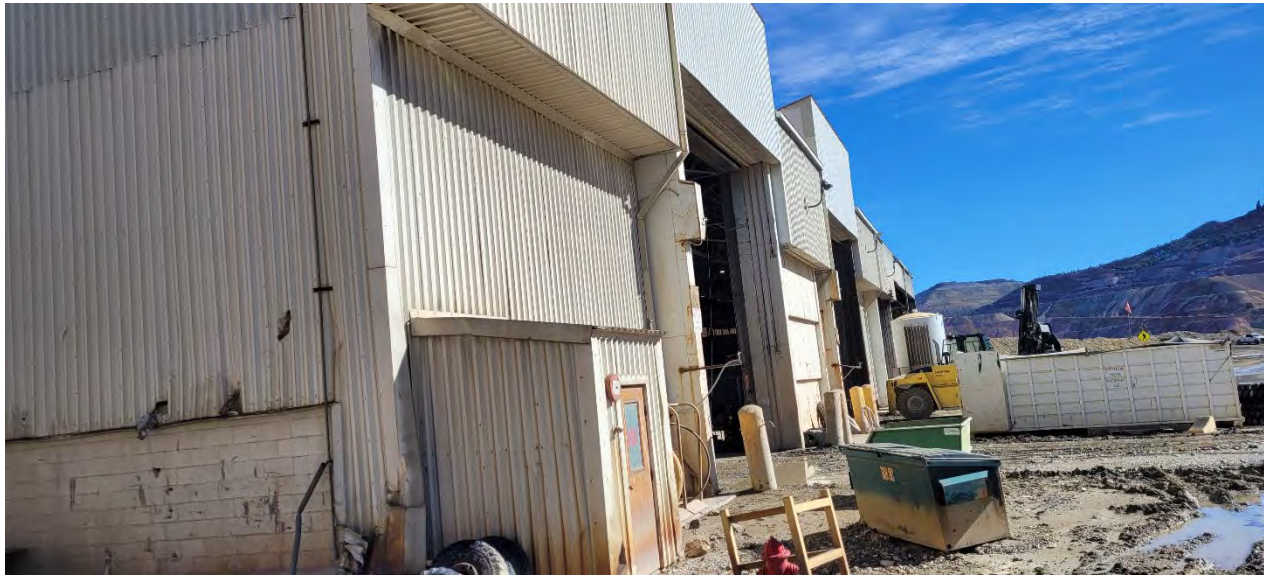
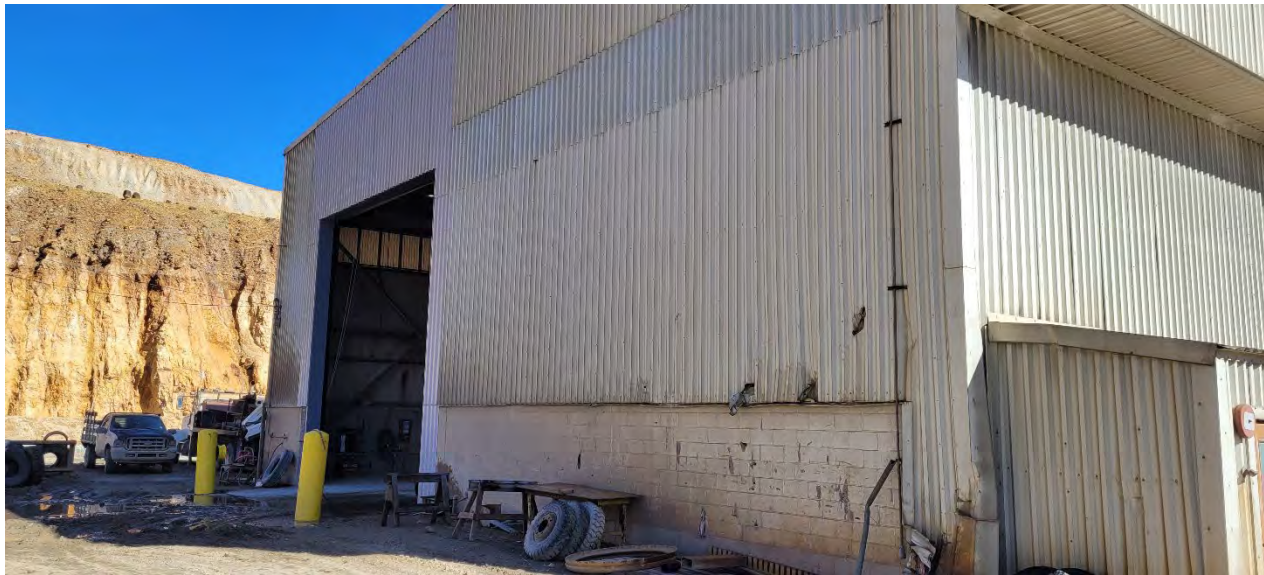
**MF-03**  
**External Damage**

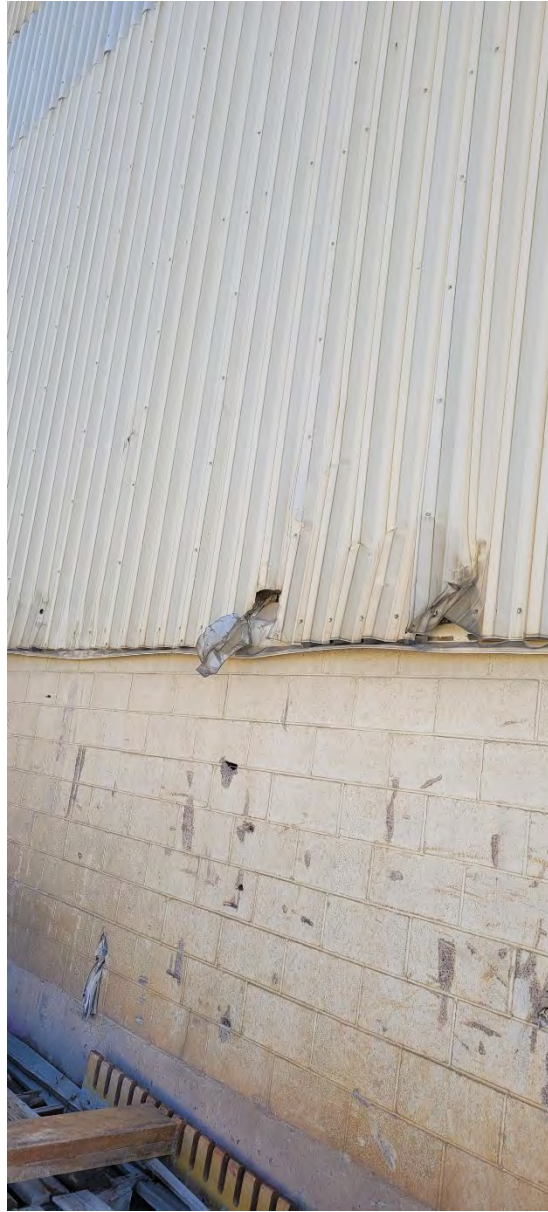
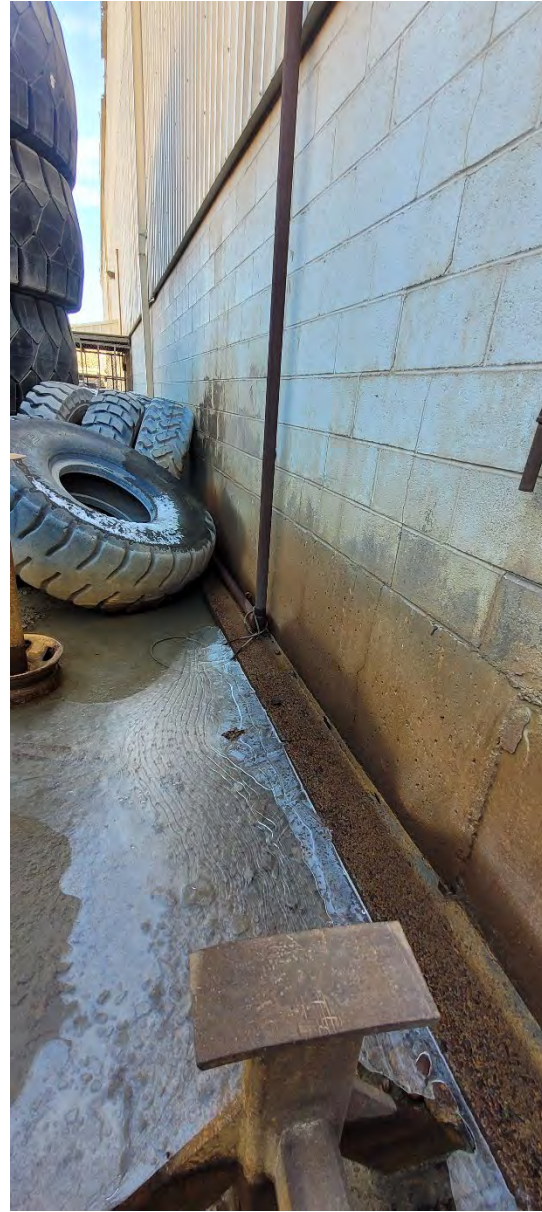
**MF-03**  
**External Damage**

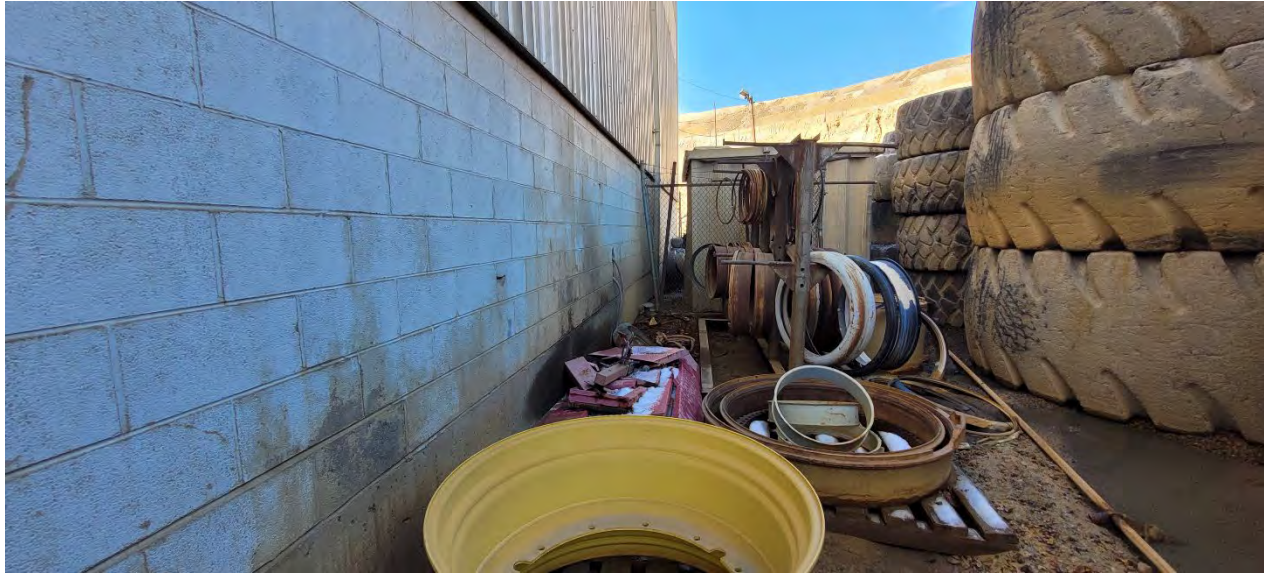
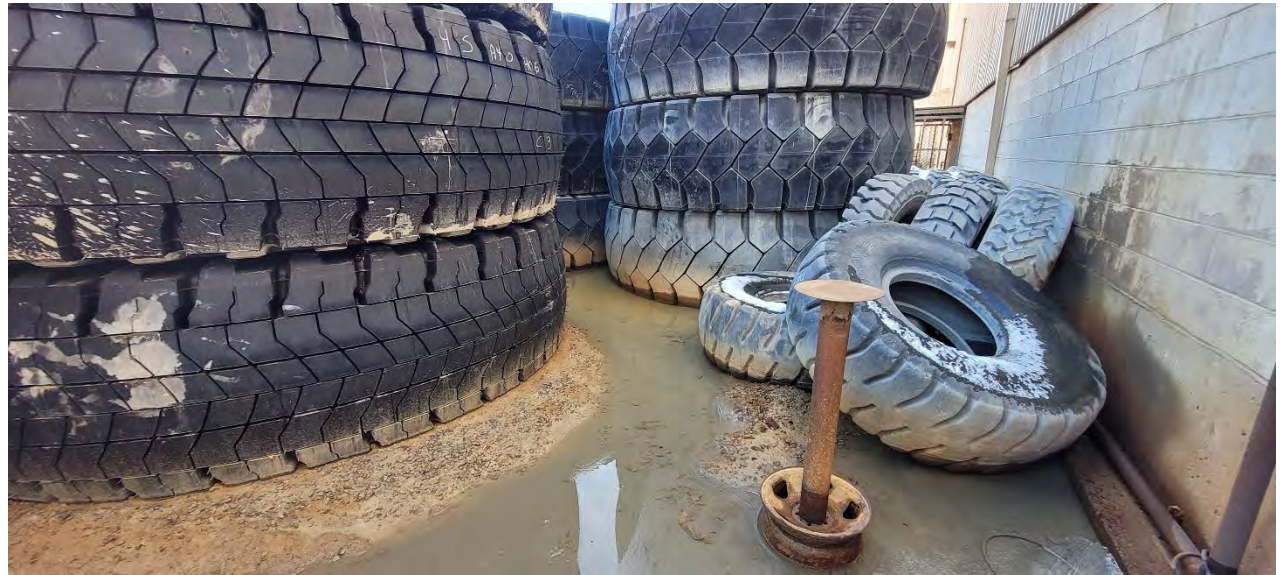
**MF-03**  
**Tire & Wheel Storage - Exterior**

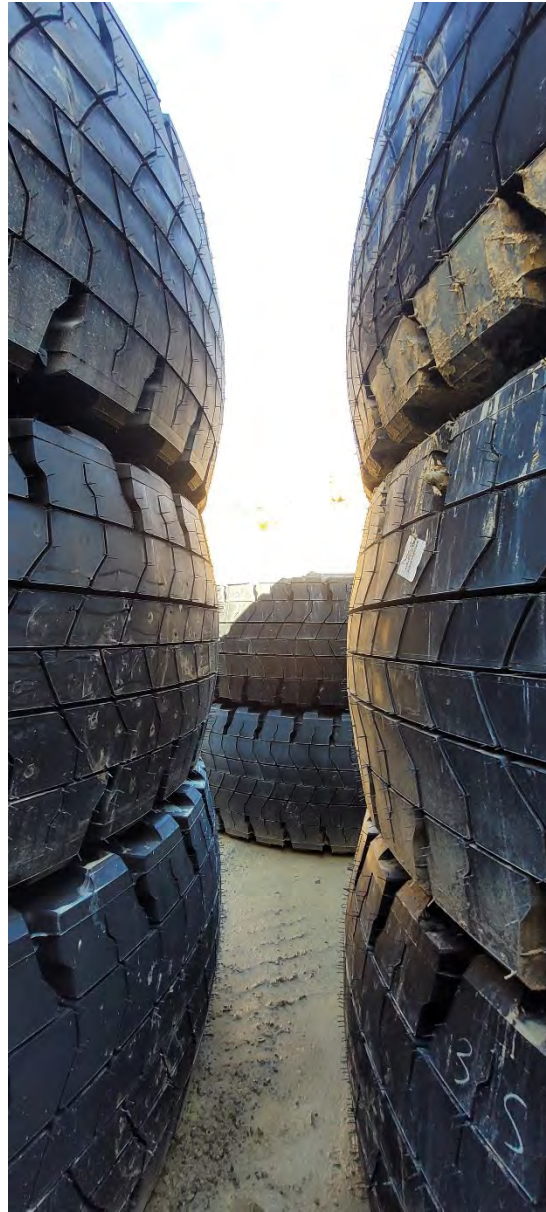
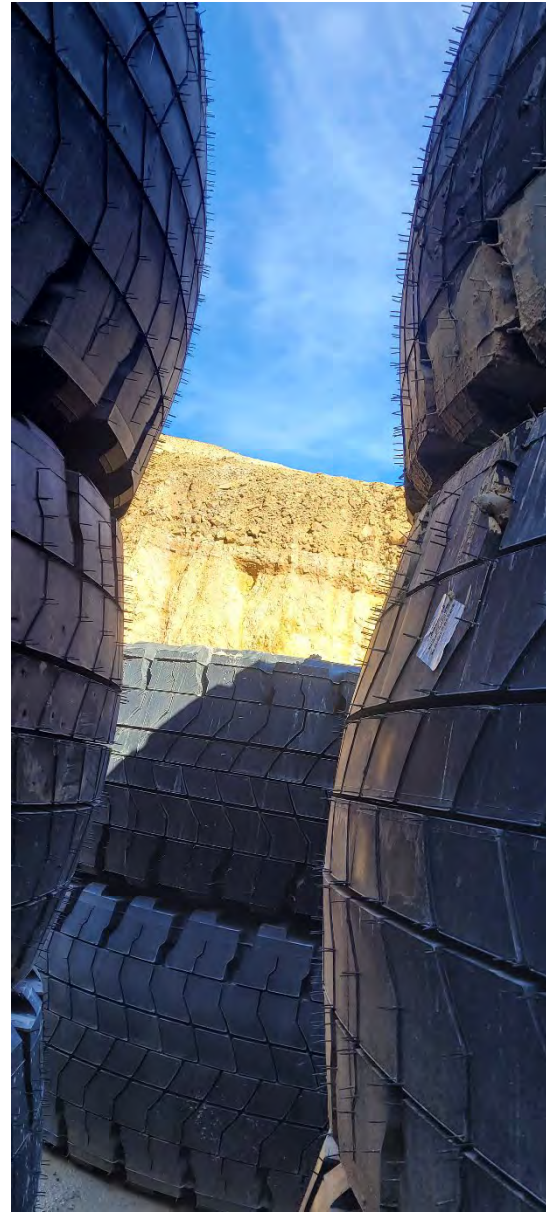
**MF-03  
Tire Stacks**

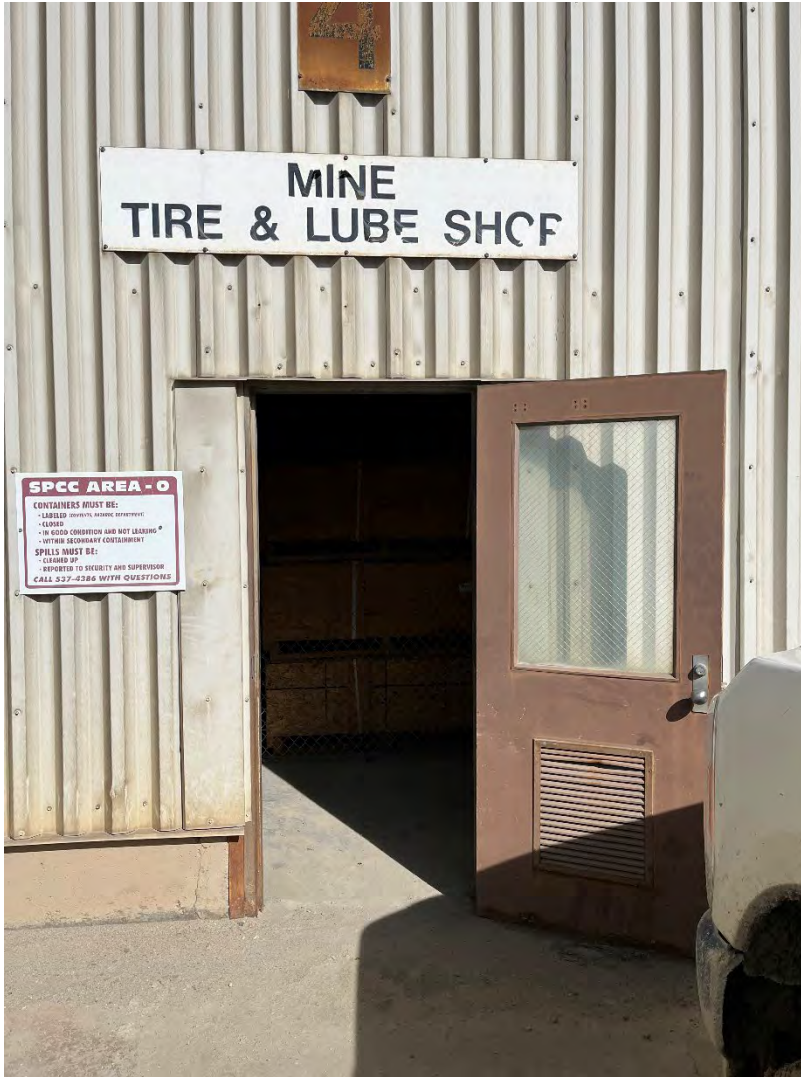
**MF-03  
External Damage**

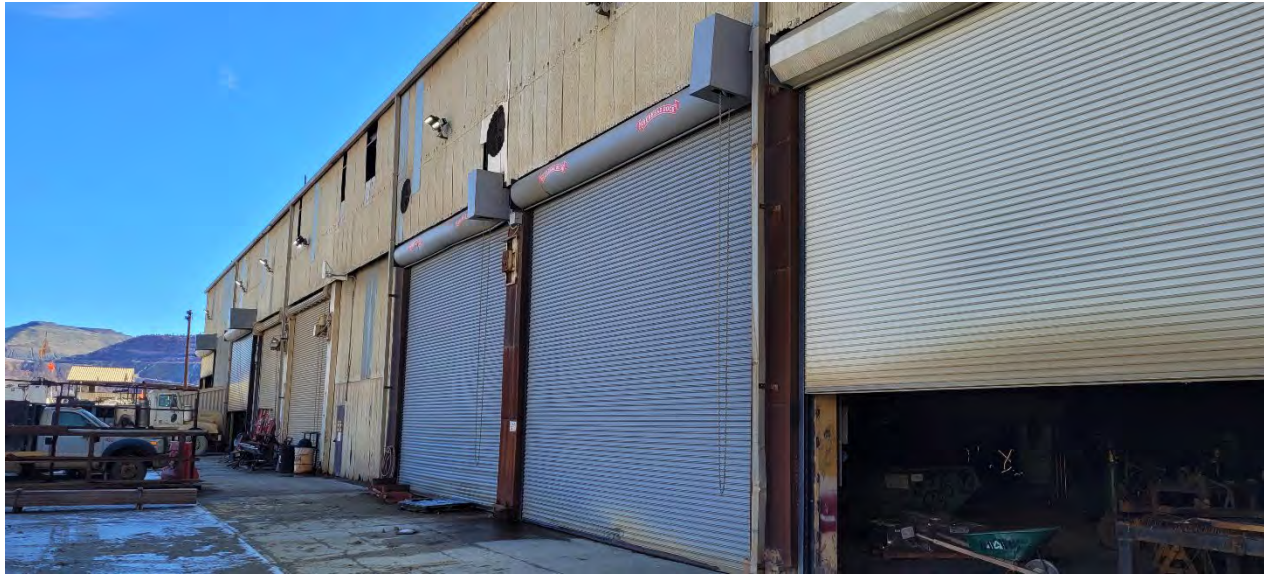
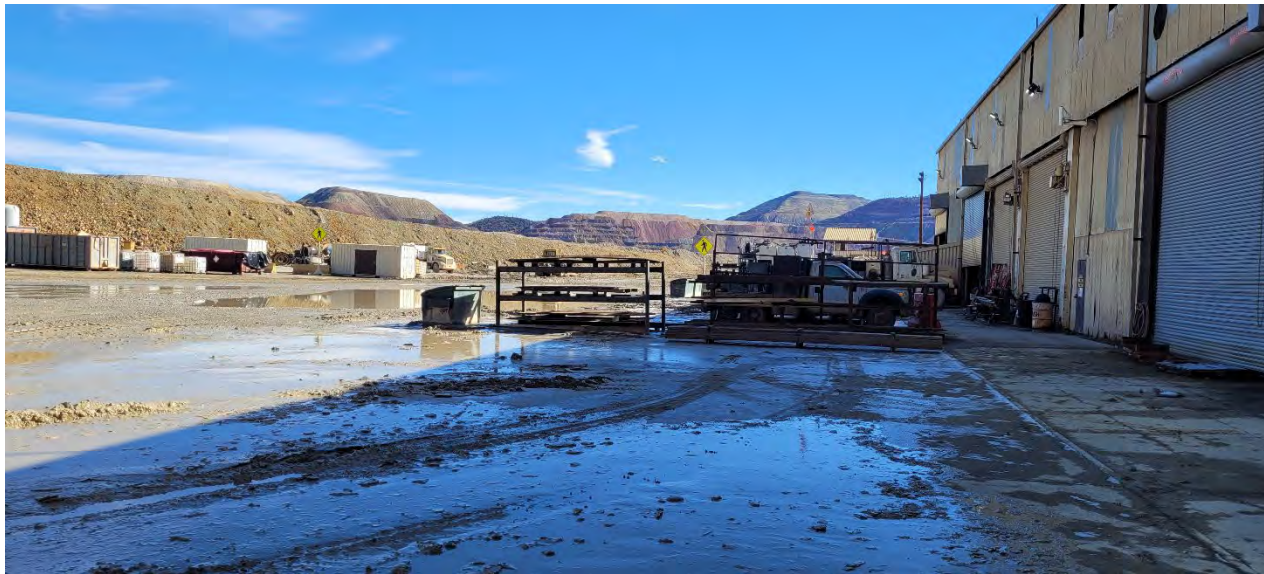
Category	Condition			Comments
	Good	Fair	Poor	
<b>Civil</b>				
Condition of Site	X			- Fair on NE side Demo small add on SE side N/A N/A
Drainage Around Facility	X			
Access to Facility	X			
Building Parking				
Fencing or Security				
<b>Foundation</b>				
Foundation		X		Flar slabs w/ 2x2 feeters, north side pillar foundations need repair
Floor Slabs	X			
If process Facility: Cond of equip fnds	X			
<b>Structure</b>				
Framing: Walls	X			
Framing: Roofs	X			
Framing: Internal	X			
If Concrete structure				
<b>Mechanical</b>				
HVAC if present	X			-> Didn't observe
Water Supply if present	X			
Waste water if present	X			
Other utilities if present				
Fire protection if present				
<b>Piping</b>				
if facility is not building				
if facility is process				
<b>Electrical</b>				
Power supply	X			
Power distribution	X			
Lighting	X			
Other utilities if present				
<b>Architectural</b>				
Condition of Flooring	X			
Wall systems	X

**MF-04**  
**External View**

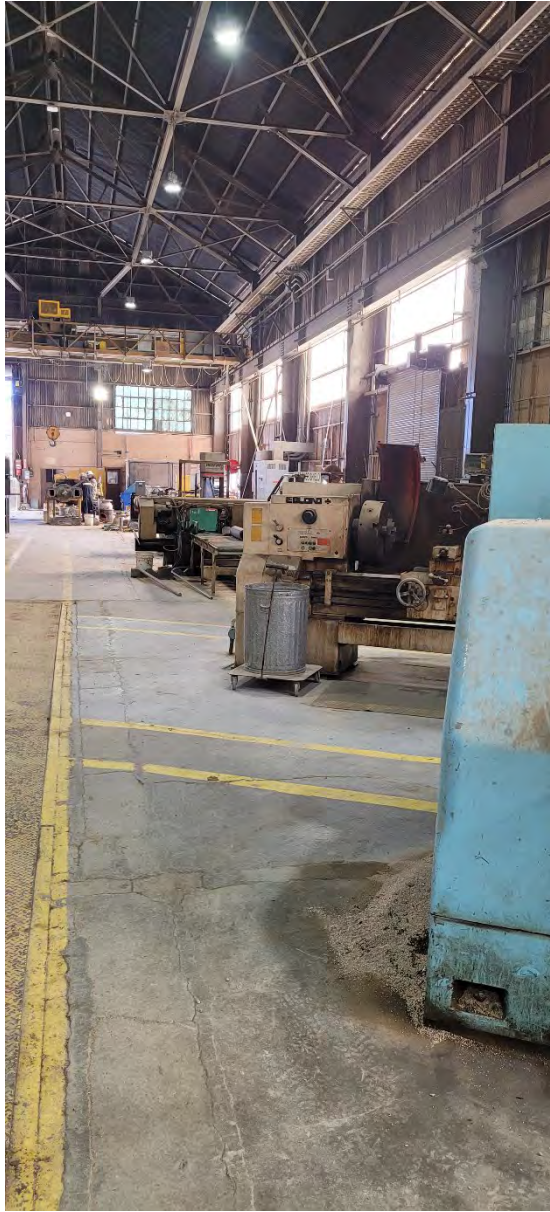
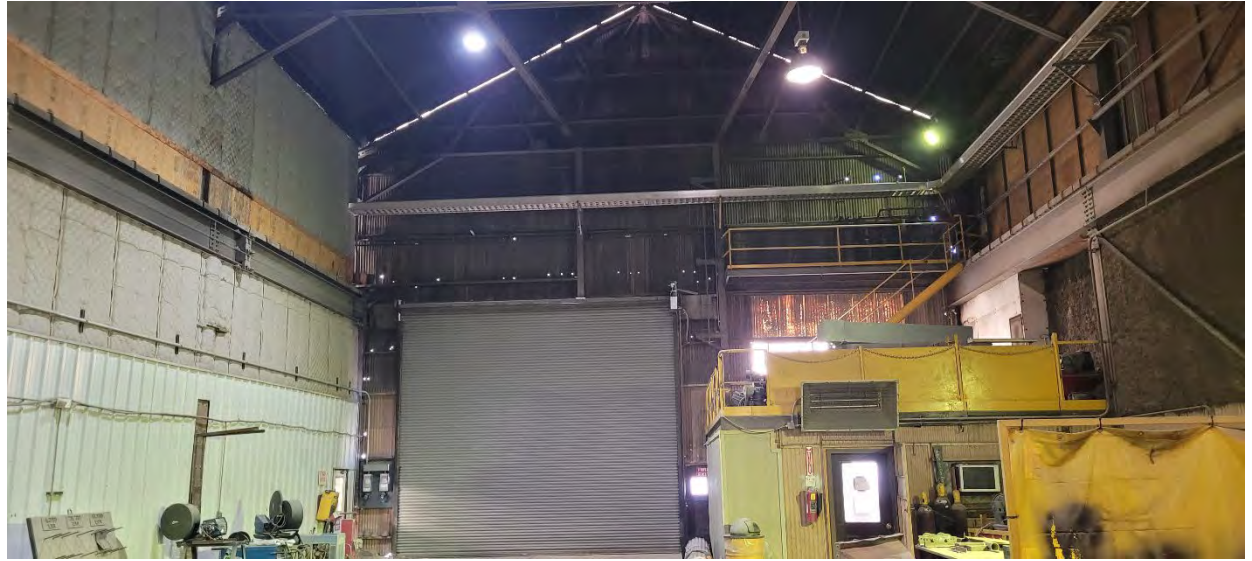
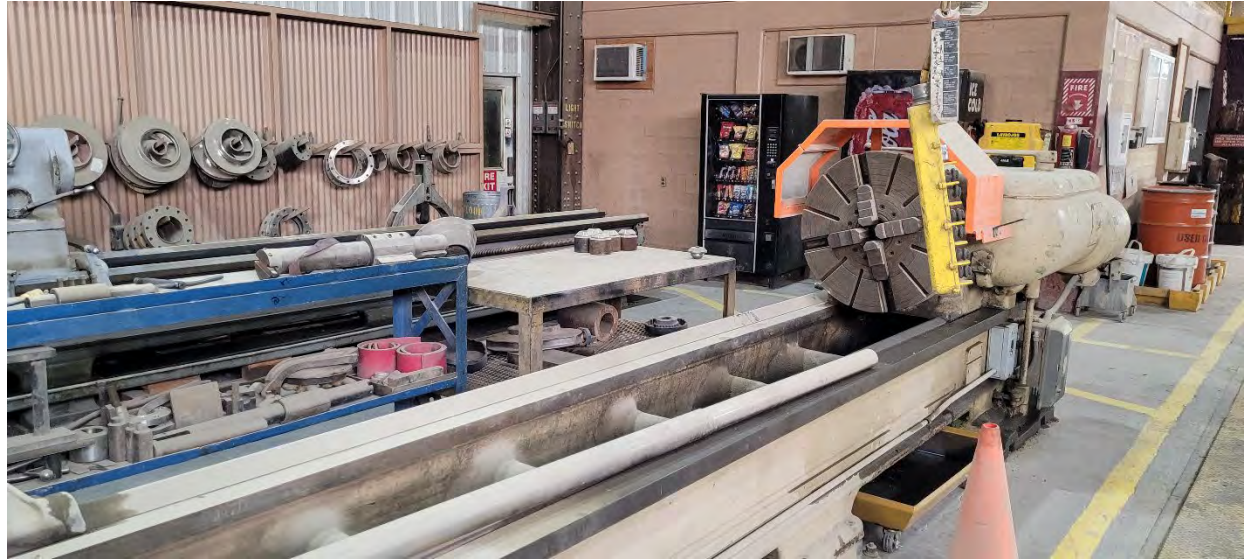
**MF-04**  
**Internal View**

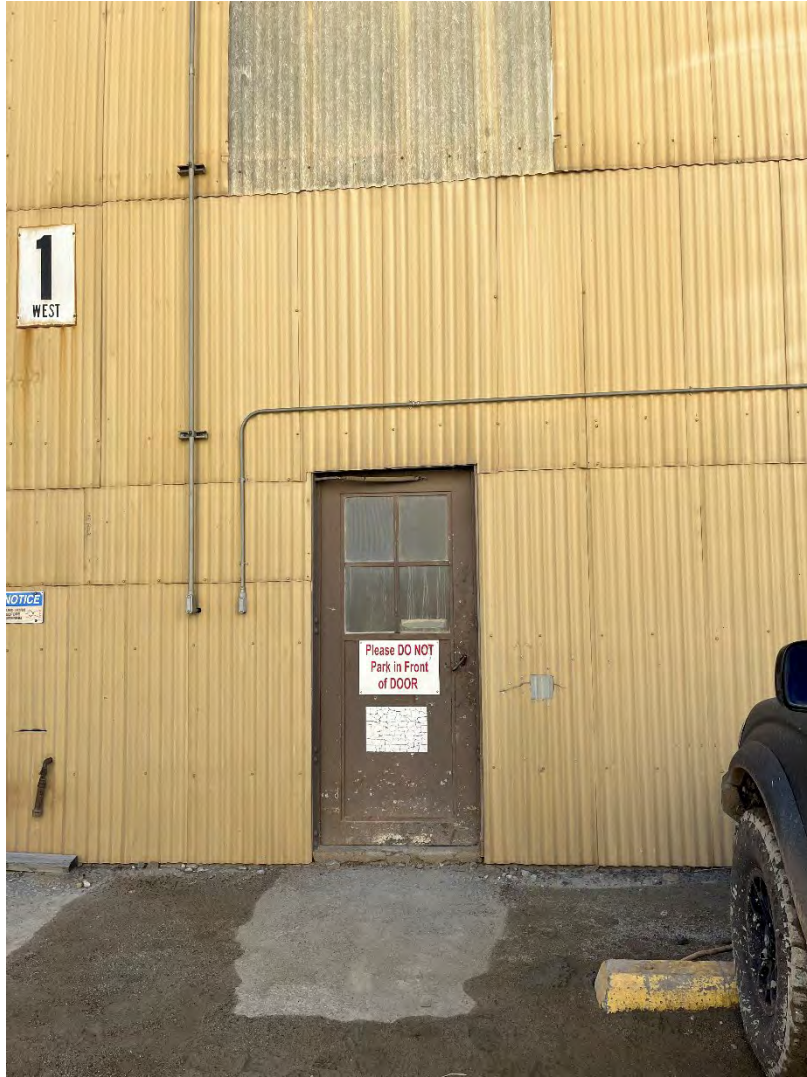
**MF-04**  
**External Door & Damage**

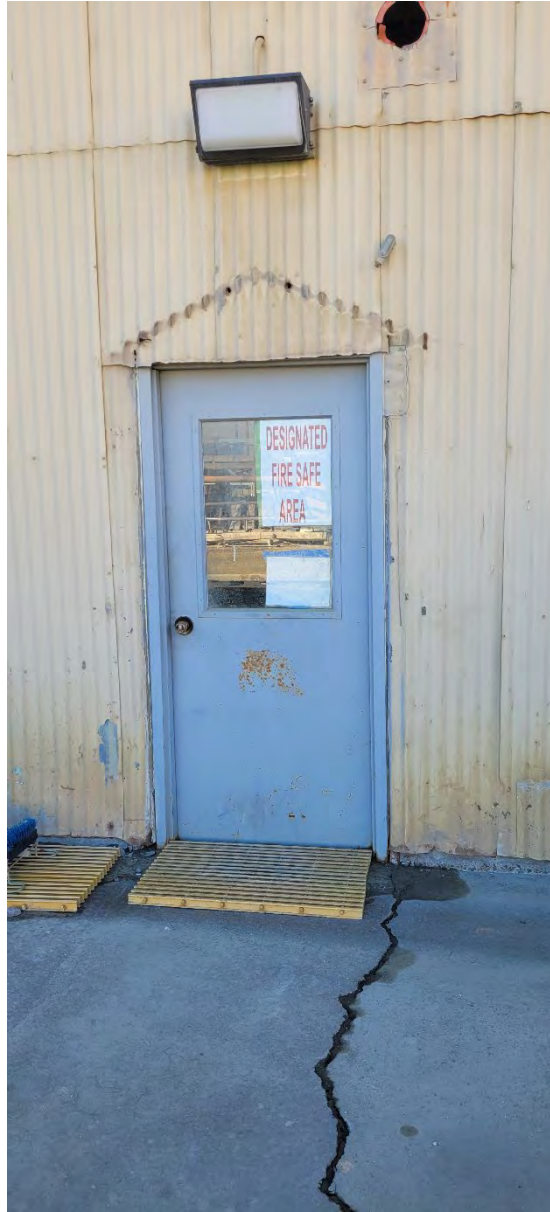
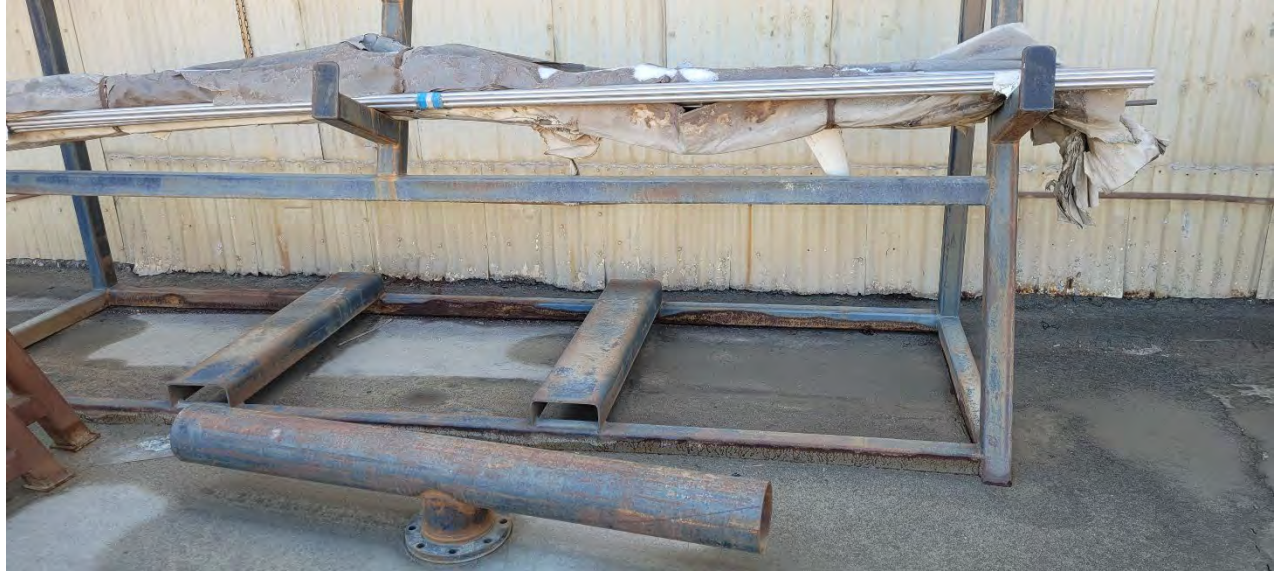
Category	Condition			Comments
	Good	Fair	Poor	
<b>Civil</b>				
Condition of Site	X			
Drainage Around Facility		X		North side pooling N/A
Access to Facility	X			
Building Parking				
Fencing or Security				
<b>Foundation</b>				
Foundation	X			Northside wet, small crack (not load bearing)
Floor Slabs	X			
If process Facility: Cond of equip fnds				
<b>Structure</b>				
Framing: Walls		X		Bldg skin rusting
Framing: Roofs	X			
Framing: Internal	X			
If Concrete structure				
<b>Mechanical</b>				
HVAC if present				- piping looks good
Water Supply if present	X			
Waste water if present	X			
Other utilities if present	X			
Fire protection if present	X			
<b>Piping</b>				
if facility is not building				
if facility is process				
<b>Electrical</b>				
Power supply	X			- Am, vac system
Power distribution	X			
Lighting	X			
Other utilities if present	X			
<b>Architectural</b>				
Condition of Flooring	X			- A few need replacing

**MF-05**  
**External Damage**
