# Post Mine Land Use Building Inspections

**Freeport-McMoRan Inc.  
Chino Mines Company  
99 Santa Rita Mine Road  
Vanadium, New Mexico 88043**

**Telesto Solutions Inc.  
750 14<sup>th</sup> Street SW  
Loveland, Colorado 80537**

**March 2024**

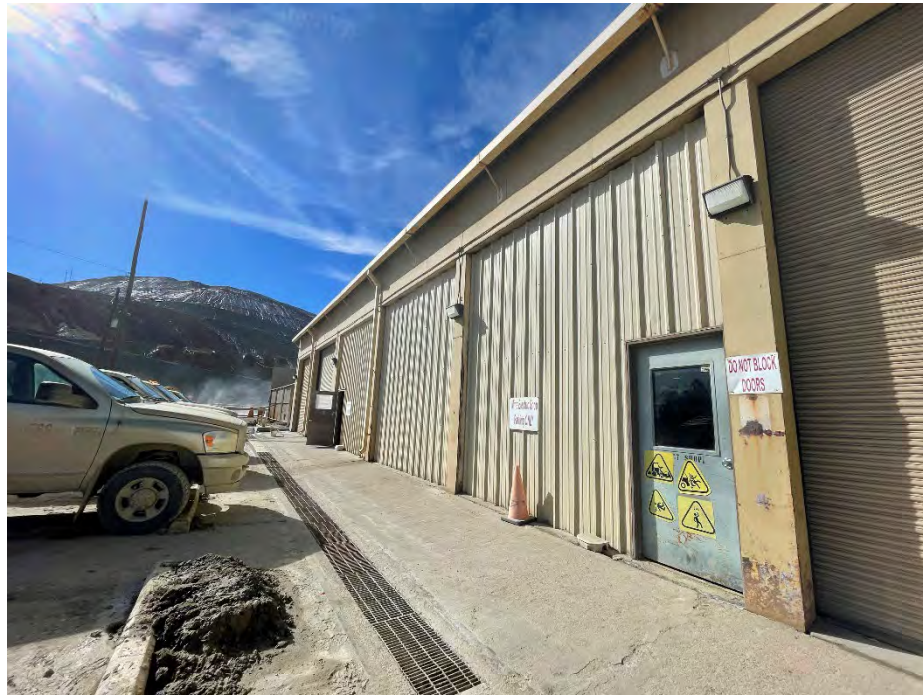
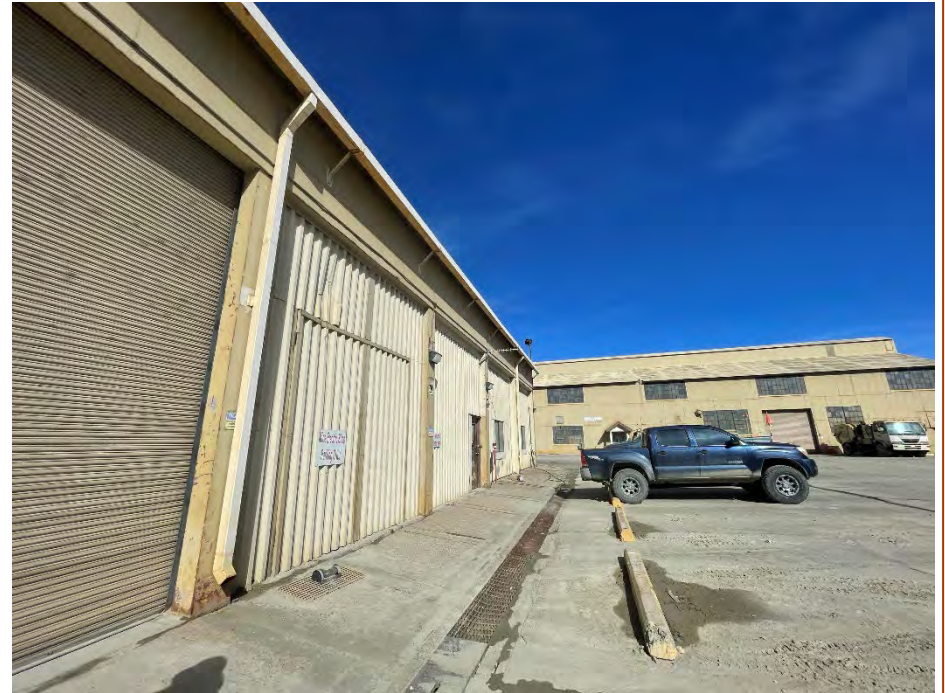
**MF-06**  
**External View**

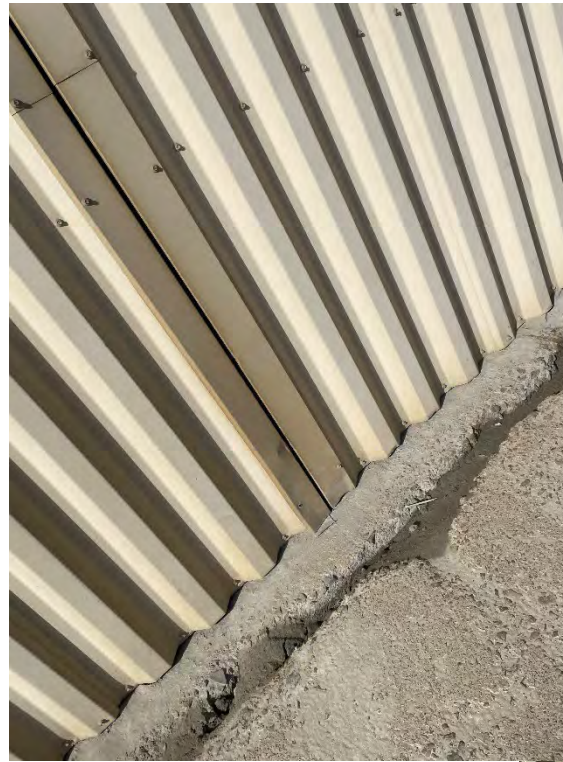
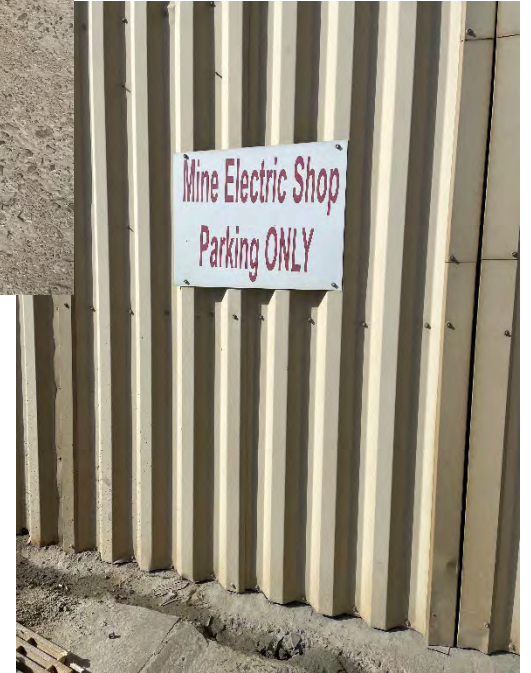
Category	Condition			Comments
	Good	Fair	Poor	
<b>Civil</b>				
Condition of Site	X			N/A
Drainage Around Facility	X			
Access to Facility	X			
Building Parking	X			
Fencing or Security				
<b>Foundation</b>				
Foundation	X			
Floor Slabs	X			
If process Facility: Cond of equip fnds				
<b>Structure</b>				
Framing: Walls	X			
Framing: Roofs	X			
Framing: Internal	X			
If Concrete structure	X			
<b>Mechanical</b>				
HVAC if present				N/A
Water Supply if present	X			
Waste water if present	X			
Other utilities if present				
Fire protection if present				
<b>Piping</b>				
if facility is not building				
if facility is process				
<b>Electrical</b>				
Power supply	X			
Power distribution	X			
Lighting	X			
Other utilities if present				
<b>Architectural</b>				
Condition of Flooring	X			concrete crack outside
Wall systems	X			
roofing	X			
ceilings	X			
doors	X			
windows	X			
points of egress	X			
		X

**MF-06**  
**Internal View & External Damage**

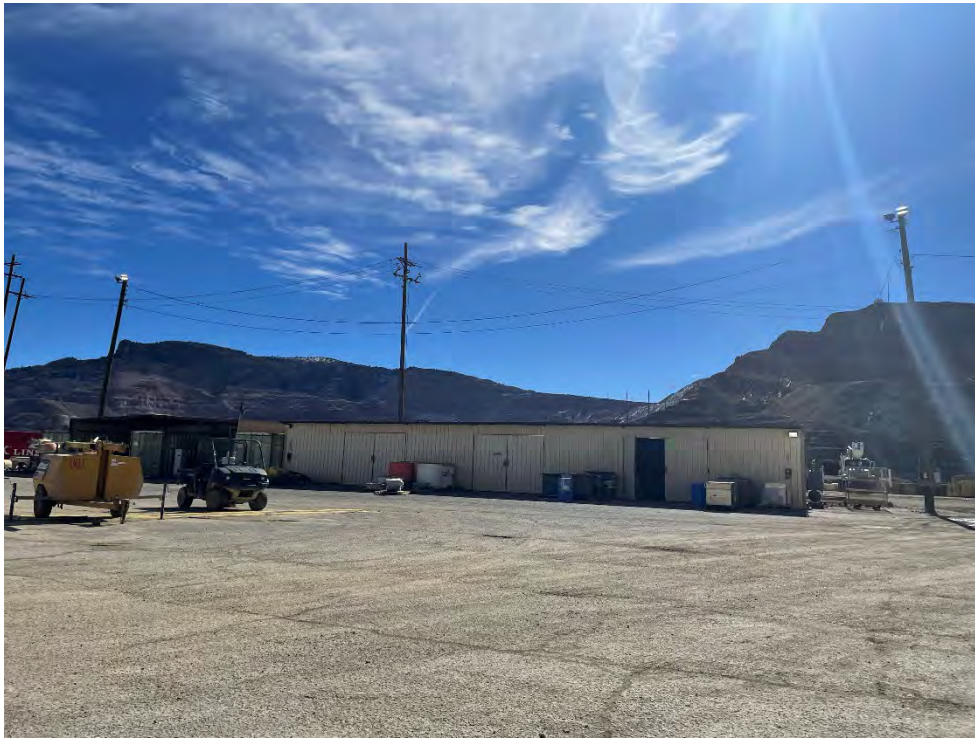
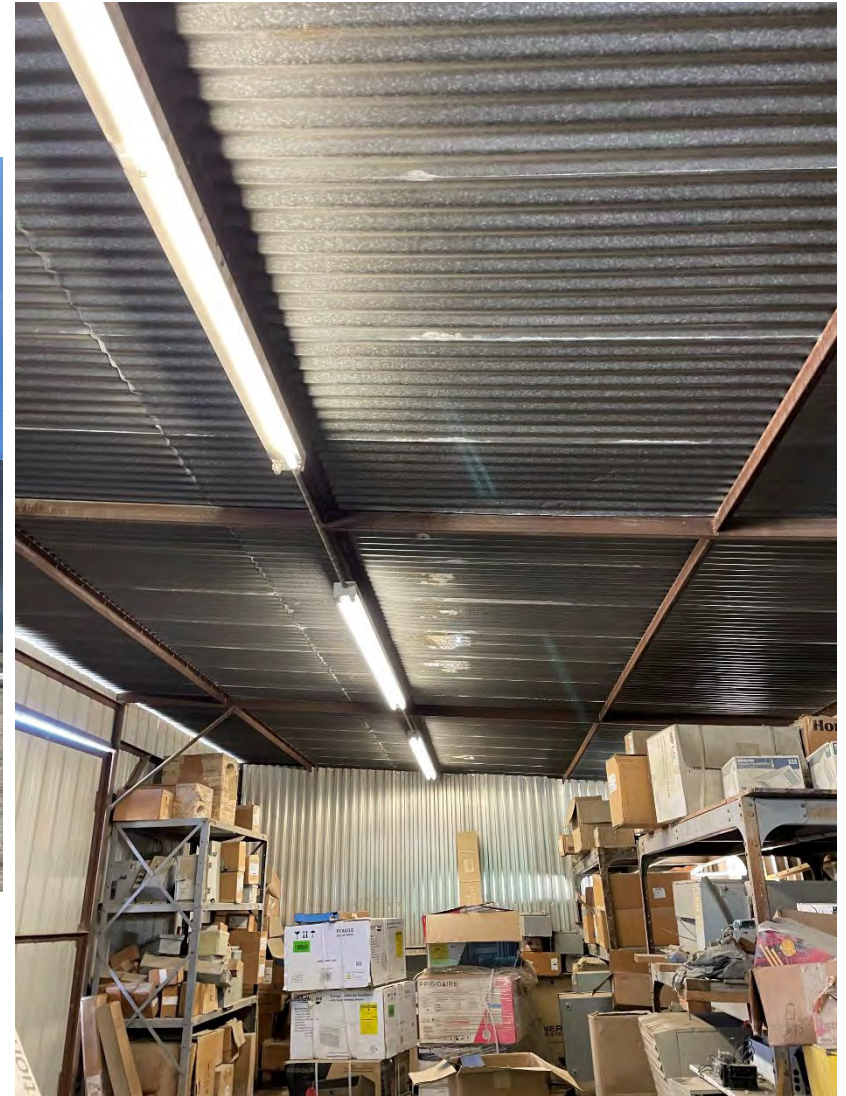
Category	Condition			Comments
	Good	Fair	Poor	
<b>Civil</b>				
Condition of Site	X			no gutters N/A
Drainage Around Facility	X			
Access to Facility	X			
Building Parking	X			
Fencing or Security				
<b>Foundation</b>				
Foundation	X			
Floor Slabs	X			
If process Facility: Cond of equip fnds				
<b>Structure</b>				
Framing: Walls	X			
Framing: Roofs	X			
Framing: Internal	X			
If Concrete structure	X			
<b>Mechanical</b>				
HVAC if present				N/A
Water Supply if present				N/A
Waste water if present				N/A
Other utilities if present				N/A
Fire protection if present				N/A
<b>Piping</b>				
if facility is not building				
if facility is process				
<b>Electrical</b>				
Power supply	X			
Power distribution	X			
Lighting	X			
Other utilities if present				
<b>Architectural</b>				
Condition of Flooring	X			rust spots ☐
Wall systems	X			
roofing		X		
ceilings	X			
doors	X			
windows	X			
points of egress	X

**MF-07**  
**External & Internal View**

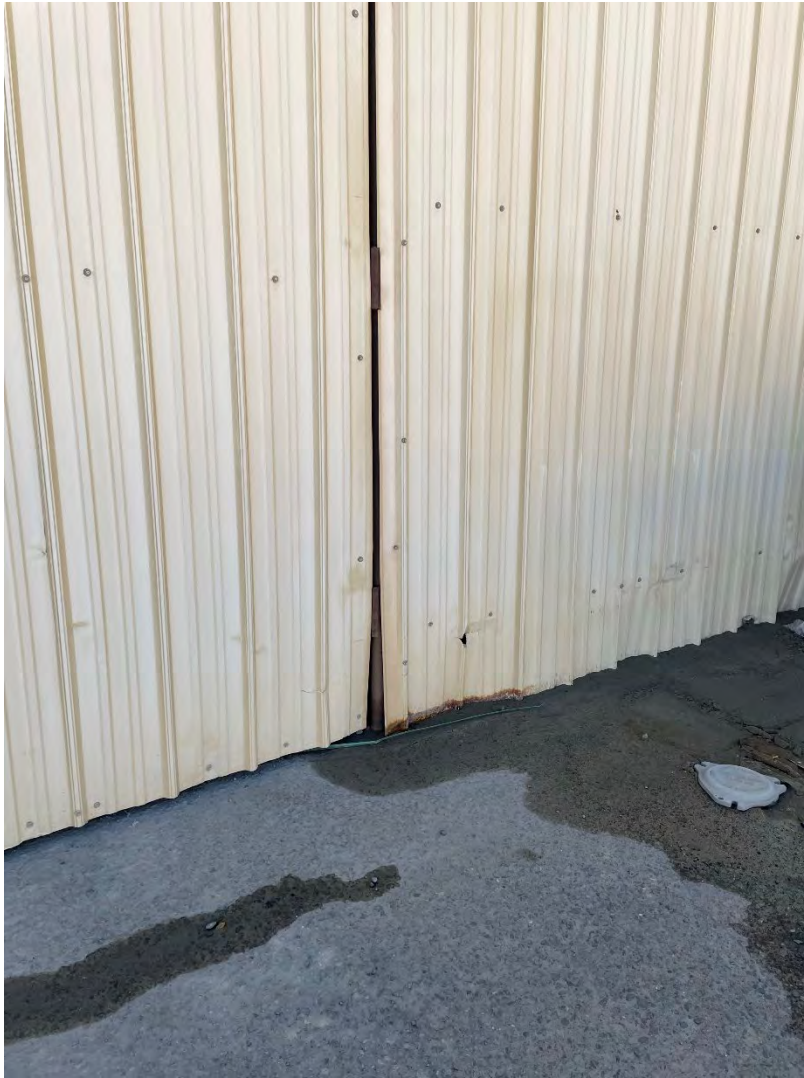
**MF-07**  
**External Damage**

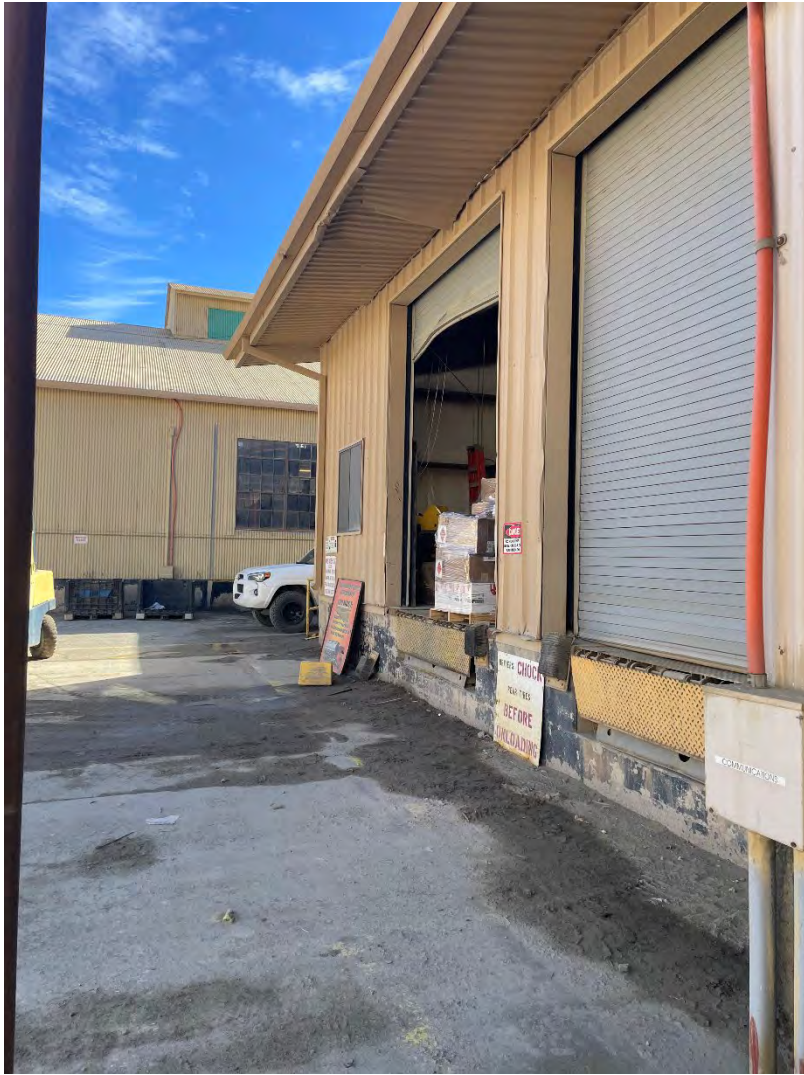
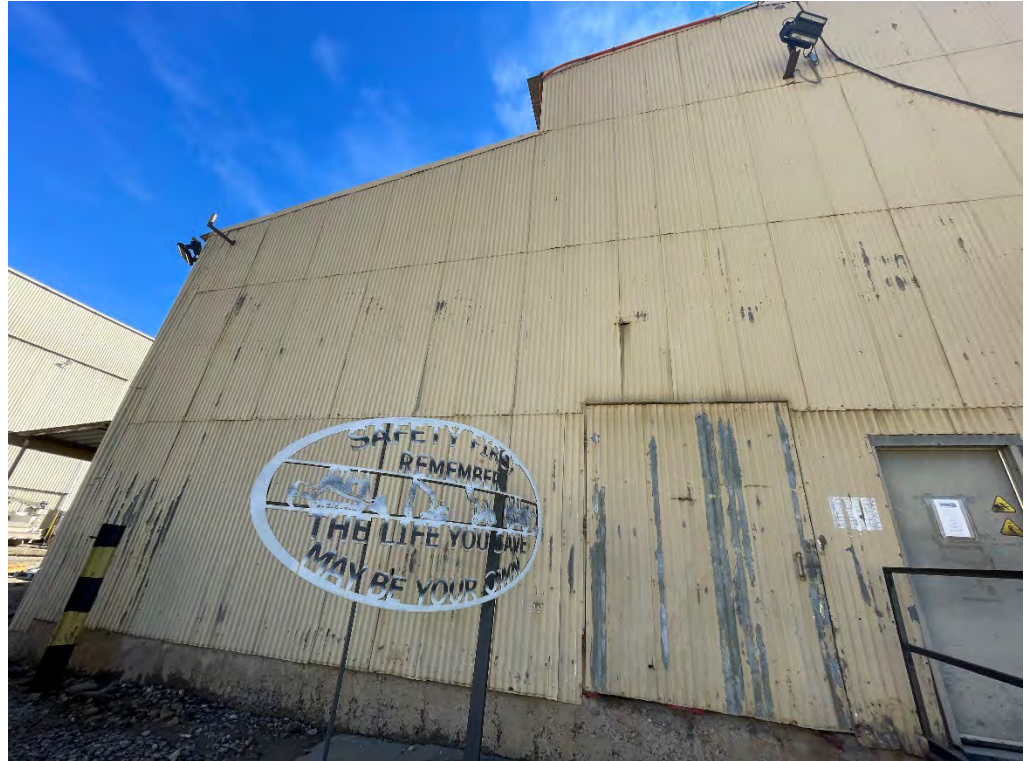
Category	Condition			Comments
	Good	Fair	Poor	
<b>Civil</b>				
Condition of Site	X			no gutters  N/A
Drainage Around Facility				
Access to Facility	X			
Building Parking	X			
Fencing or Security				
<b>Foundation</b>				
Foundation	X			
Floor Slabs	X			
If process Facility: Cond of equip fnds				
<b>Structure</b>				
Framing: Walls		X		Dents holes
Framing: Roofs	X			
Framing: Internal	X			
If Concrete structure	X			
<b>Mechanical</b>				
HVAC if present	X			N/A
Water Supply if present	X			
Waste water if present	X			
Other utilities if present				
Fire protection if present	X			
<b>Piping</b>				
if facility is not building				
if facility is process				
<b>Electrical</b>				
Power supply	X			
Power distribution	X			
Lighting	X			
Other utilities if present				
<b>Architectural</b>				
Condition of Flooring	X			
Wall systems	X			
roofing	X			
ceilings	X			
doors	X			
windows	X			
points of egress	X

**MF-08**  
**External View**

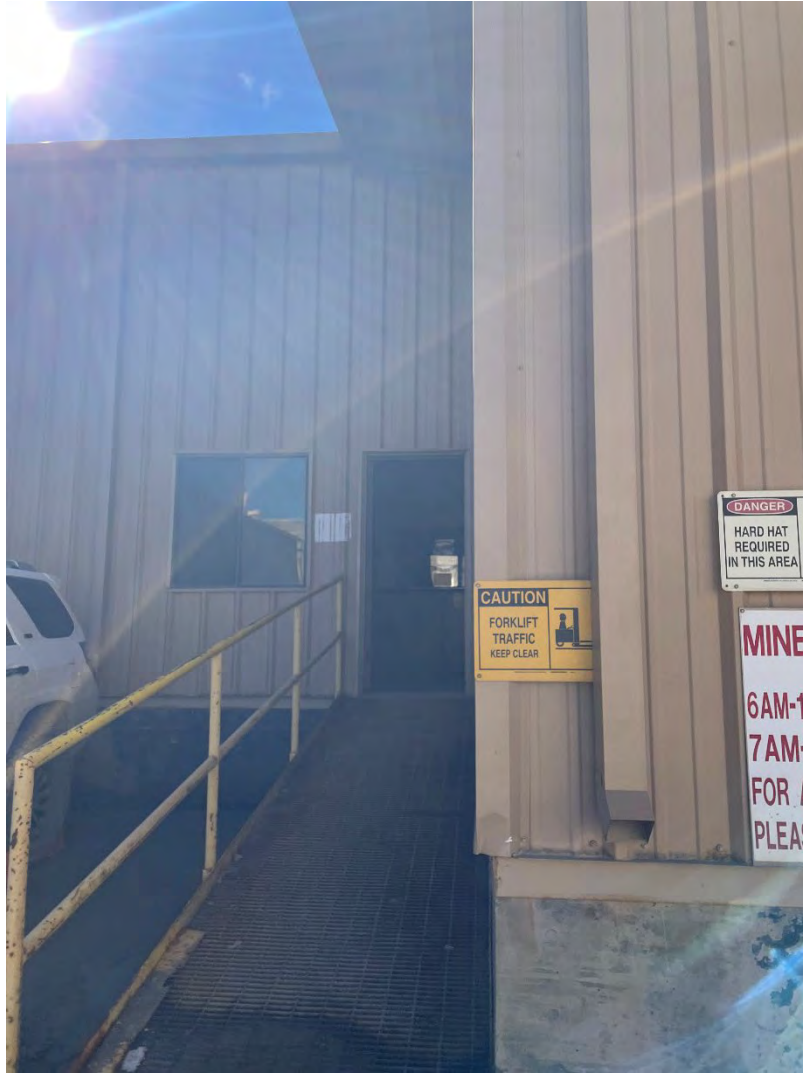
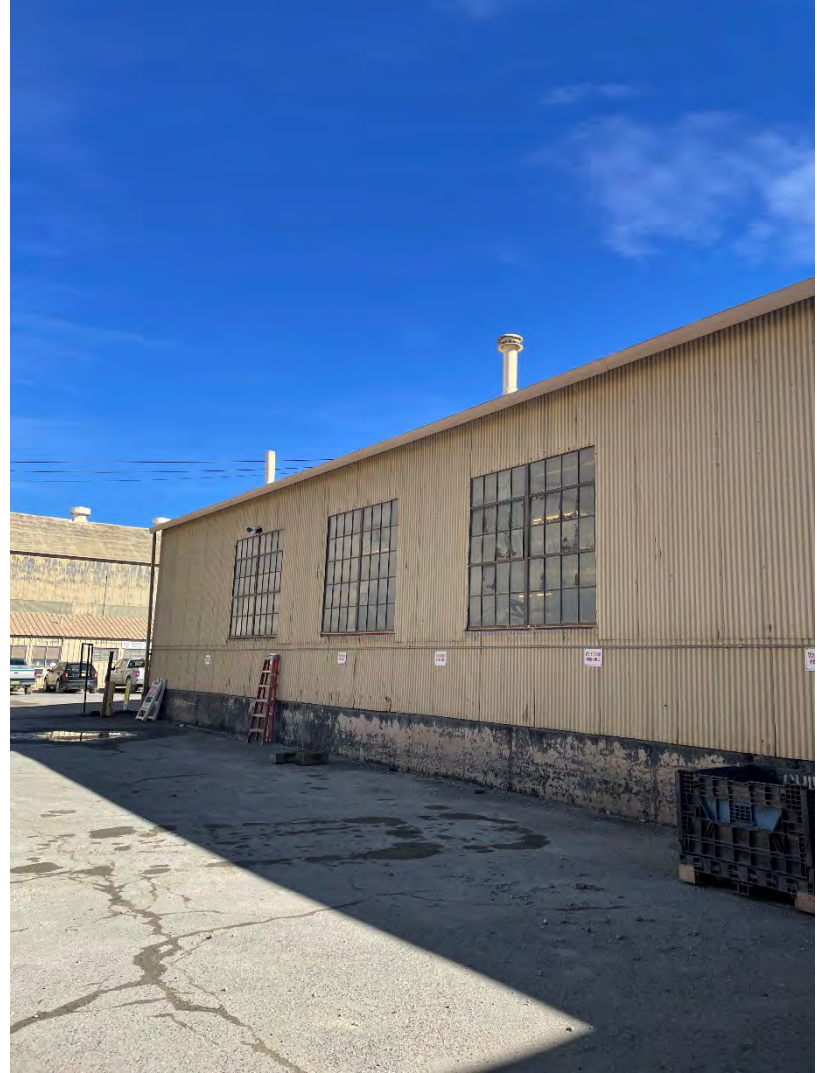
**MF-08**  
**External View**

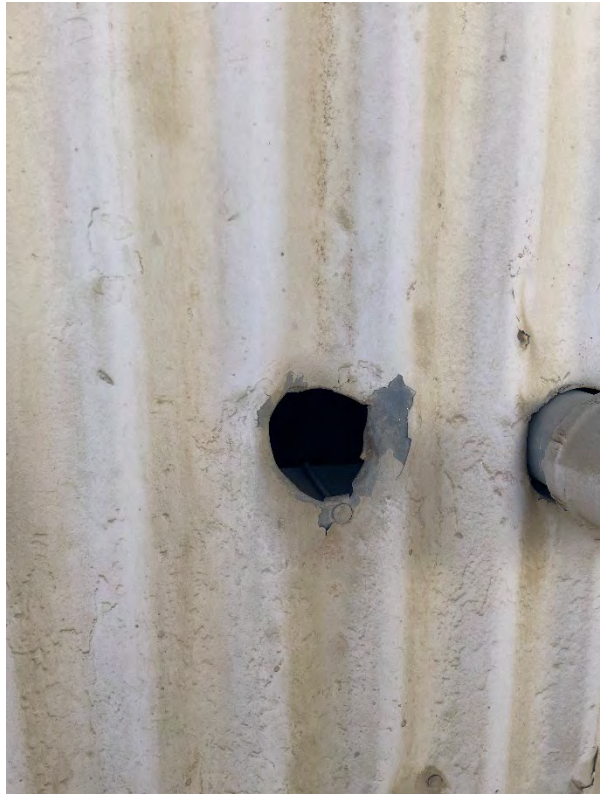
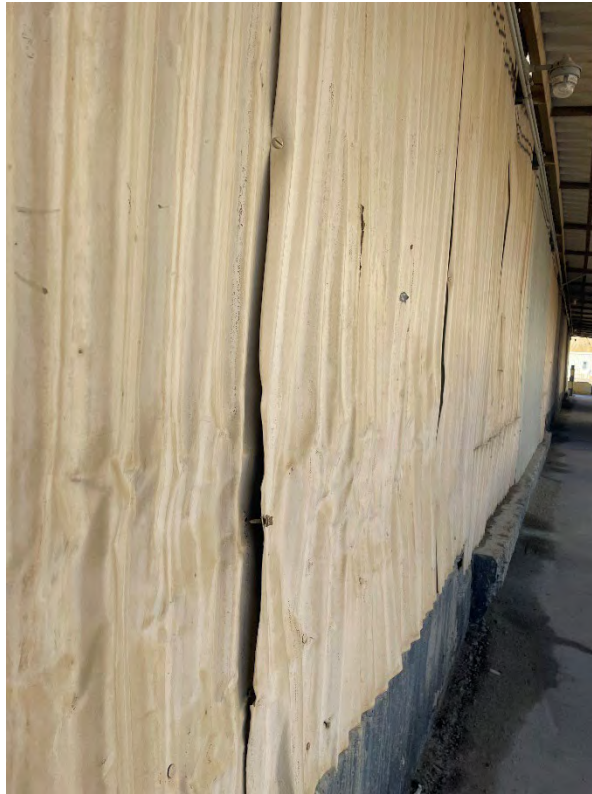
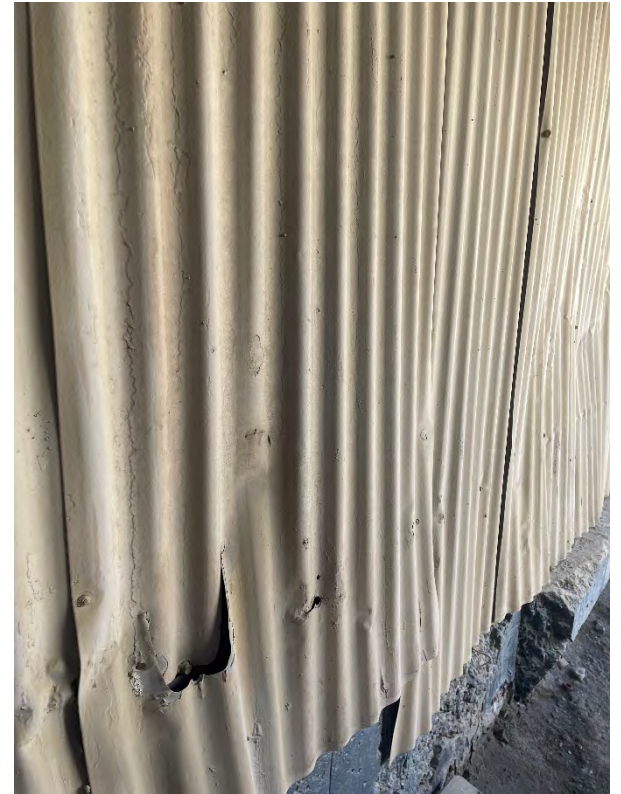
**MF-08**  
**External Damage**

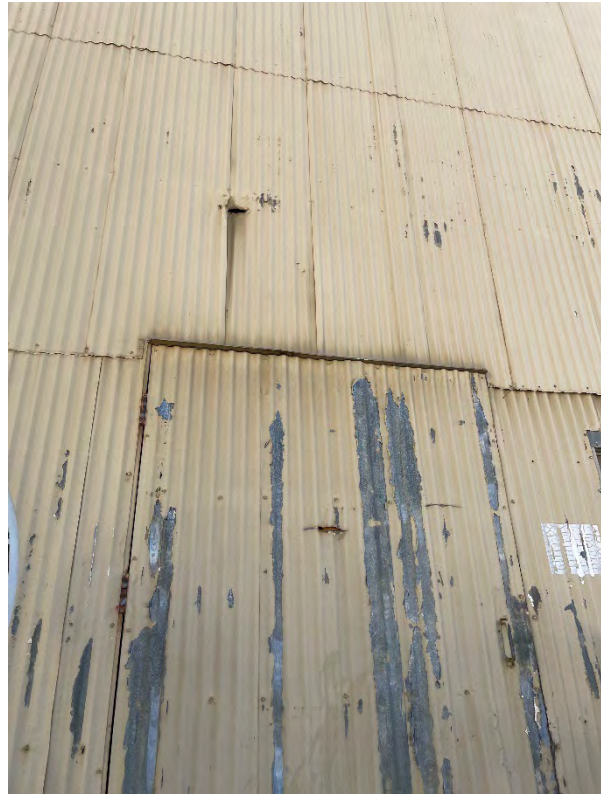
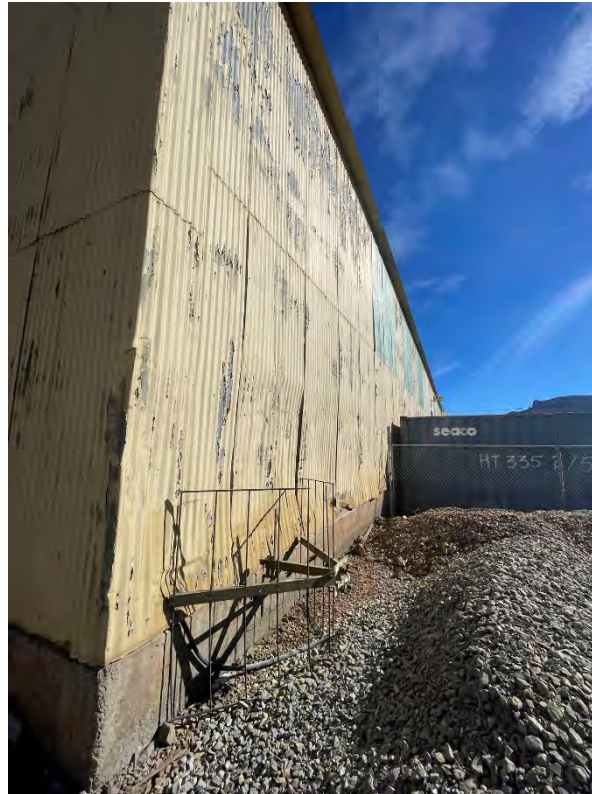
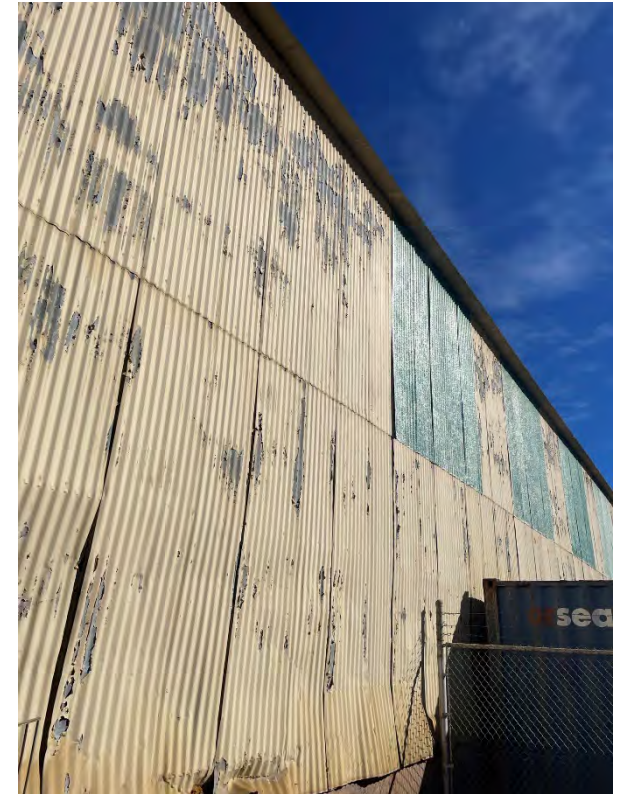
**MF-08**  
**External Damage**

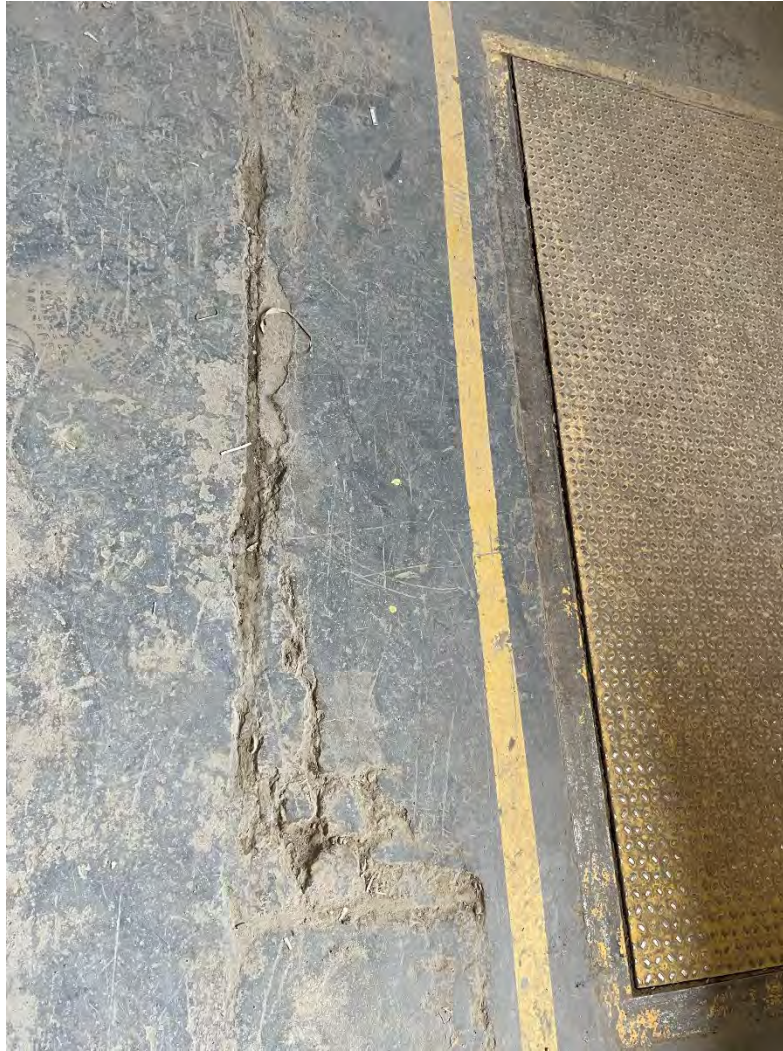
**MF-08**  
**Internal Damage**

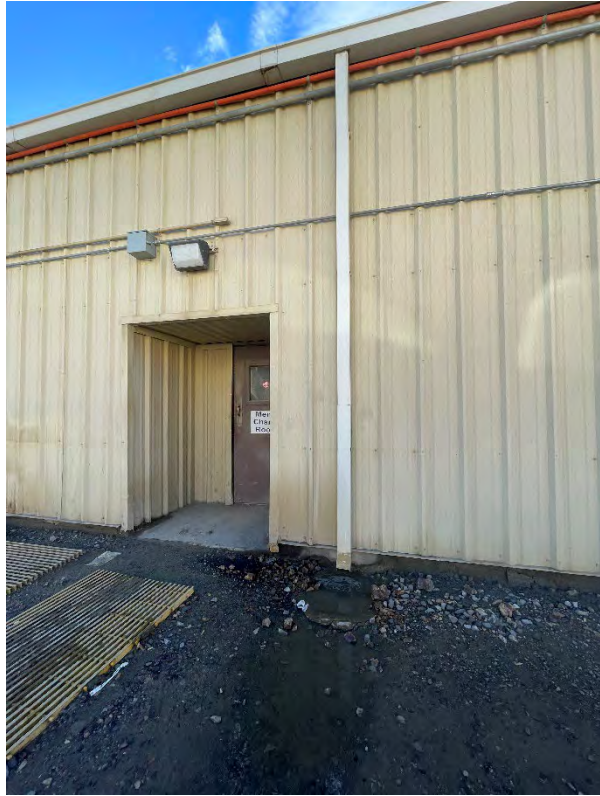
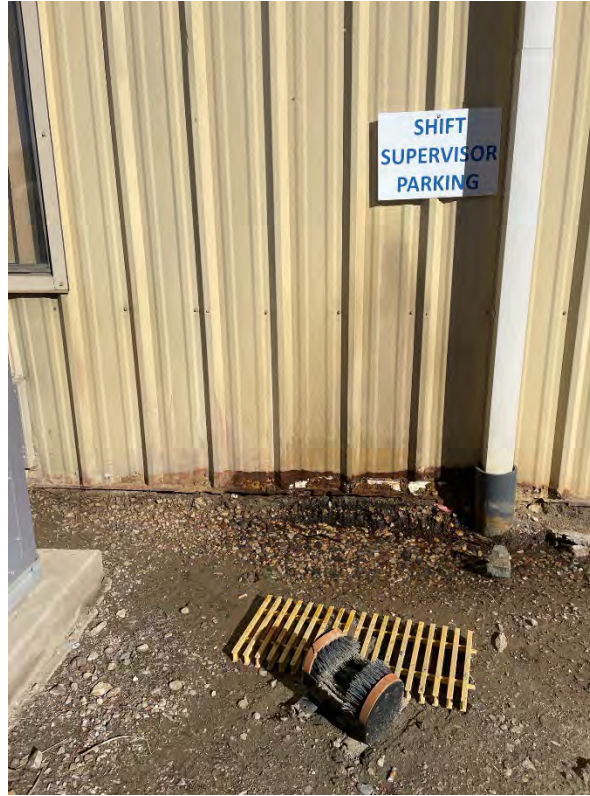
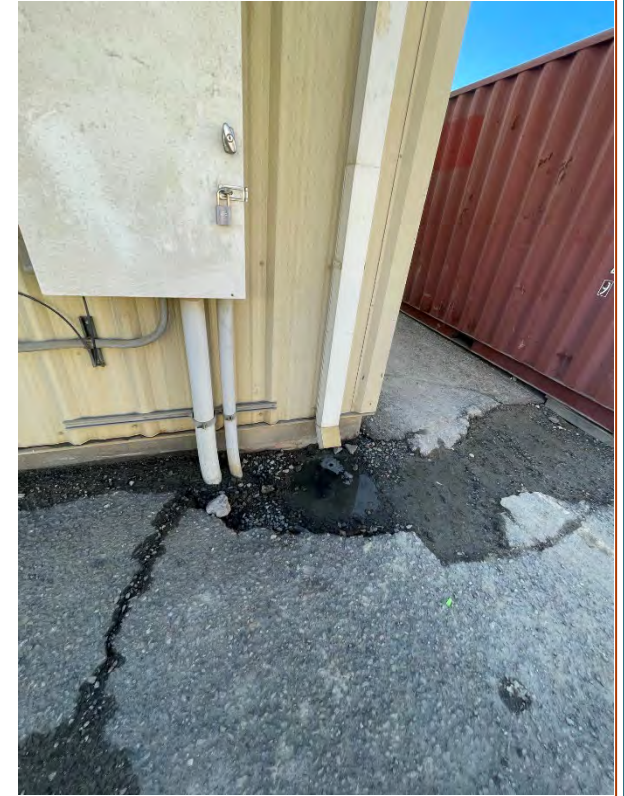
**MF-09**  
**External Damage**

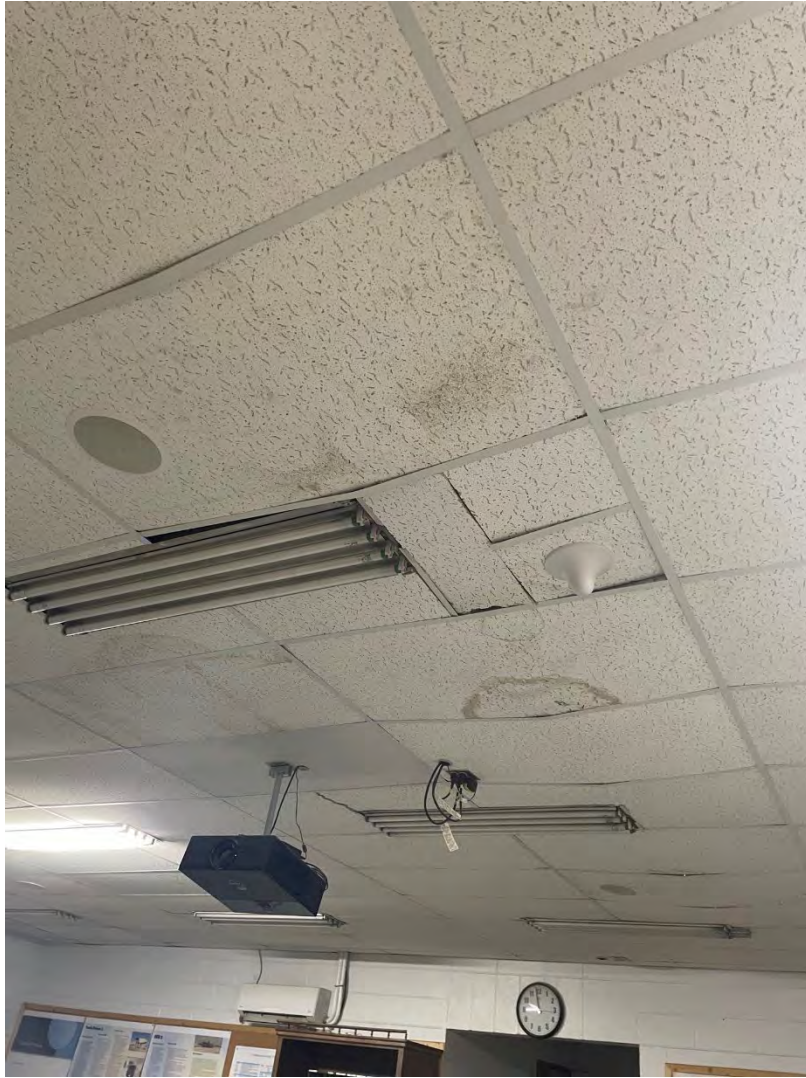
**MF-09**  
**Internal Damage**

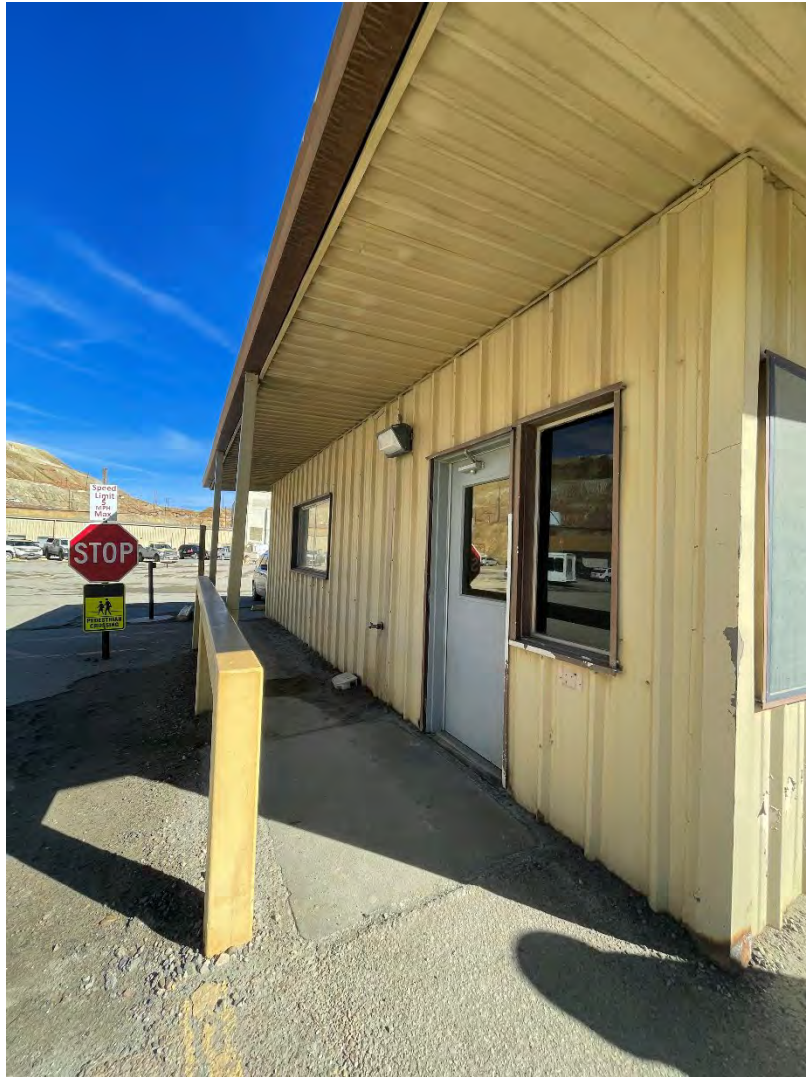
**MF-11**  
**External View & Damage**

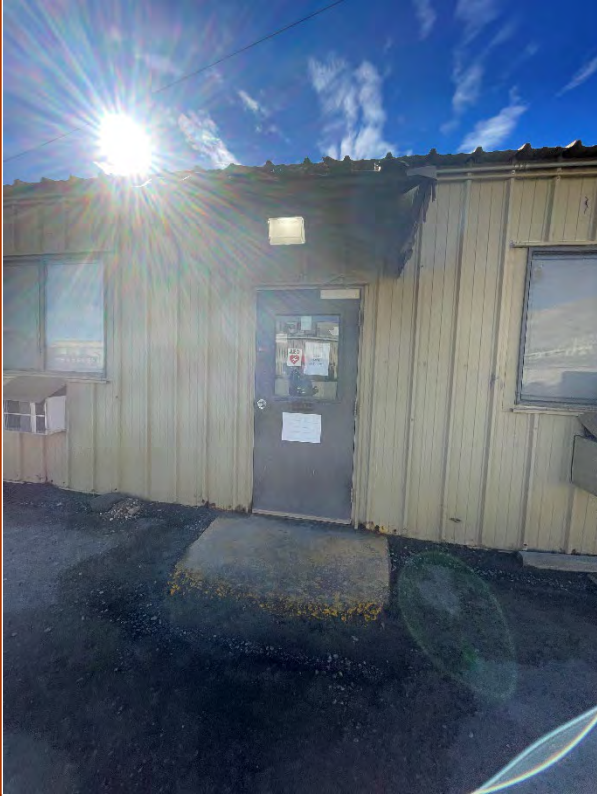
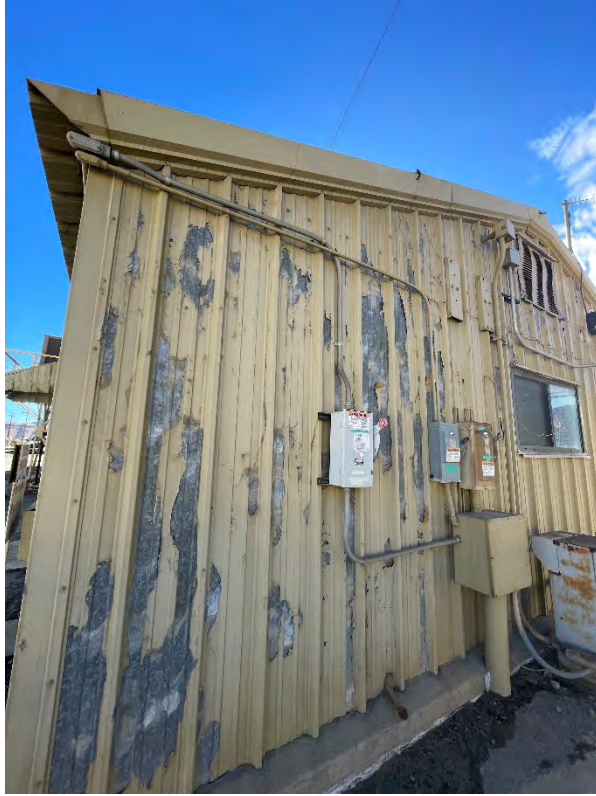
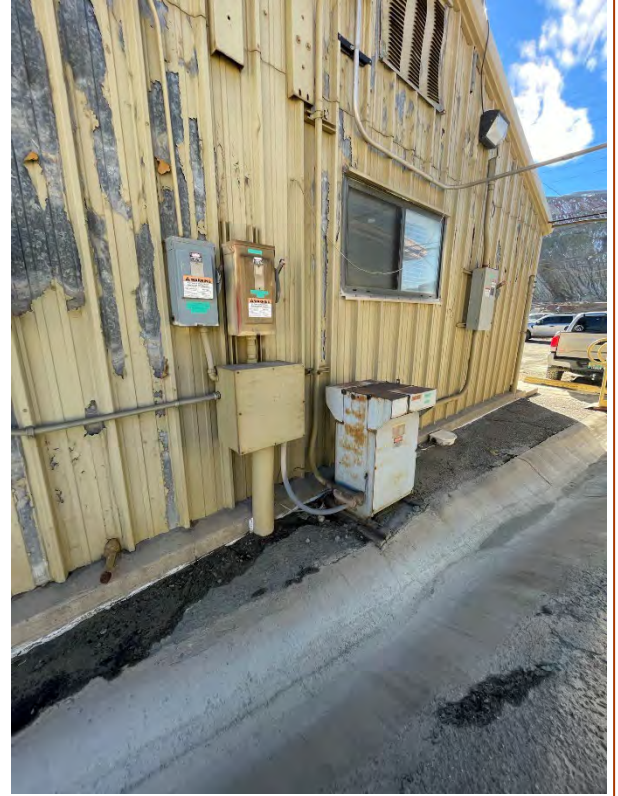
**MF-12**  
**External View & Damage**

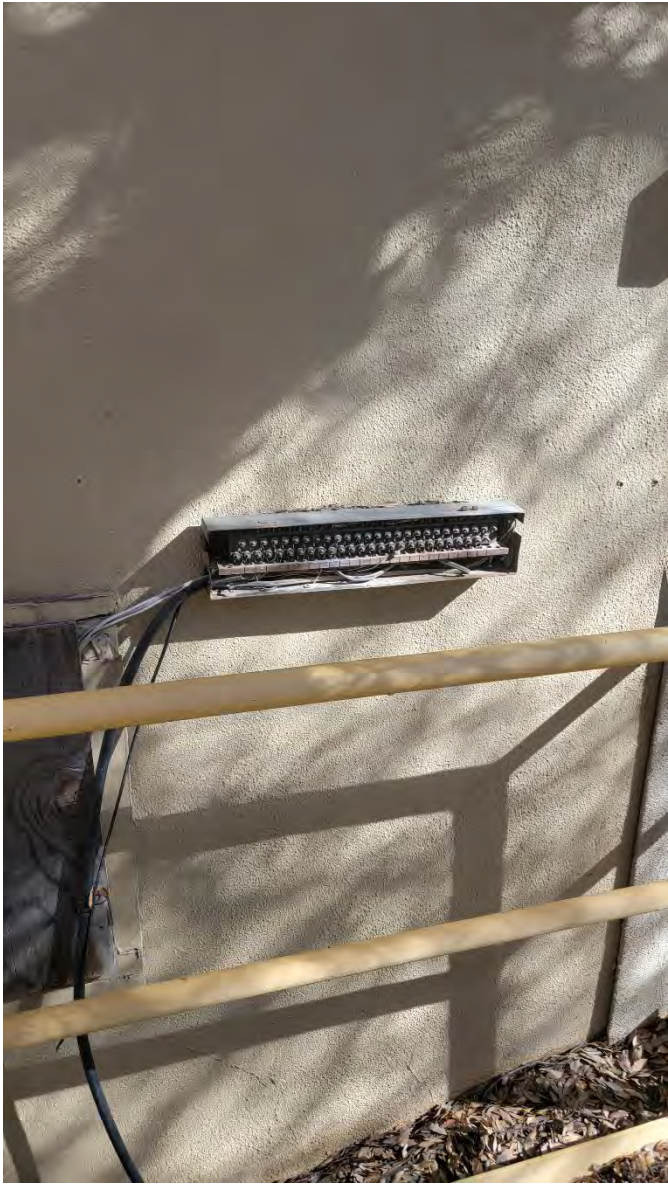
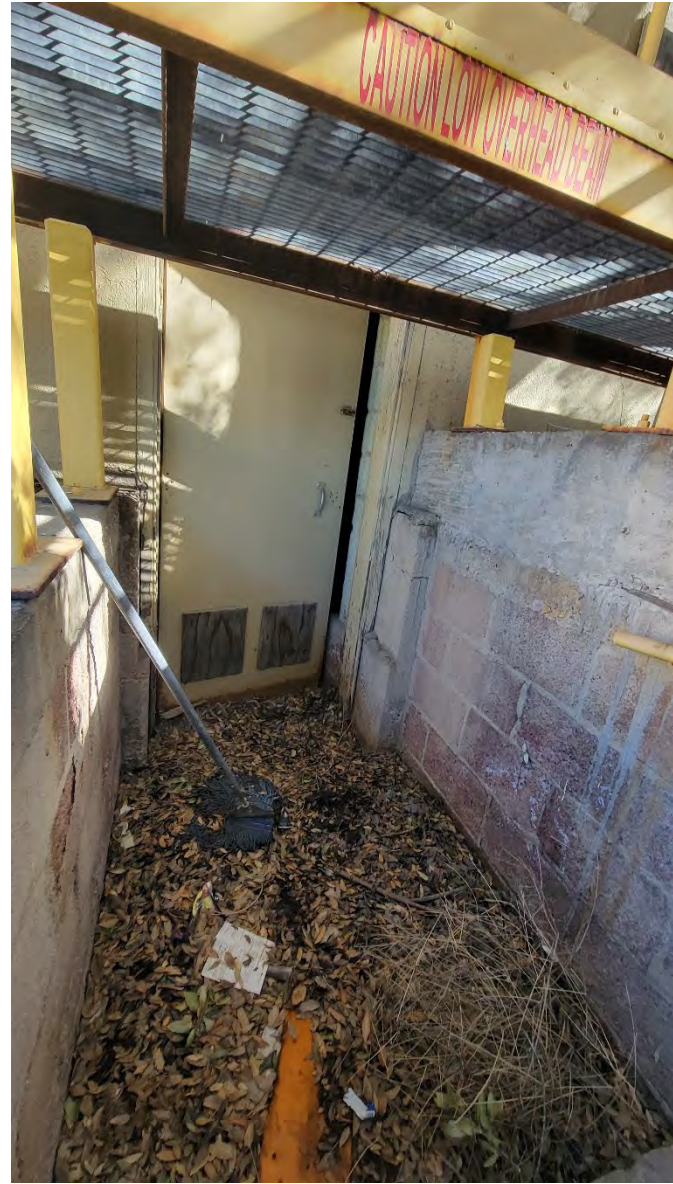
**MF-13**  
**External Damage**

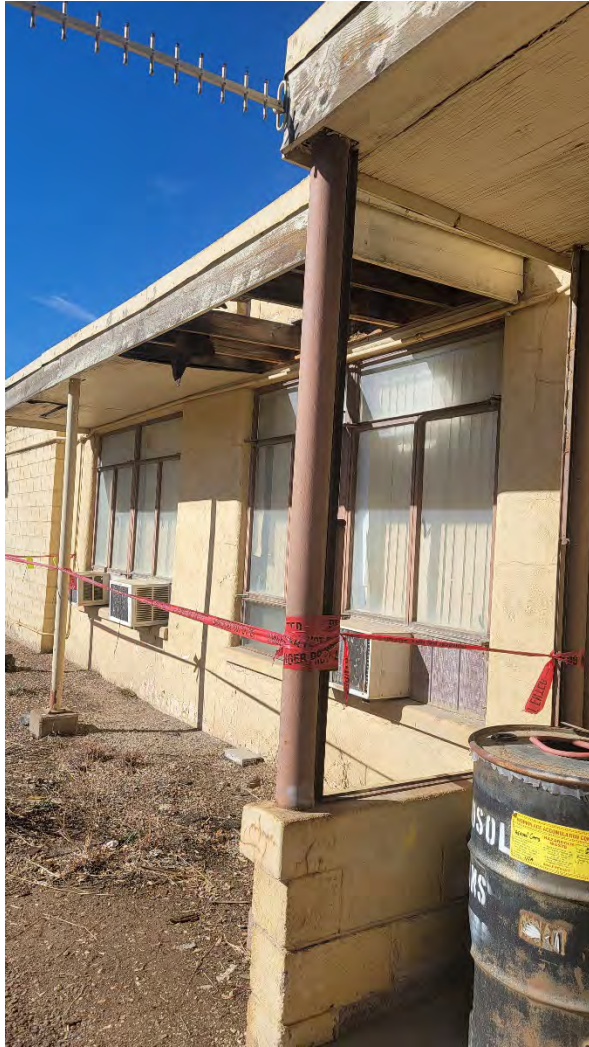
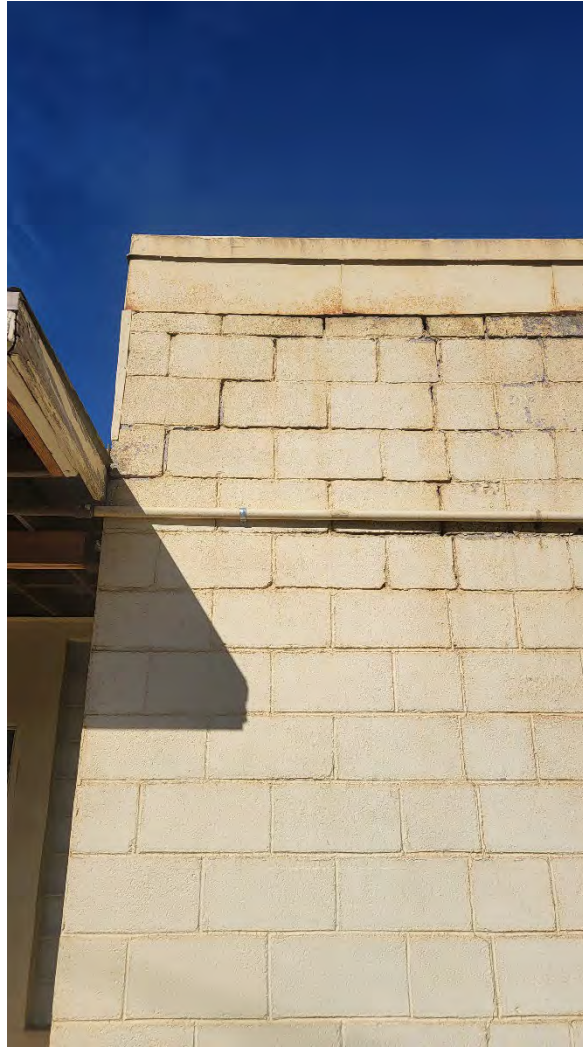
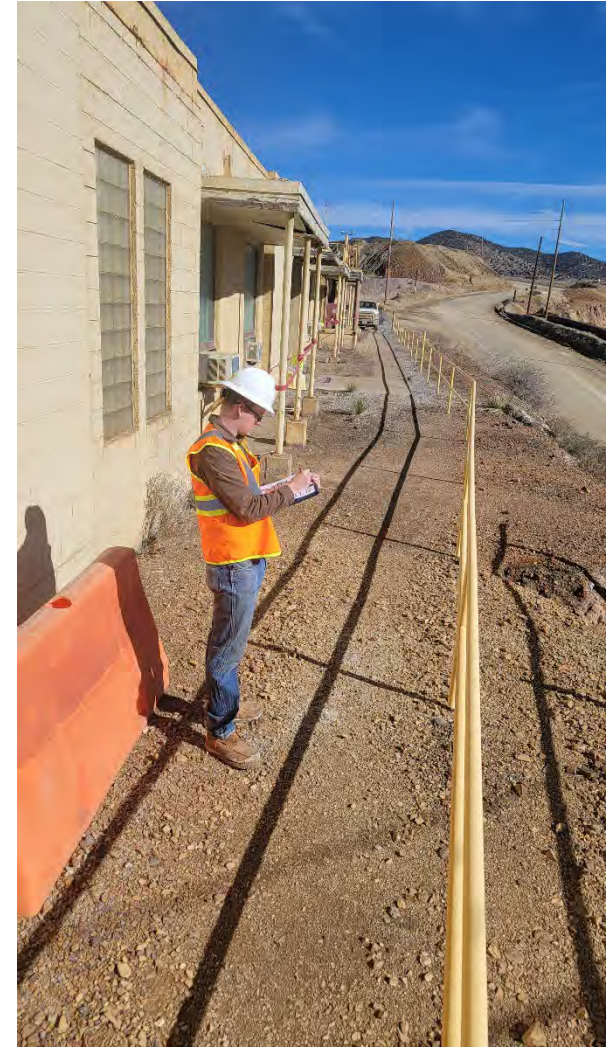
**MF-14**  
**External View & Damage**

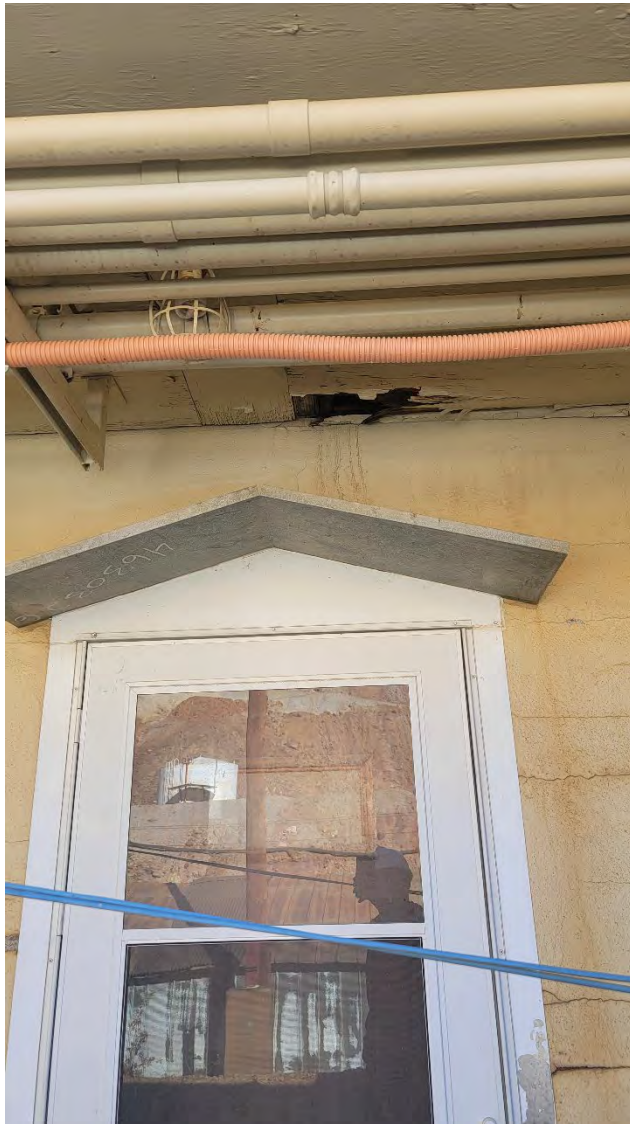
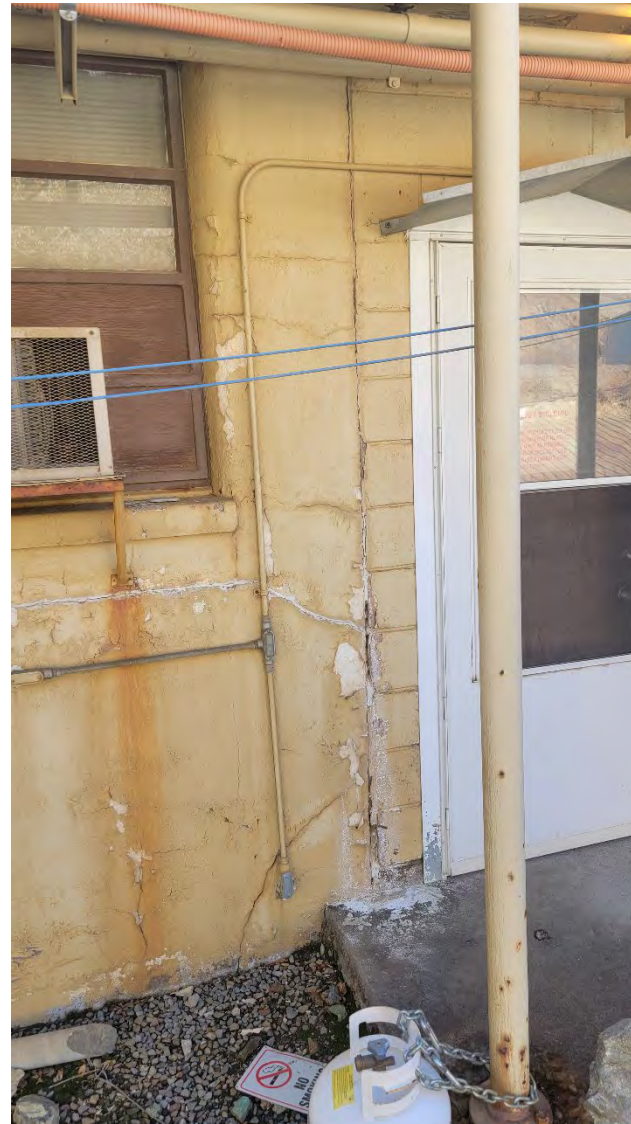
**MF-14**  
**External Damage**
