# Post Mine Land Use Building Inspections

**Freeport-McMoRan Inc.  
Chino Mines Company  
99 Santa Rita Mine Road  
Vanadium, New Mexico 88043**

**Telesto Solutions Inc.  
750 14<sup>th</sup> Street SW  
Loveland, Colorado 80537**

**March 2024**

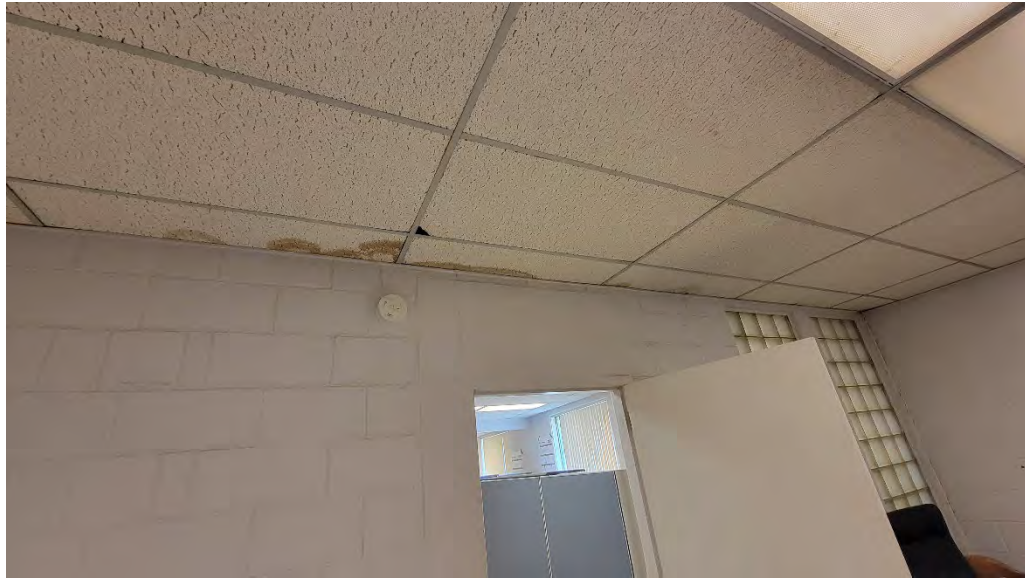
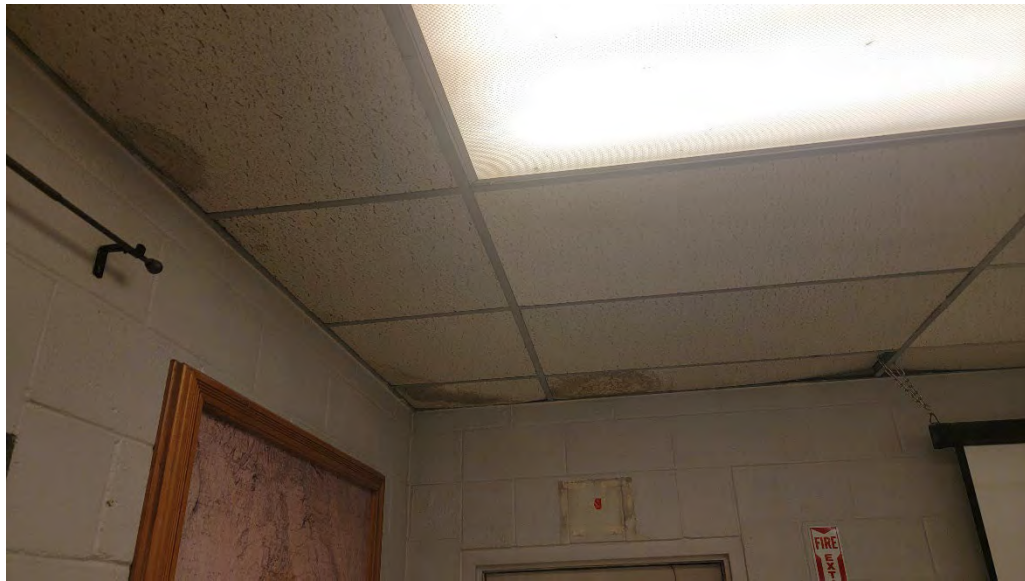
**MF-14**  
**Internal Damage**

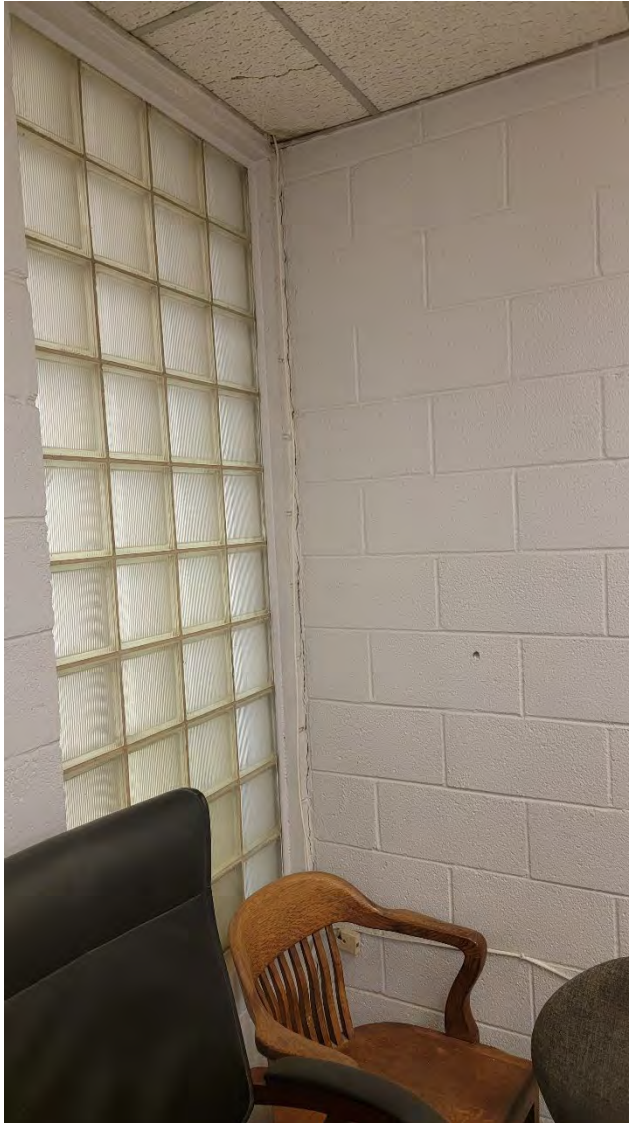
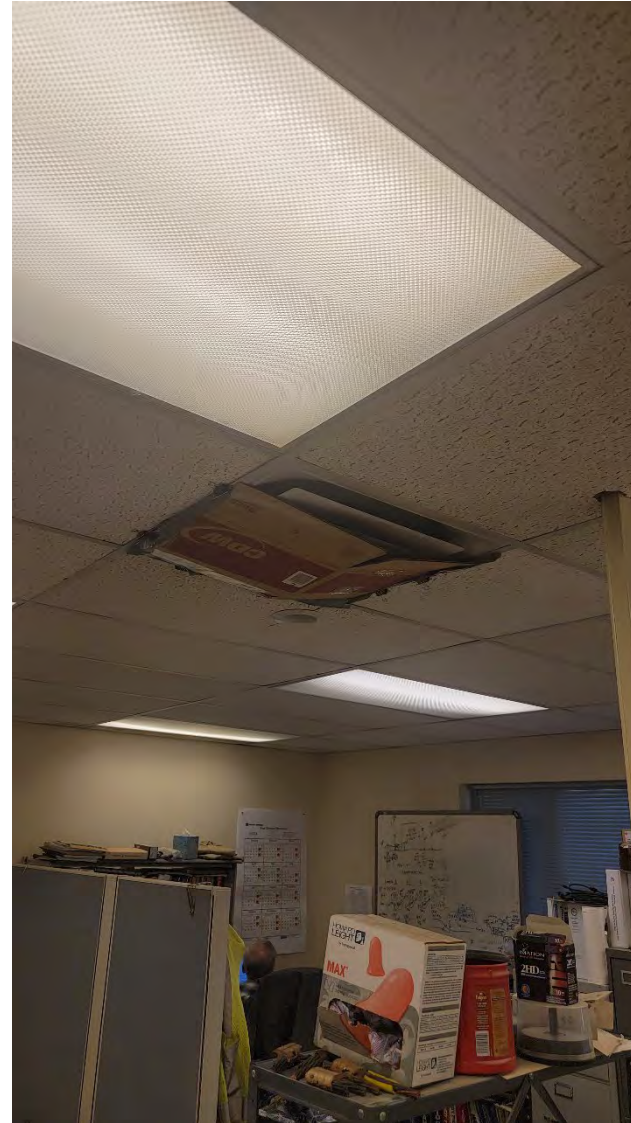
**MF-14**  
**Internal Damage**

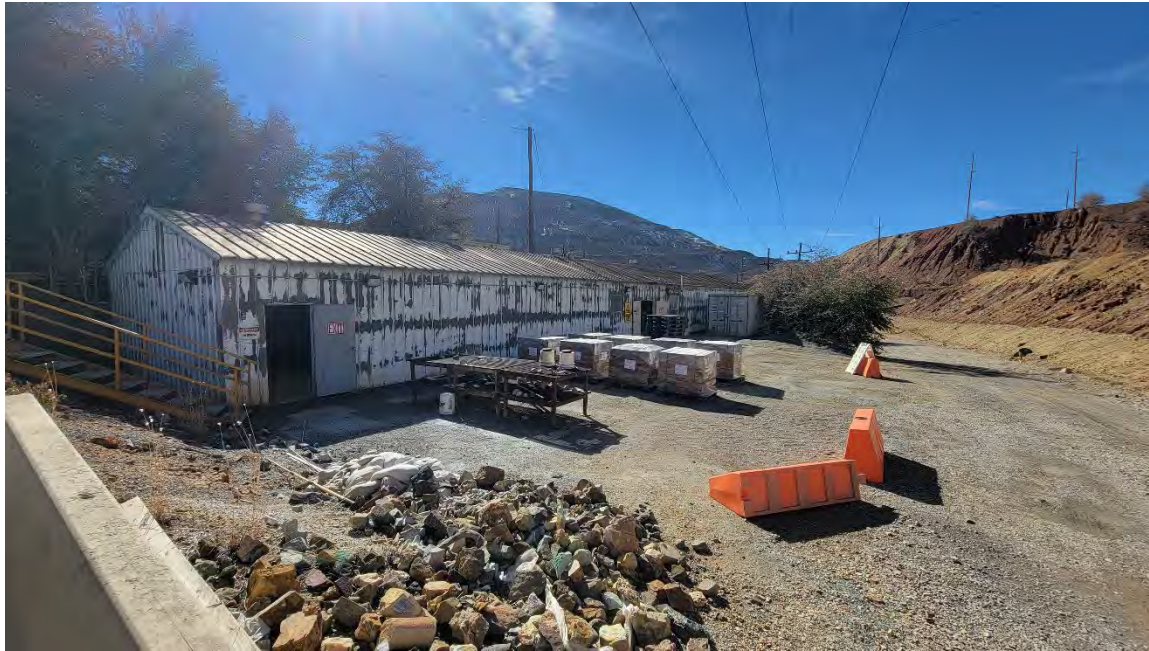
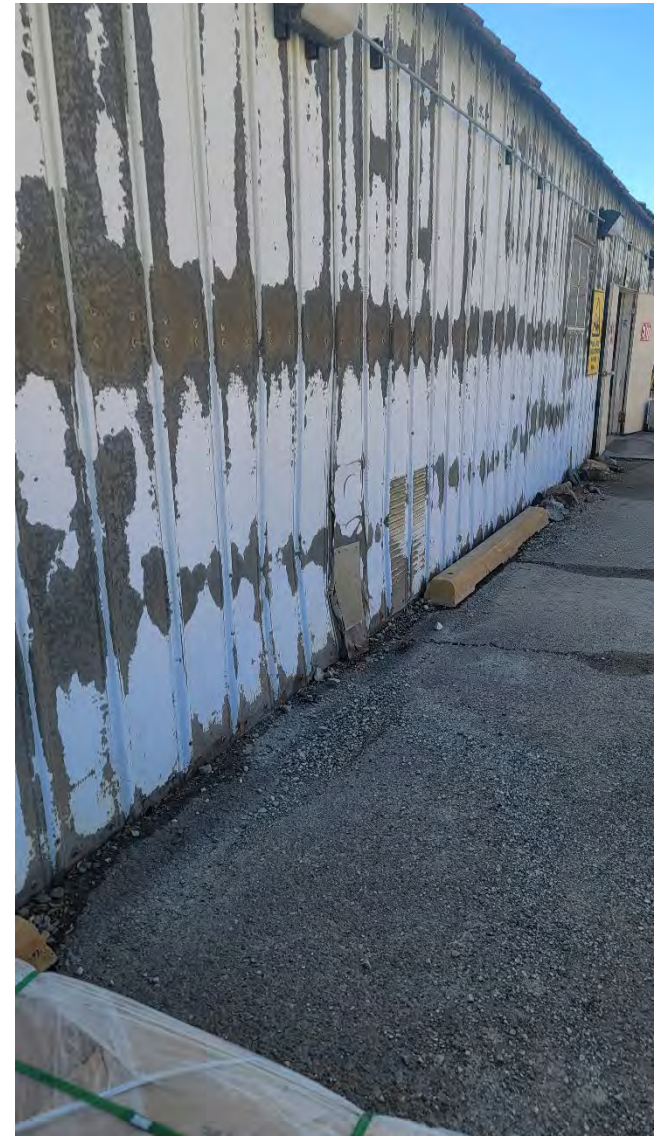
Category	Condition			Comments
	Good	Fair	Poor	
<b>Civil</b>				
Condition of Site	X			
Drainage Around Facility	X			
Access to Facility	X			
Building Parking	X			
Fencing or Security				
<b>Foundation</b>				
Foundation		X		
Floor Slabs		X		
If process Facility: Cond of equip fnds				
<b>Structure</b>				
Framing: Walls	<del>X</del>	X		Dent TV side of building Holes in rock ☐
Framing: Roofs		X		
Framing: Internal	X			
If Concrete structure				
<b>Mechanical</b>				
HVAC if present				na
Water Supply if present				na
Waste water if present				na
Other utilities if present				
Fire protection if present				na - 1 fire extinguisher
<b>Piping</b>				
if facility is not building				
if facility is process				
<b>Electrical</b>				
Power supply	X			
Power distribution	X			
Lighting	X			
Other utilities if present				
<b>Architectural</b>				
Condition of Flooring	X			
Wall systems		X		Dent north side ☐
roofing		X		
ceilings		X

**MF-15**  
**External View & Damage**

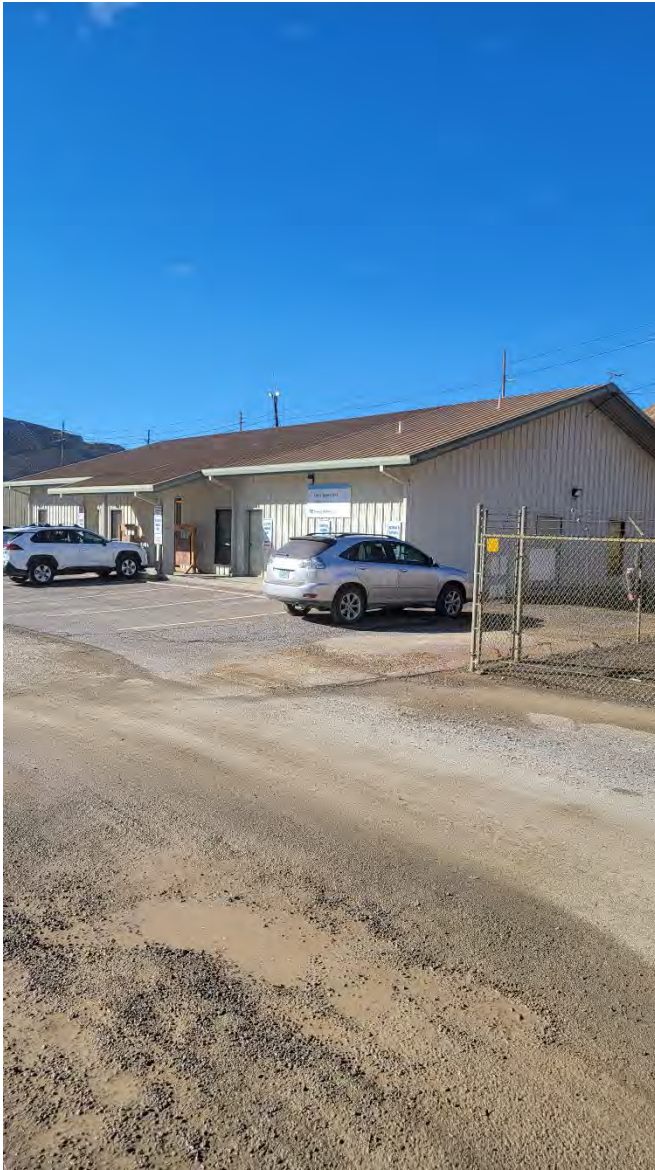
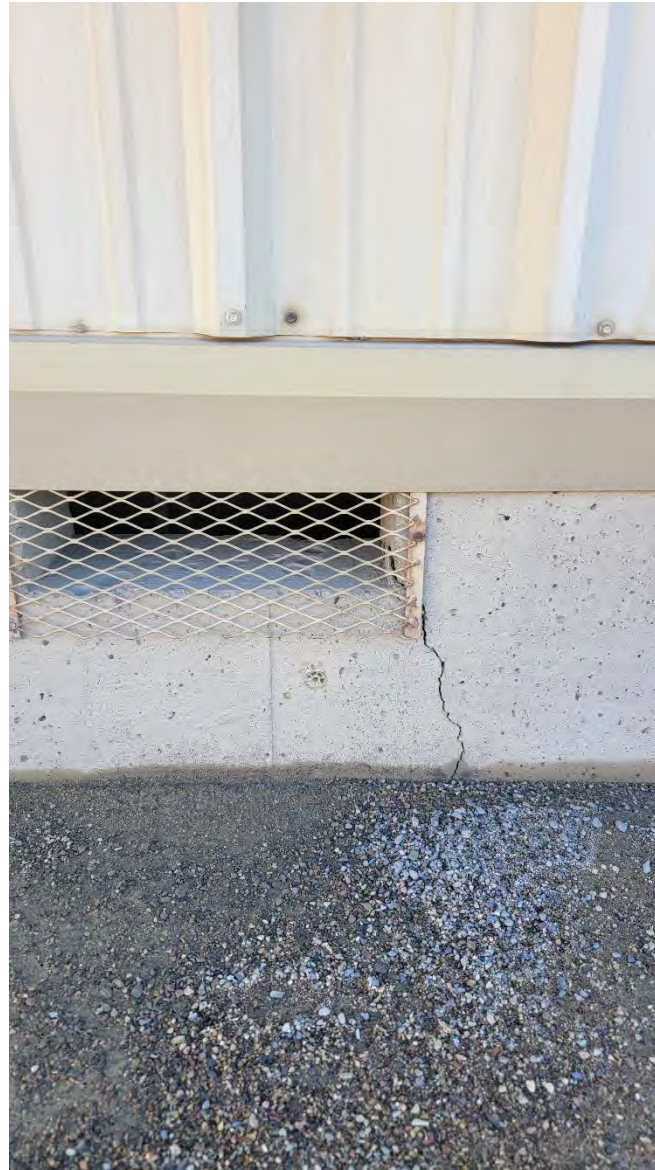
**MF-25**  
**External View & Damage**

Category	Condition			Comments
	Good	Fair	Poor	
<b>Civil</b>				
Condition of Site	X			na
Drainage Around Facility	X			
Access to Facility	X			
Building Parking	X			
Fencing or Security				
<b>Foundation</b>				
Foundation	X			
Floor Slabs	X			
If process Facility: Cond of equip fnds				
<b>Structure</b>				
Framing: Walls	X			na no access
Framing: Roofs				
Framing: Internal	X			
If Concrete structure				
<b>Mechanical</b>				
HVAC if present	X			na - multiple extinguisher
Water Supply if present	X			
Waste water if present	X			
Other utilities if present				
Fire protection if present				
<b>Piping</b>				
if facility is not building				
if facility is process				
<b>Electrical</b>				
Power supply	X			
Power distribution	X			
Lighting	X			
Other utilities if present				
<b>Architectural</b>				
Condition of Flooring	X			minor cracks  - 2
Wall systems	X			
roofing	X			
ceilings	X			
doors	X			
windows	X			
points of egress	X

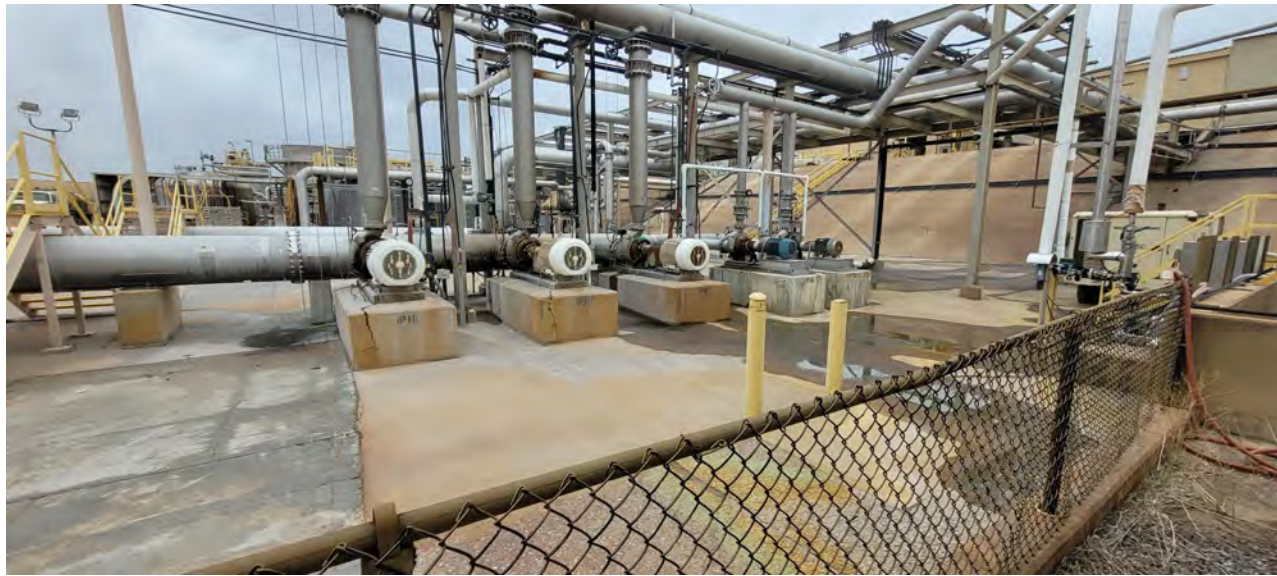
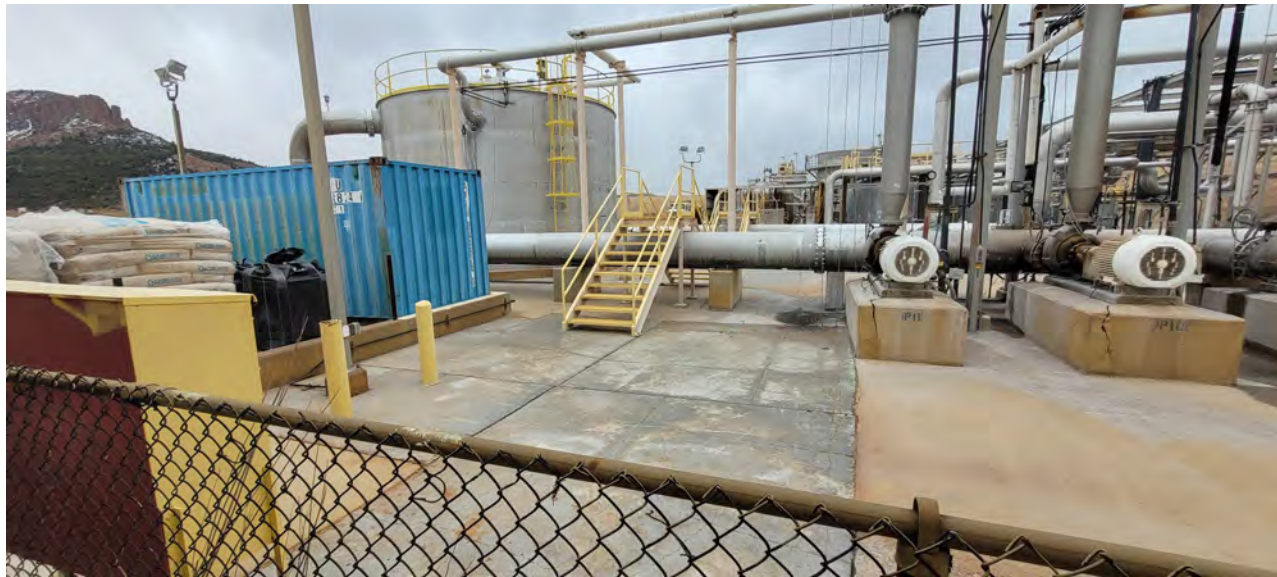
Category	Condition			Comments
	Good	Fair	Poor	
<b>Civil</b>				N/A
Condition of Site	X			- meant to contain <del>the</del> - Facilities intact
Drainage Around Facility				
Access to Facility	X			
Building Parking			X	
Fencing or Security			X	
<b>Foundation</b>				
Foundation	X			- East pmp foundation cracking
Floor Slabs	X			
If process Facility: Cond of equip fnds				
<b>Structure</b>				
Framing: Walls				↓
Framing: Roofs				
Framing: Internal				
If Concrete structure				
<b>Mechanical</b>				
HVAC if present				↓
Water Supply if present				
Waste water if present				
Other utilities if present				
Fire protection if present				
<b>Piping</b>				
if facility is not building				
if facility is process	X			
<b>Electrical</b>				
Power supply	X			
Power distribution	X			
Lighting	X			
Other utilities if present				
<b>Architectural</b>				
Condition of Flooring				↓
Wall systems				
roofing				
ceilings				
doors				
windows

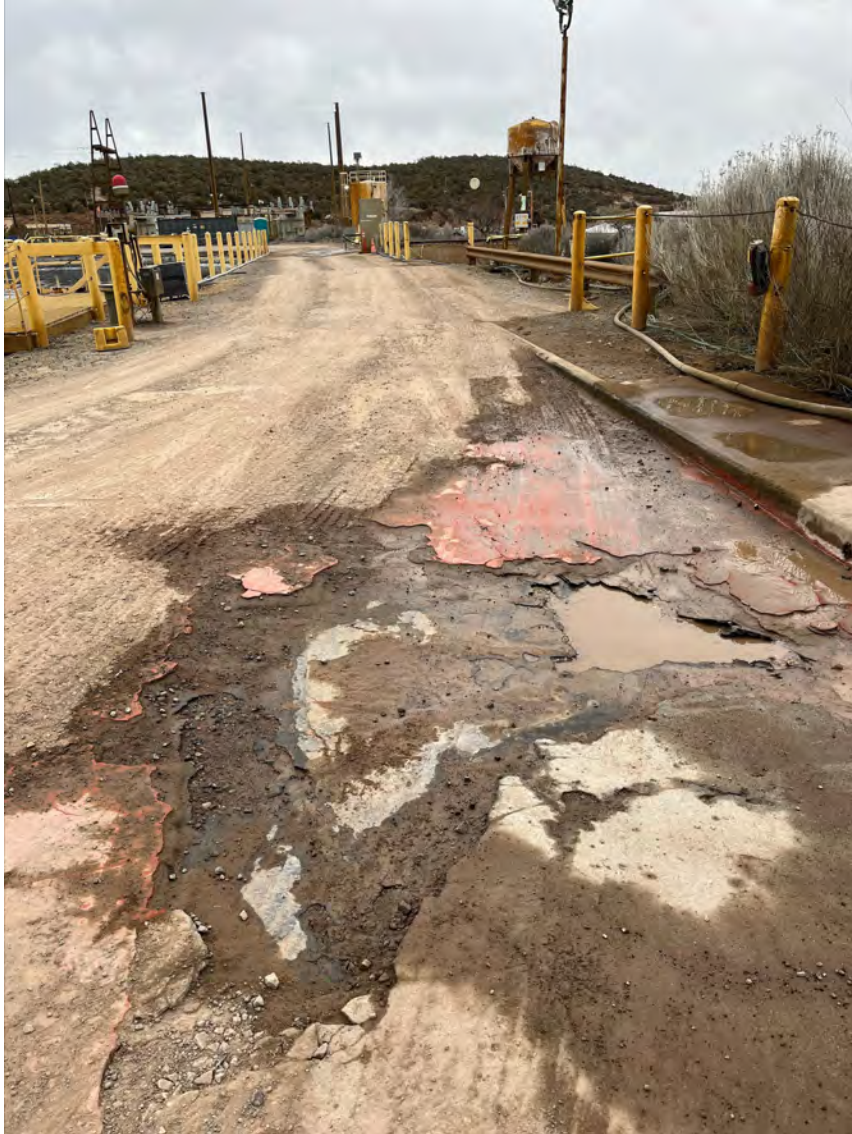
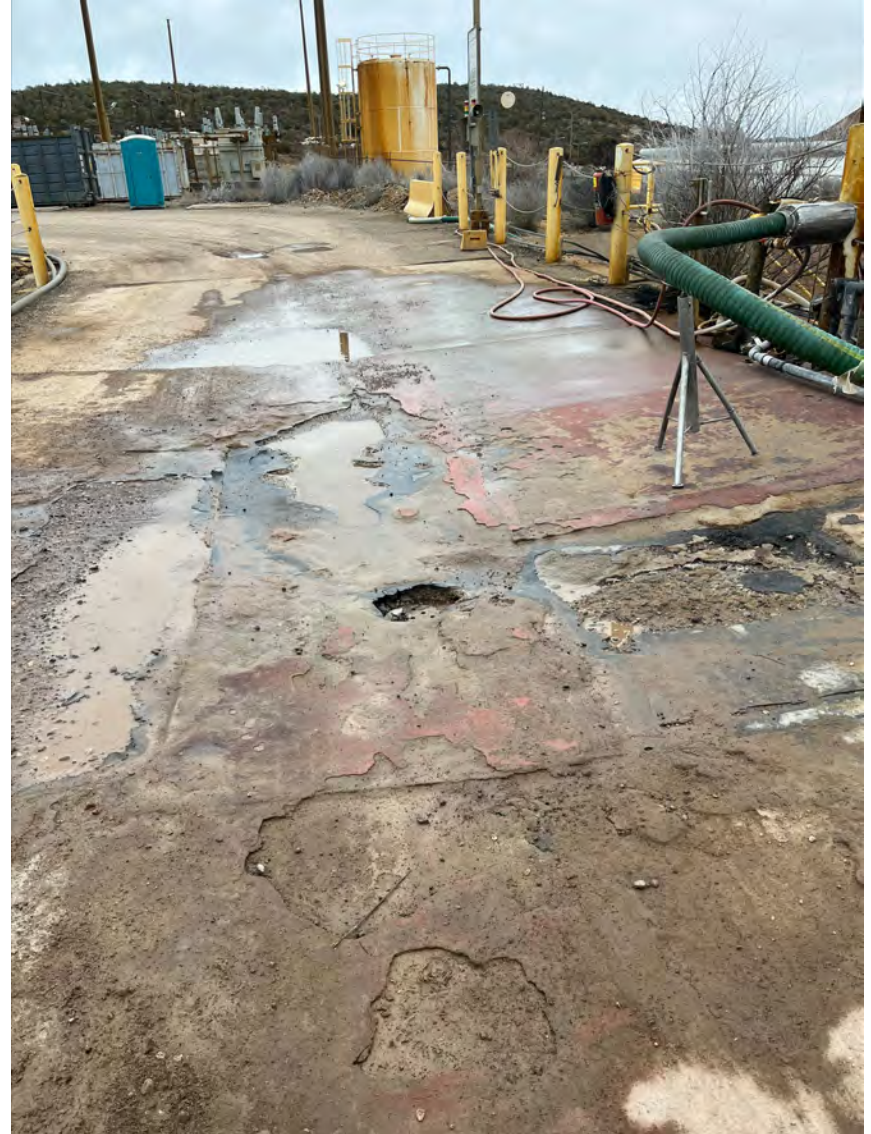
**SX-11**  
**External Damage**
